Åtgärder på läckande dammar i Australien

SwedCOLD

2016-10-25
Rohan Sutton
WSP Vattenbyggnad

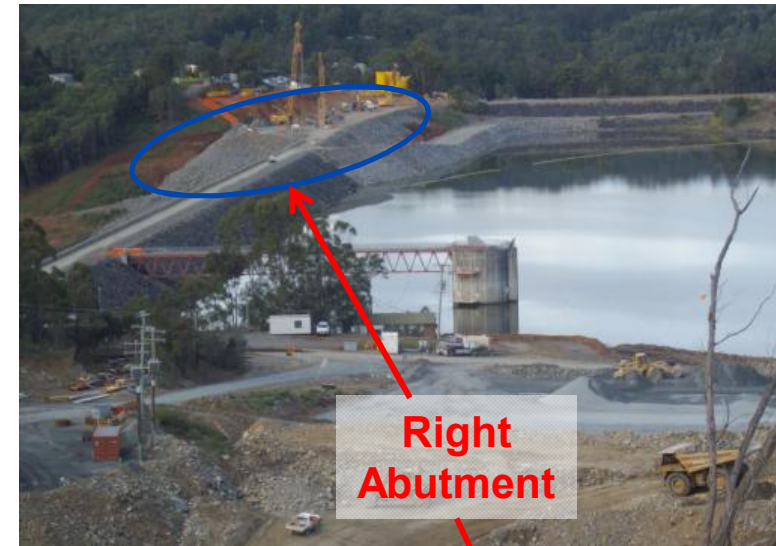
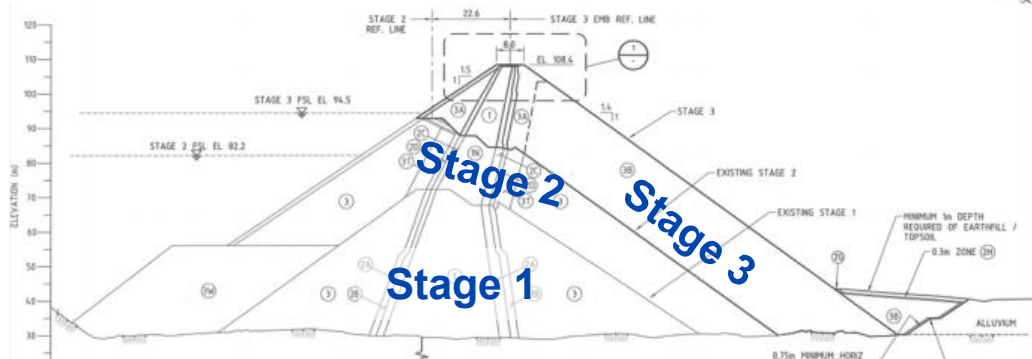
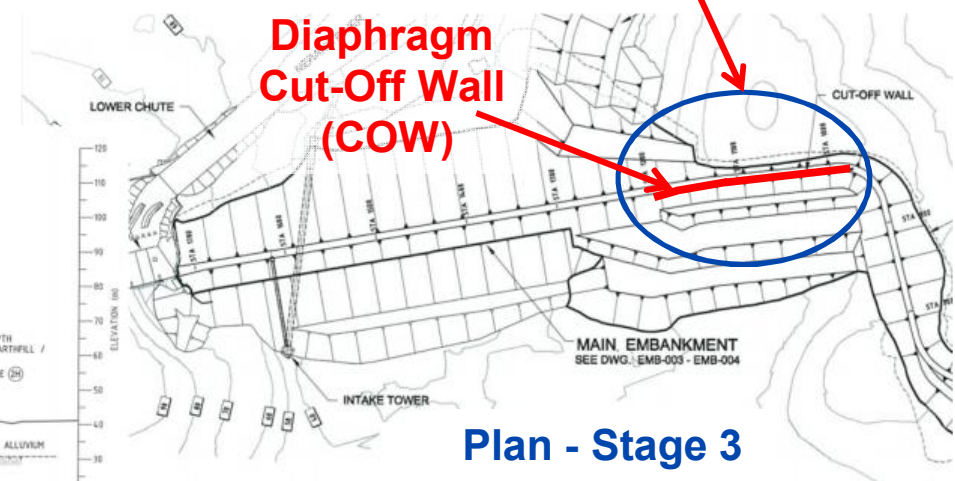
Diaphragm walls – Hinze Dam

- Complex geology on right abutment; deep weathering up to 40m deep and highly permeable
- High risk of internal erosion and piping in the right abutment foundation
- Foundation piezometric pressures impacting embankment stability

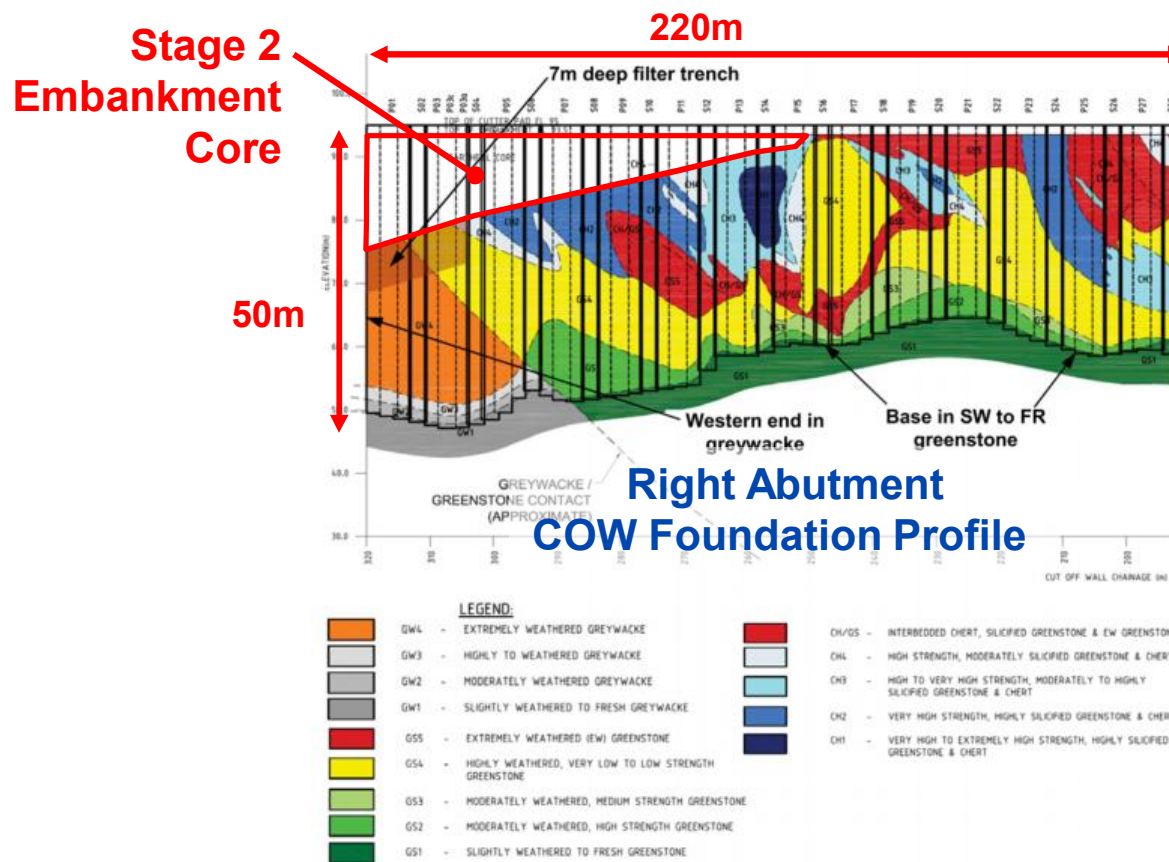
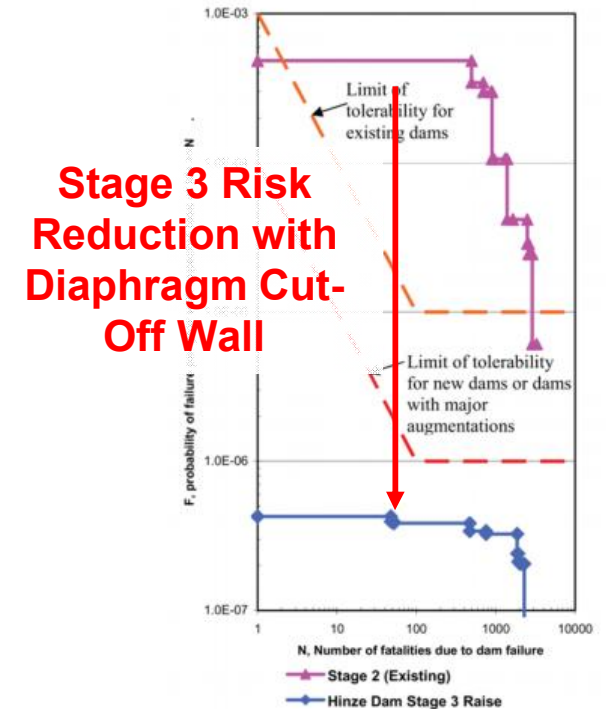
Diaphragm walls – Hinze Dam (cont.)

- Extensive foundation grouting performed during Stage 2; does not provide an effective cut-off to seepage
- Highly varied weathering and strength (UCS up to 160MPa)
- Direct seepage connection to the reservoir through the foundation

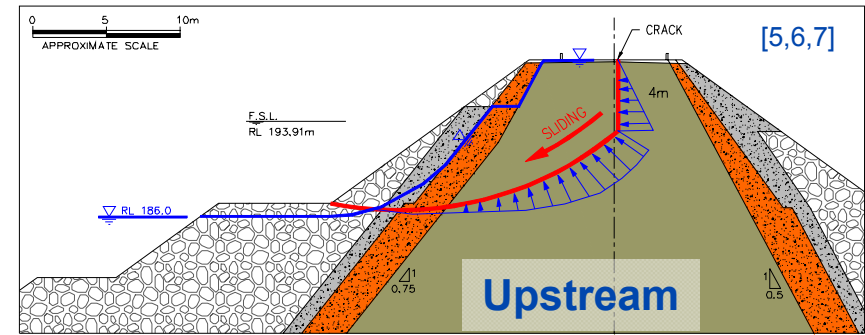
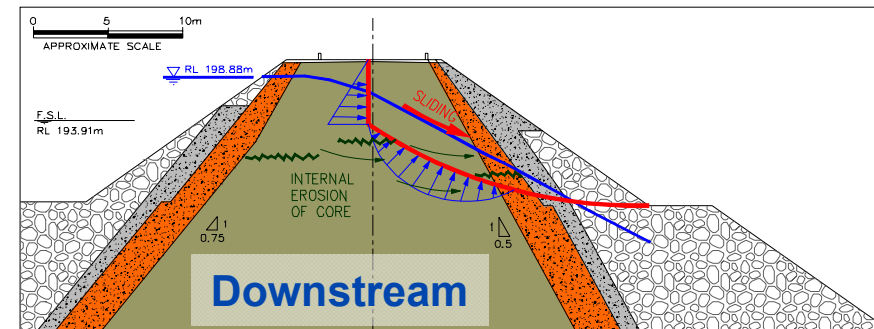
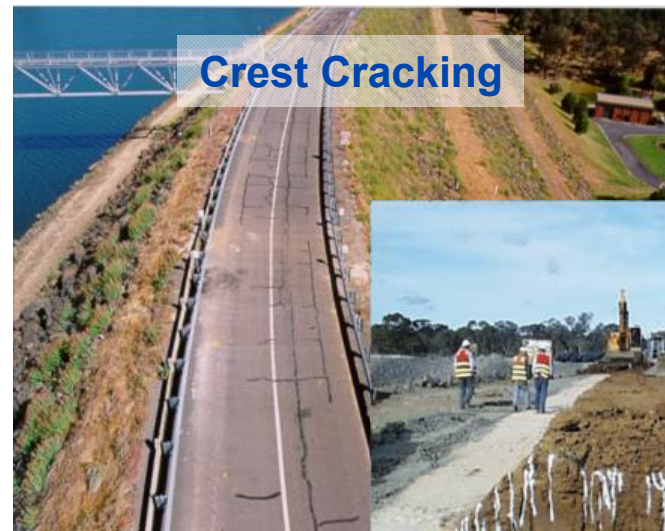
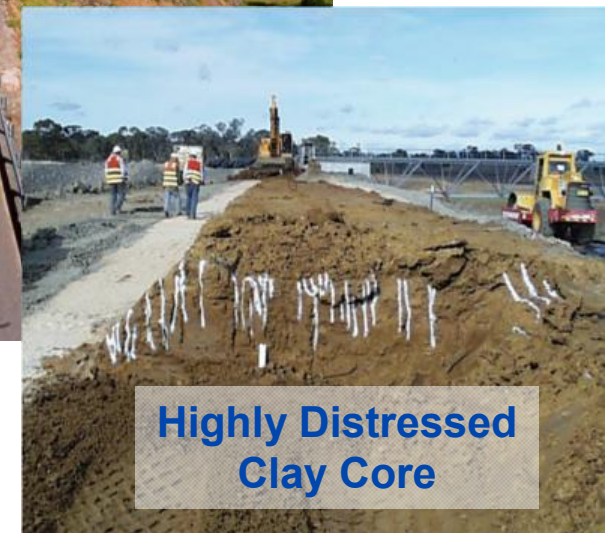
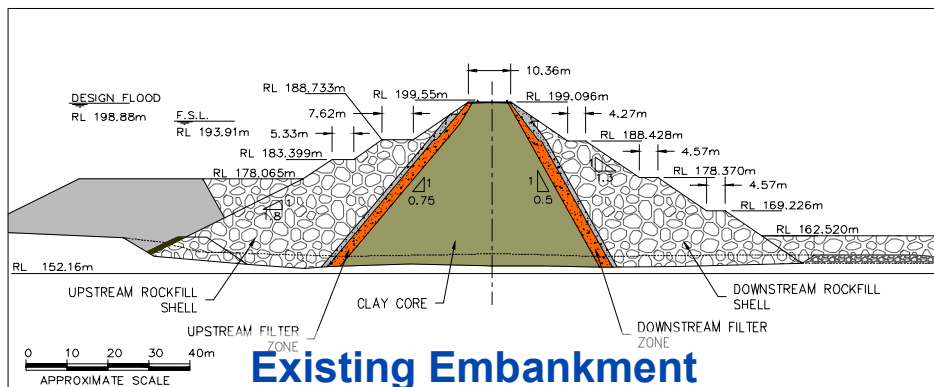
Filter Buttresses - Crest

- Large differential settlement between the core and the rockfill shoulders; longitudinal cracking, water infiltration/softening of core
- Upstream – instability
- Downstream - instability and piping (dirty, cohesive filters)

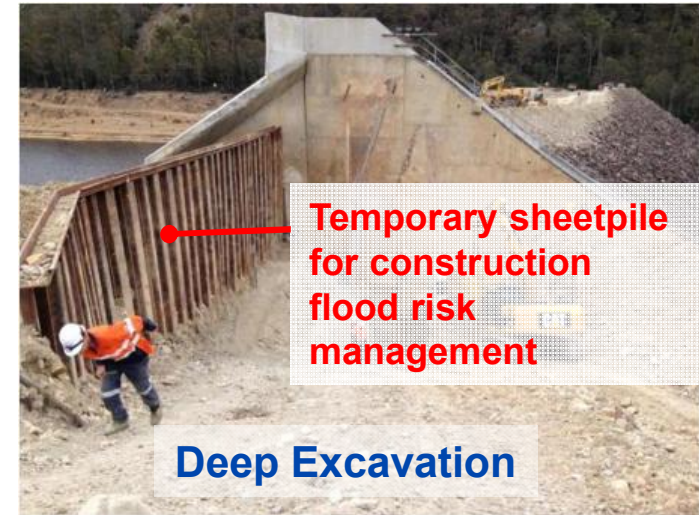
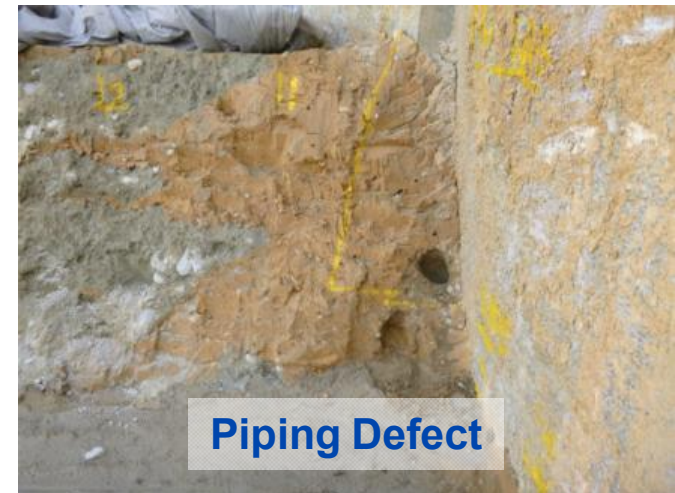
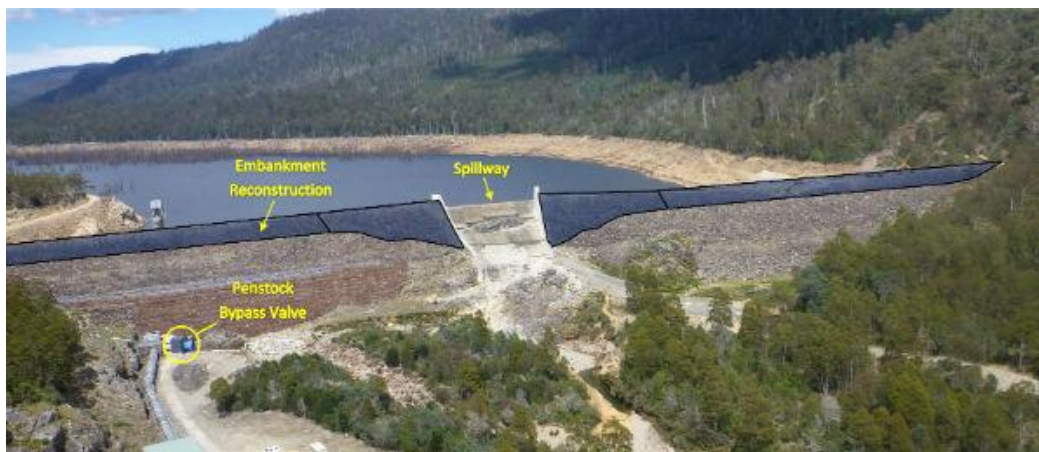
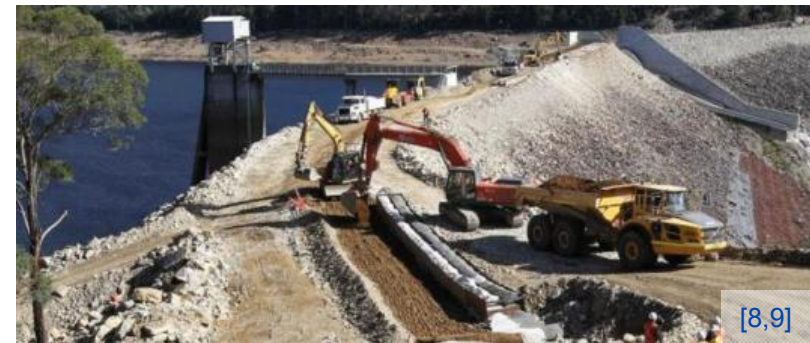
Embankment Reconstruction

- Piping incident in glacial fill against spillway wall (1968); poor filters

- Removal and rebuilding of the upper 7m of the embankment
- Reconstructing the embankment from crest to foundation adjacent to the central spillway walls

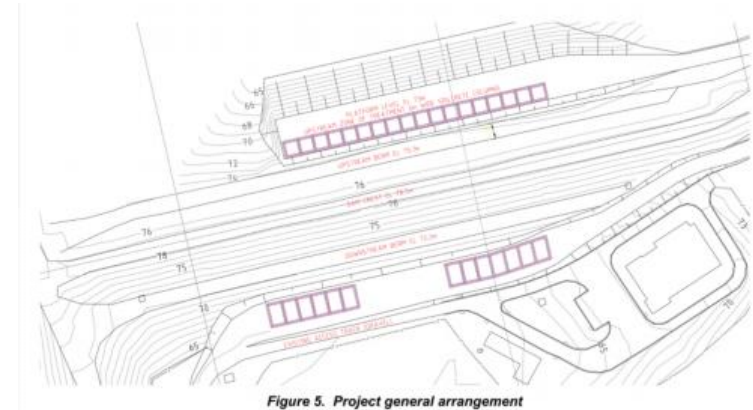
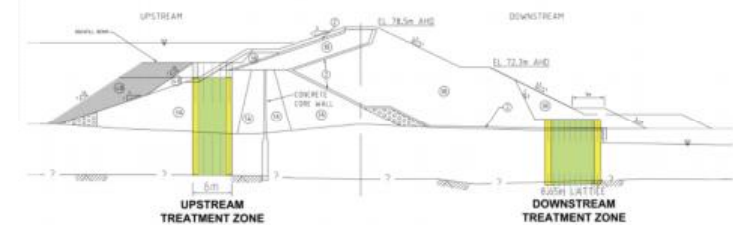
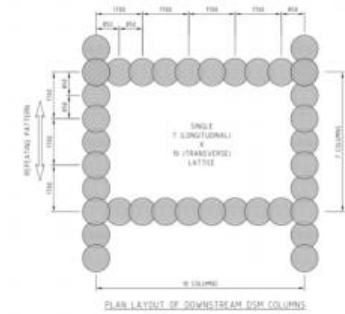
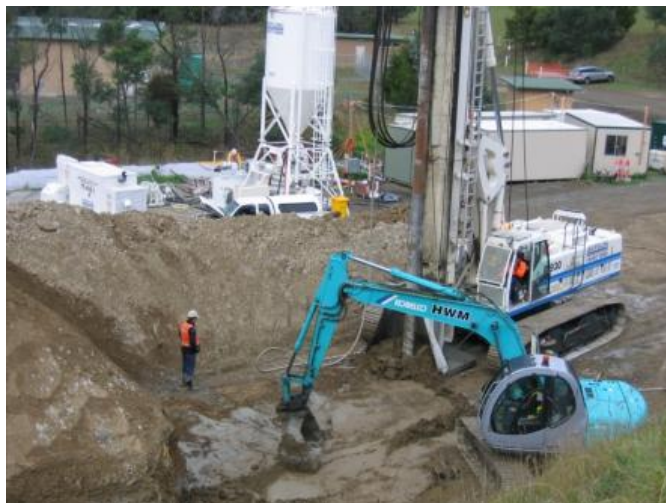
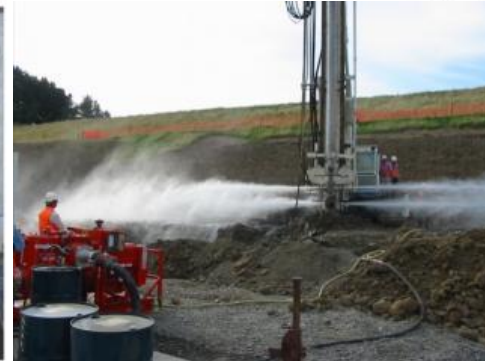
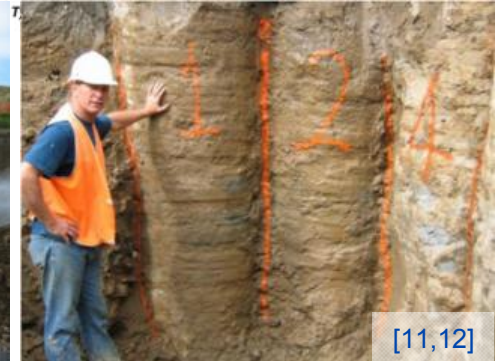
Deep-Soil Mixing (DSM)

- 10m deep alluvial soils foundation
- Sands susceptible to liquefaction under earthquake loading

- Deep-soil mixing to strengthen foundation; grout cement and bentonite mix
