# TOUS DAM REVISITED

## A Common Sense Disaster

Stockholm  
October, 19th., 2022

Dr. Juan B. Marco  
Professor "Ad Honorem"  
Universidad Politécnica de Valencia

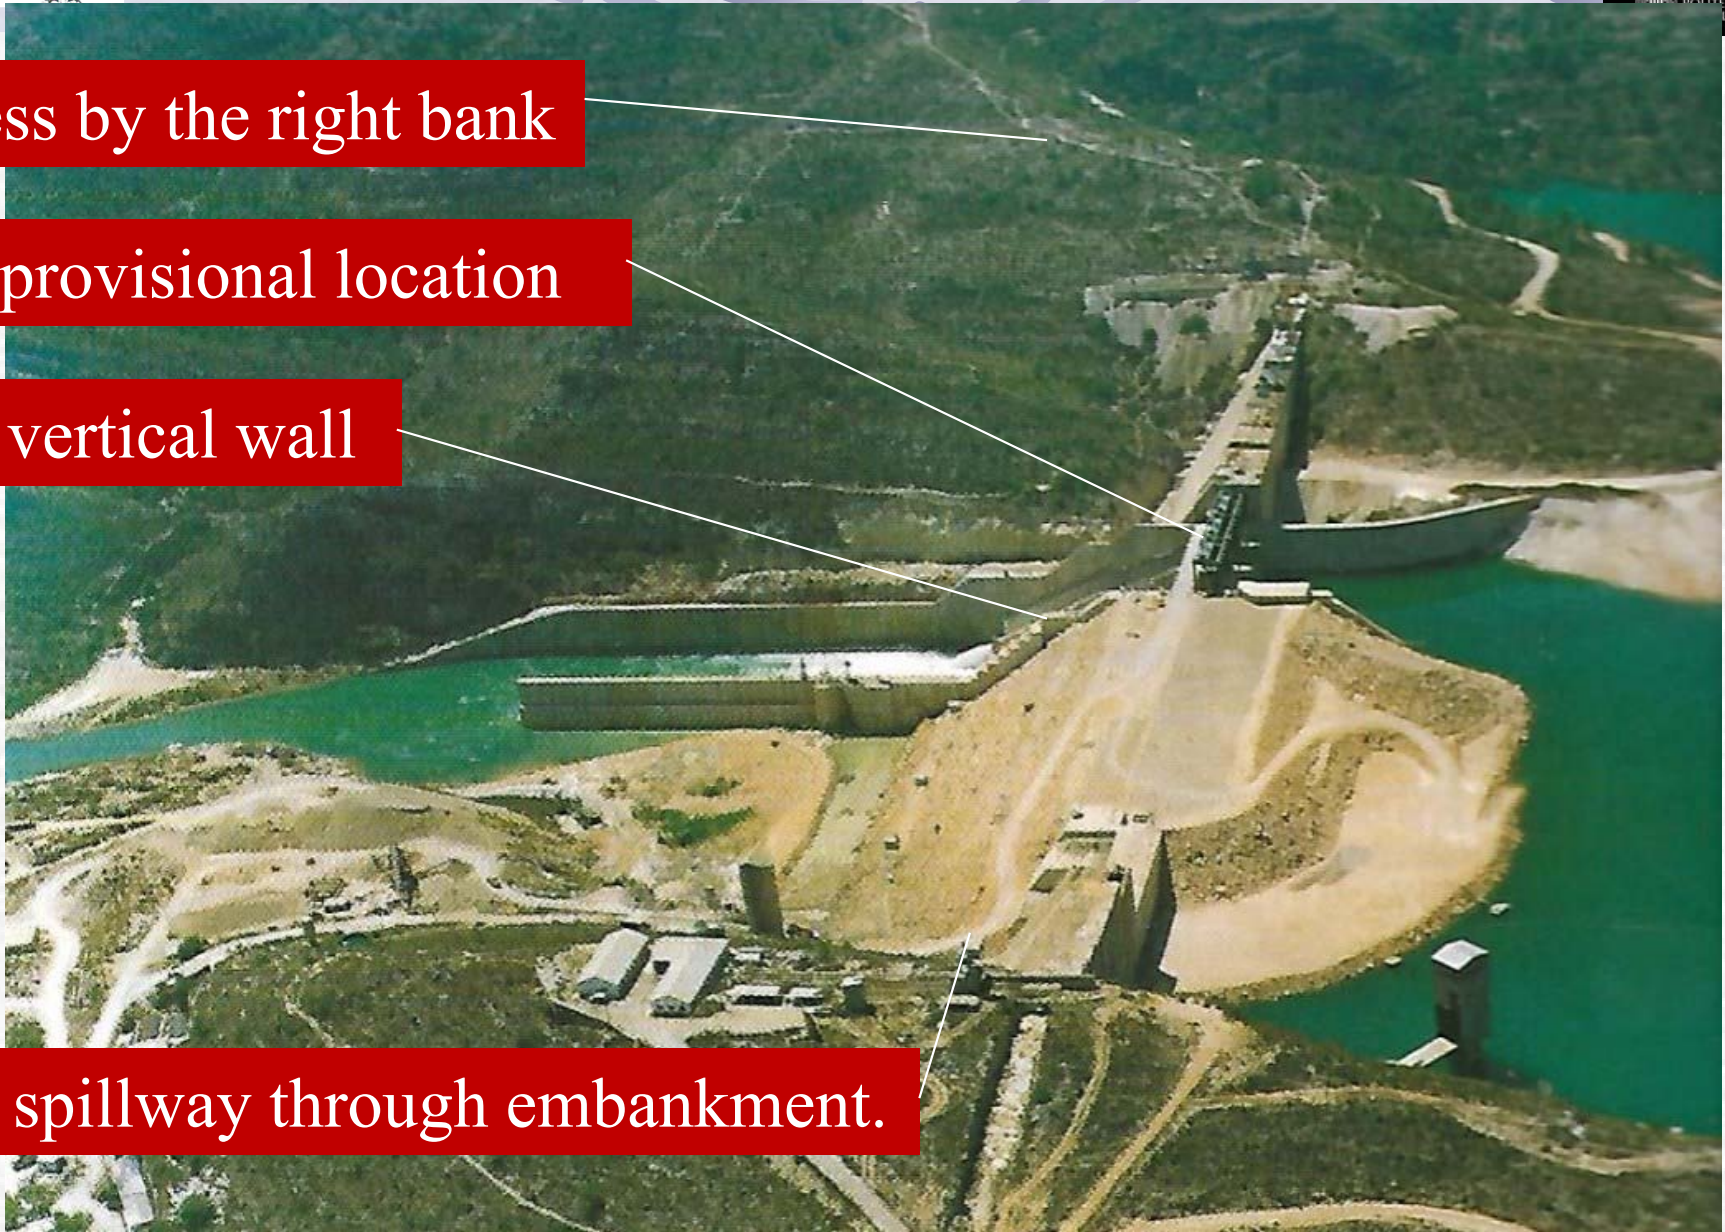
No Access by the right bank

Gates at provisional location

Flexible vertical wall

Acces to spillway through embankment.

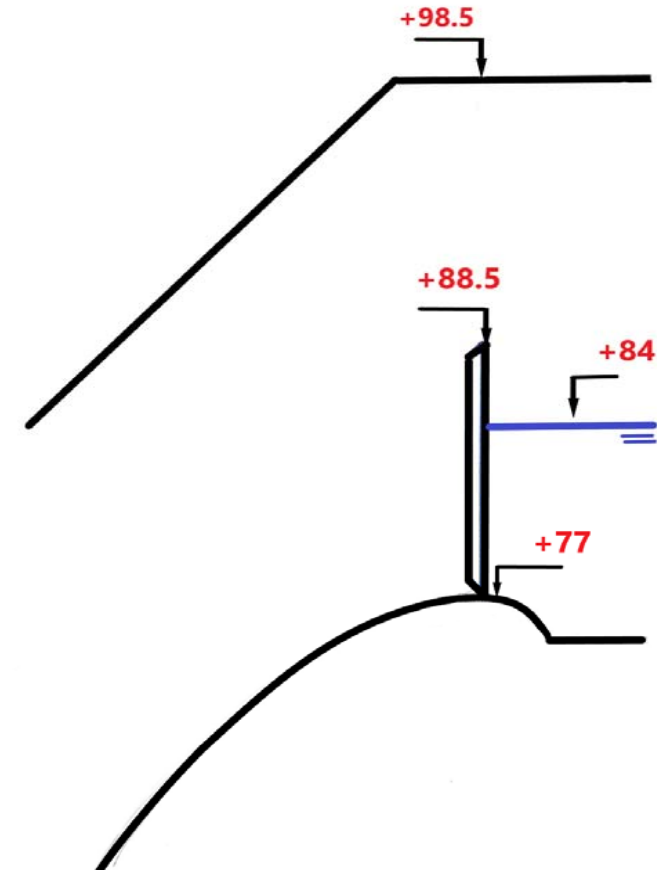
**POOR HYDROLOGICAL DESIGN !!!**  
Modified Fuller Empirical formula

- **First design:**  
6 x 25 m. free flow.  
Threshold at +84 m.
- **Modified design:**  
3 x 15.333 m. gated.  
3 vertical gates 15.333 m. x 10.5 m.  
Threshold at +77 m. Top at + 87.5

- **TALL RETAINING WALL ALONG THE SPILLWAY**
- **VERY HEAVY GATES DIFFICULT TO OPEN**

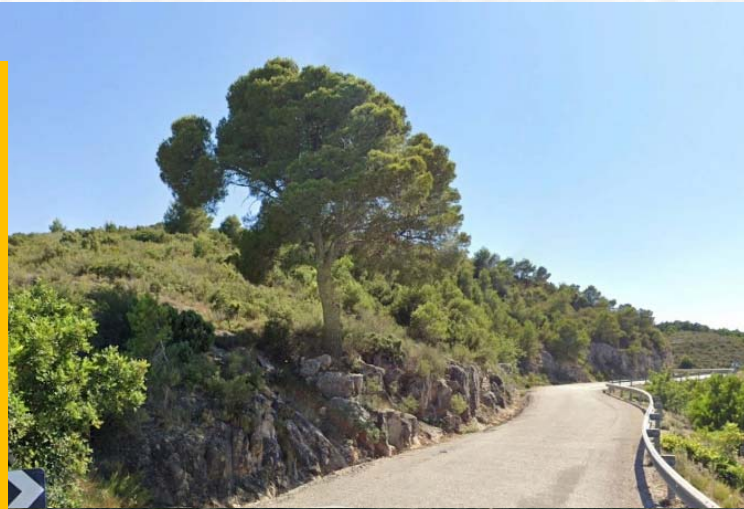
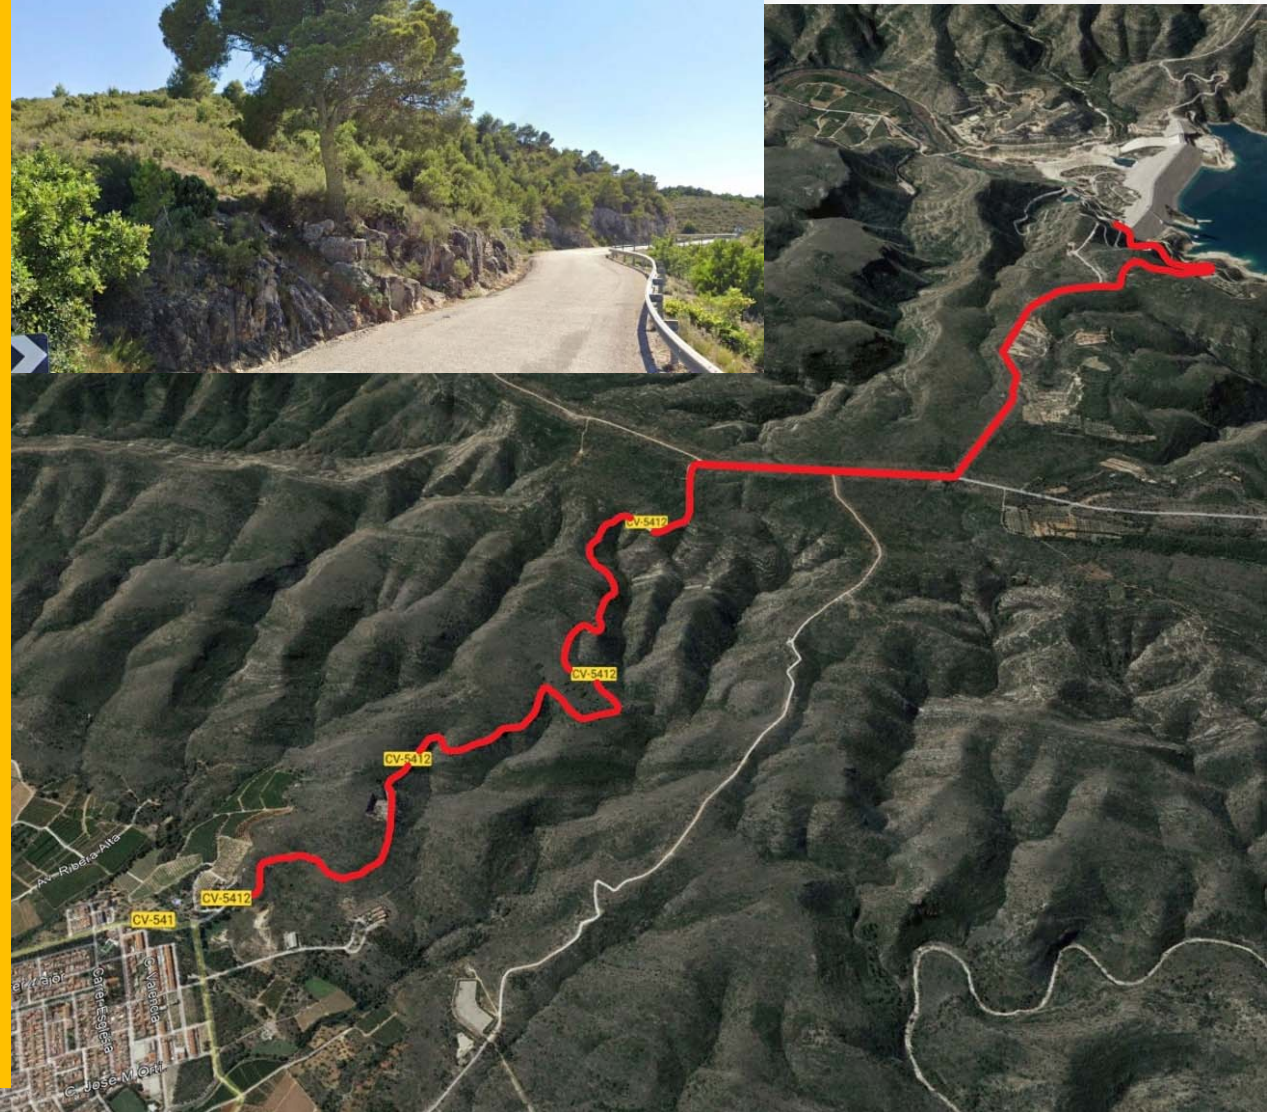
- It started raining strongly at 6 a. m.
- The dam is out of power
- At dawn the Escalona river flood filled up the reservoir spilling over the closed gates. Technicians arrive, and try to open the gates.
- Out of two emergency fuel electric generators, one was out of order, the other at a gallery for repairing a valve. The gallery entrance was flooded.

- It is decided to go to Tous village to get a new group. When returning, the road is cut by a landslide.
- They try to open manually the gates but the mechanism brokes.
- Strong rainfall resumes at 10 a. m. At 11 a.m. the dam starts to spill over the earth embankment.
- Access to the gates is cancelled. There is no road through the right bank.
- Helicopters tried unsuccessfully to fly.

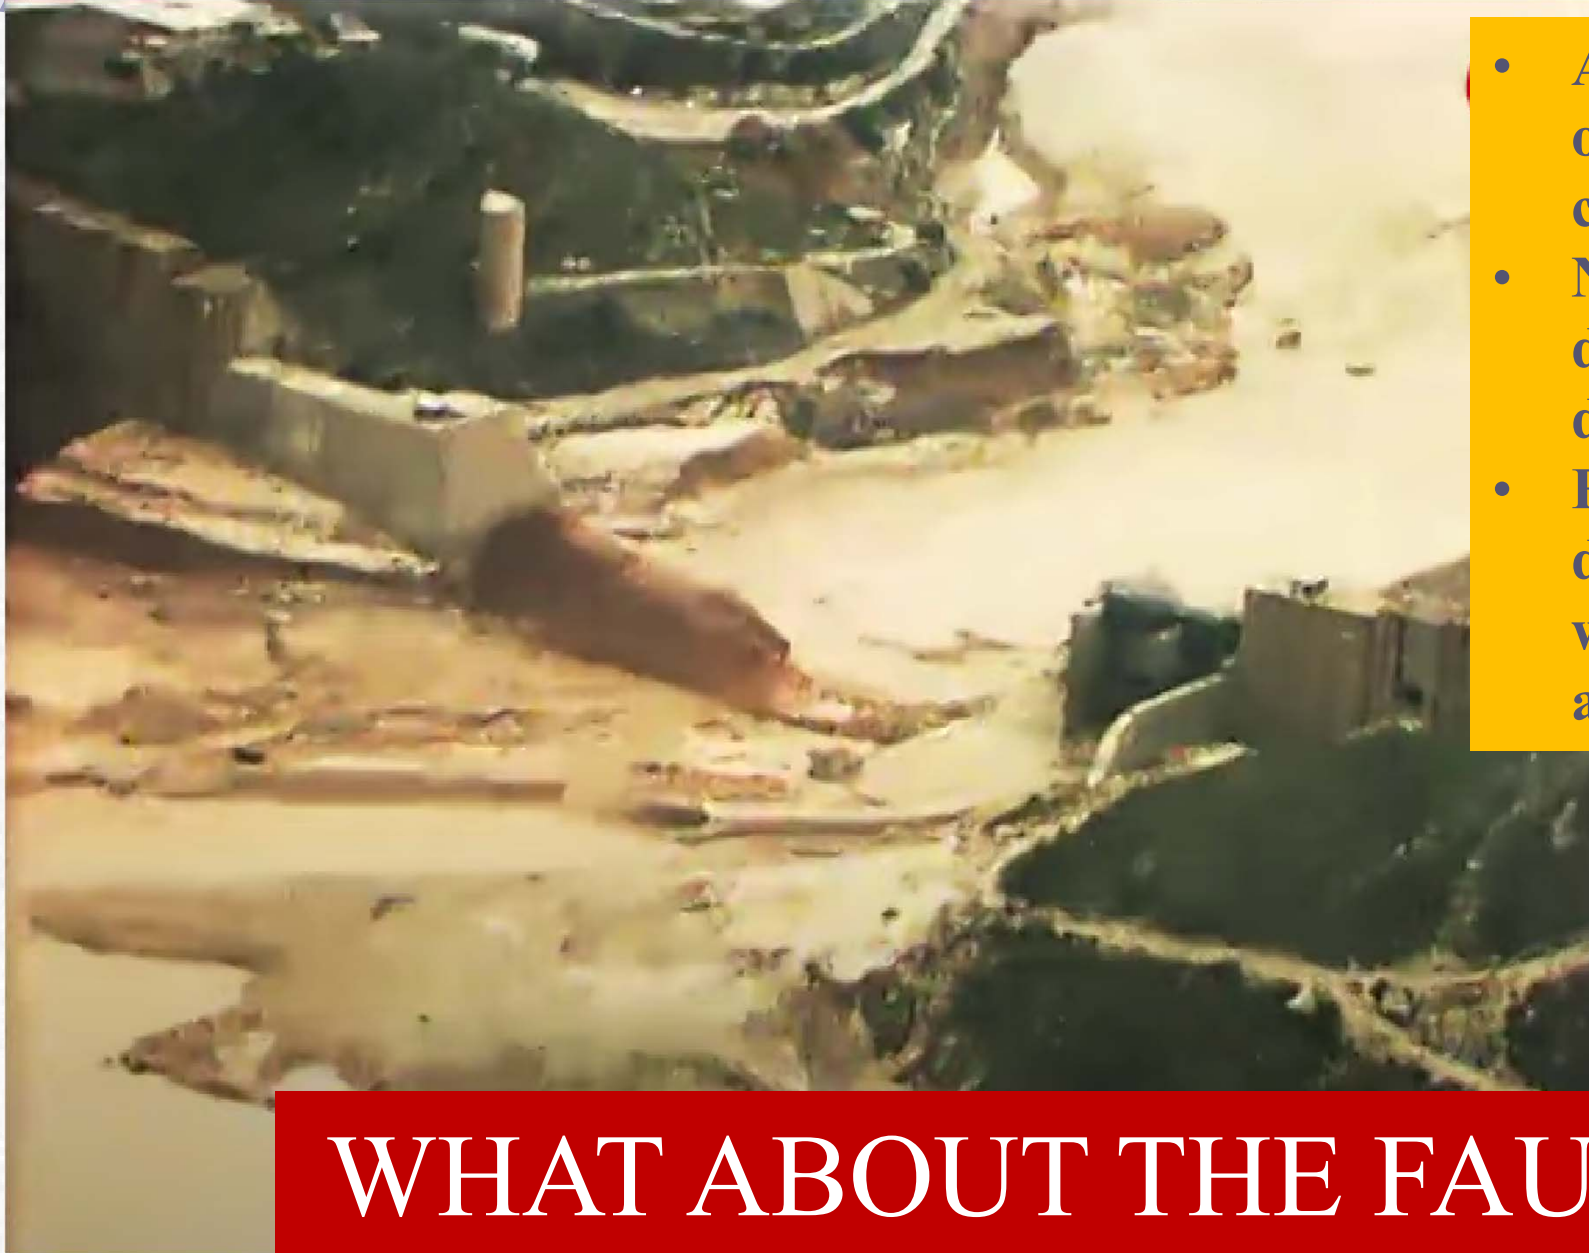
- An important part of the central clay core, remained.
- No construction defects were detected.
- Failures were design (flexible wall, hydrology) and logistics
