**“Toddbrook: an English reservoir incident and its impact on the industry”**

**Maddie Prendergast**  
National Reservoir Safety Team  
Environment Agency (England)

# Toddbrook Reservoir

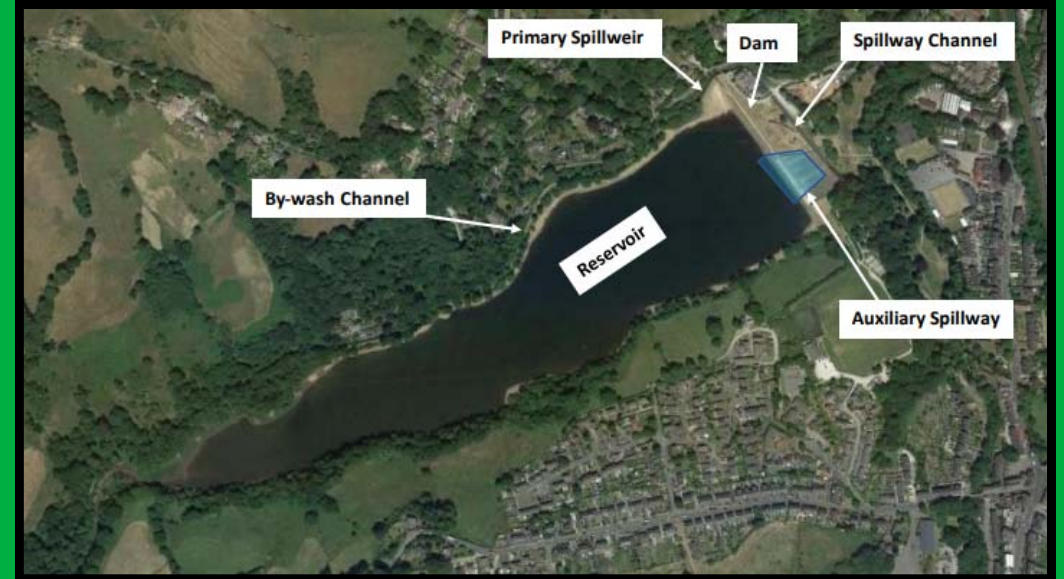
Dam 24m x 310m x 5m

Earth embankment dam with puddle clay core, and granular fill shoulders

Auxiliary spillway added 1964

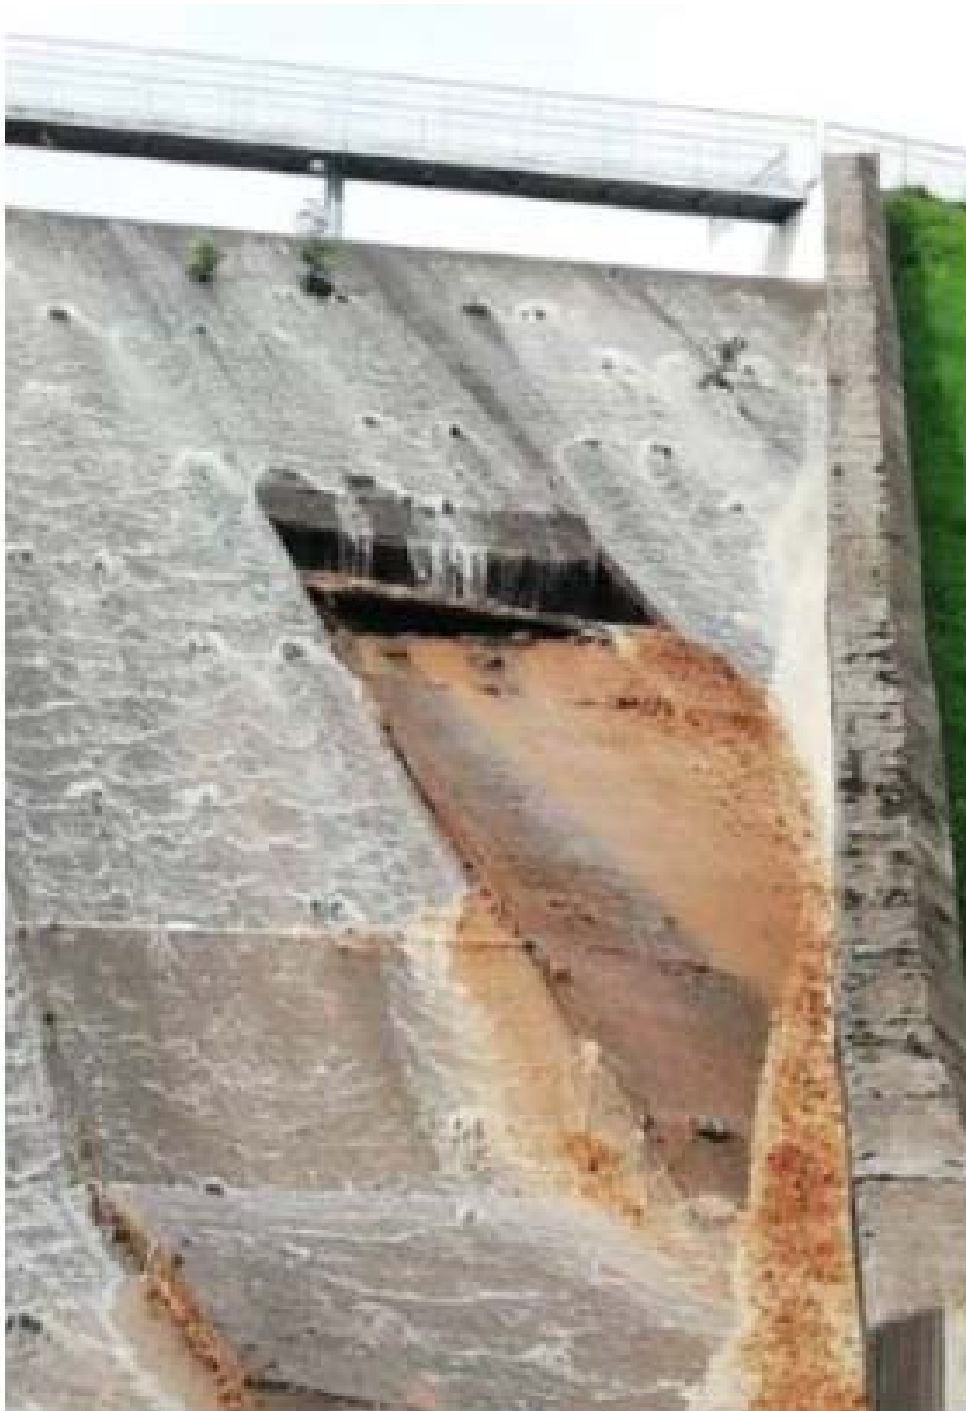
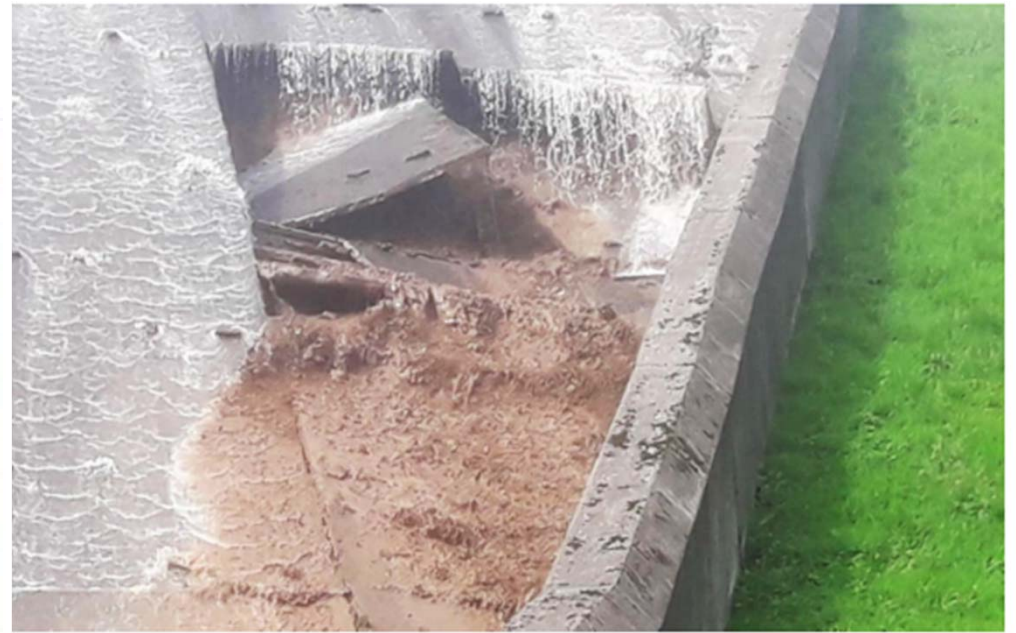
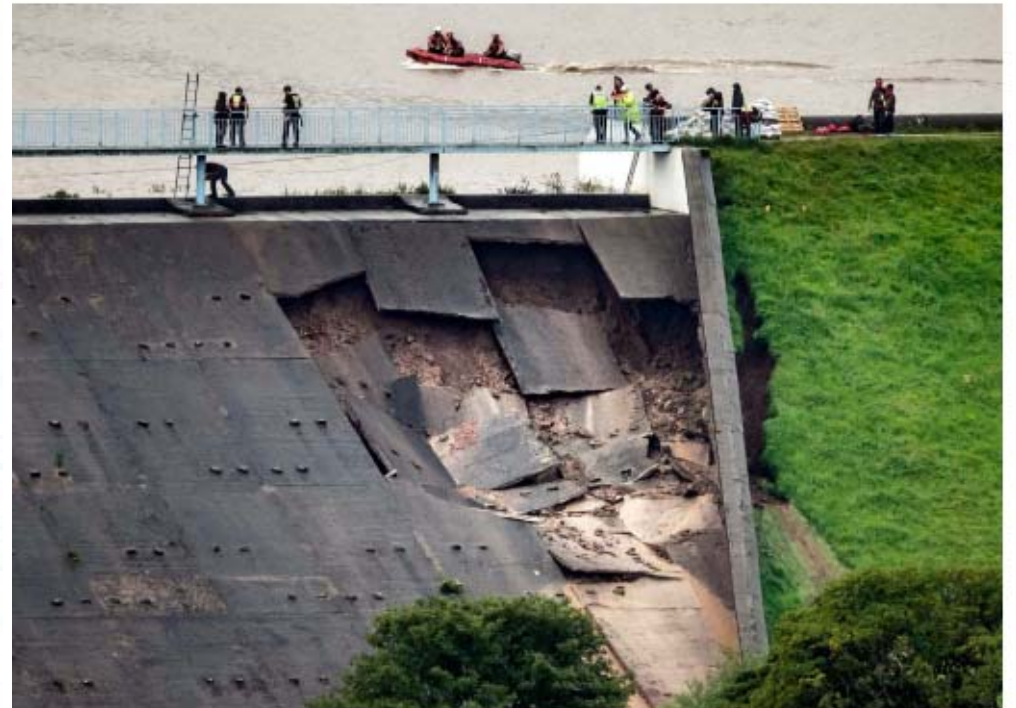
Government (Balmforth)	Owner's (Hughes)
Poor design	Poor design
Water ingress through slab joints, leading to crack injection and rapid erosion of fill.	Water ingress beneath top slab from lack of cut-off over many years, leading to long term internal erosion, exacerbated by the rainfall event of July 2019.
Poor maintenance	Maintenance issues not significant enough to contribute

- Sandbags on weir to increase level and divert flow from damaged area
- Aggregate bags dropped into the hole, and cement grouting of voids
- Pumping – reduced lake by 9 metres in 6 days.
- Reservoir held low (10% capacity) until permanent repairs are in place  
(due completion 2024)
