AN ASSESSMENT OF THE FAILURE OF THE WADI DERNA DAMS AND LESSONS FOR ENHANCING DAM SAFETY

Laurent Mouvet
Civil Eng. EPFL-SIA
Vice President ICOLD
Past President SwissCOLD

Wadi Derna Dams Failure

Libya - September 10-11, 2023

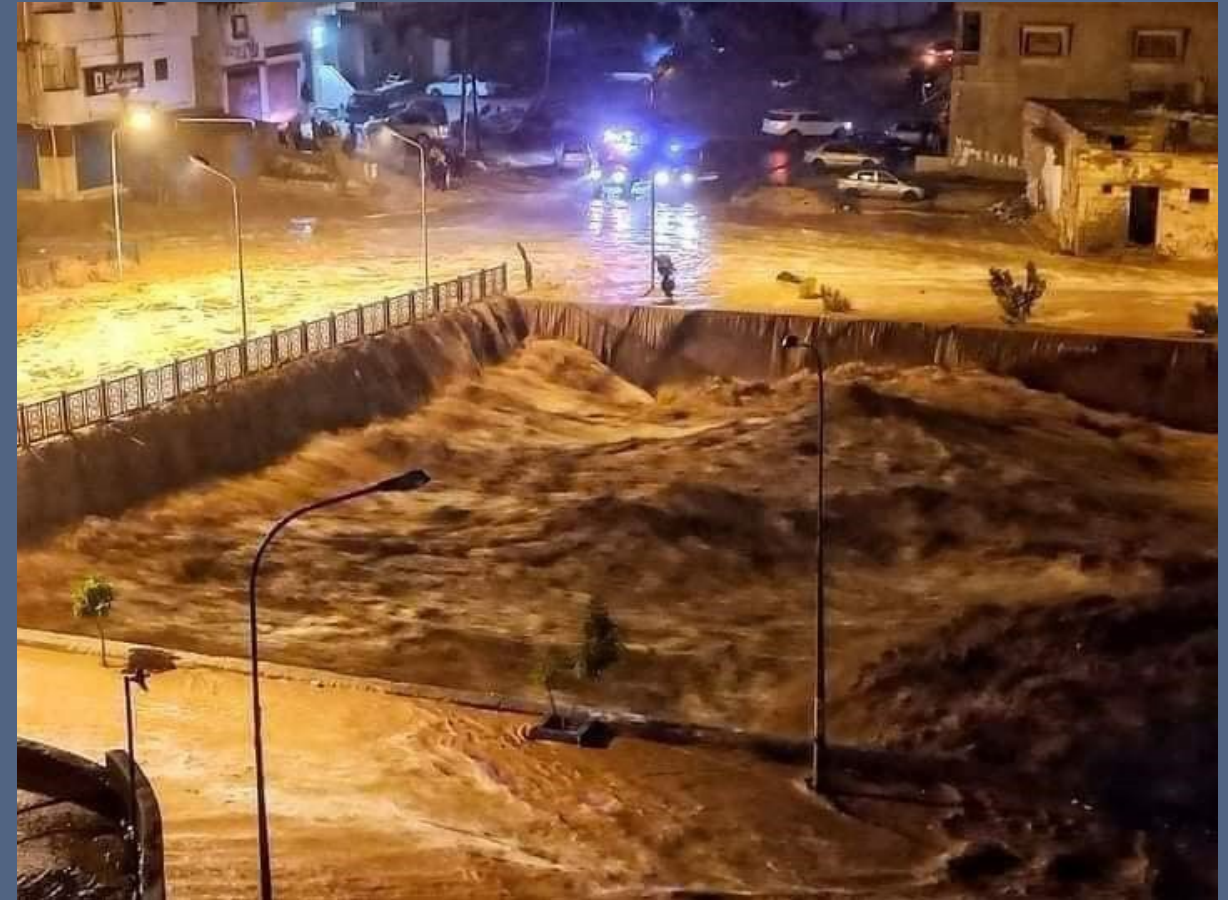
- The failure of the Derna Dam is estimated to have generated a **first flood** wave with a flow ranging between **1,500 and 5,000 m³/s**.
- Simulations of the **second flood** wave that was caused by the collapse of Abu Mansour dam suggests an estimation of discharge of **around 7,000 m³/s**, significantly exceeding the capacity of the city's river channel, which could handle a **maximum of around 1,000 m³/s**

The water level in Derna during the 2023 flood event.

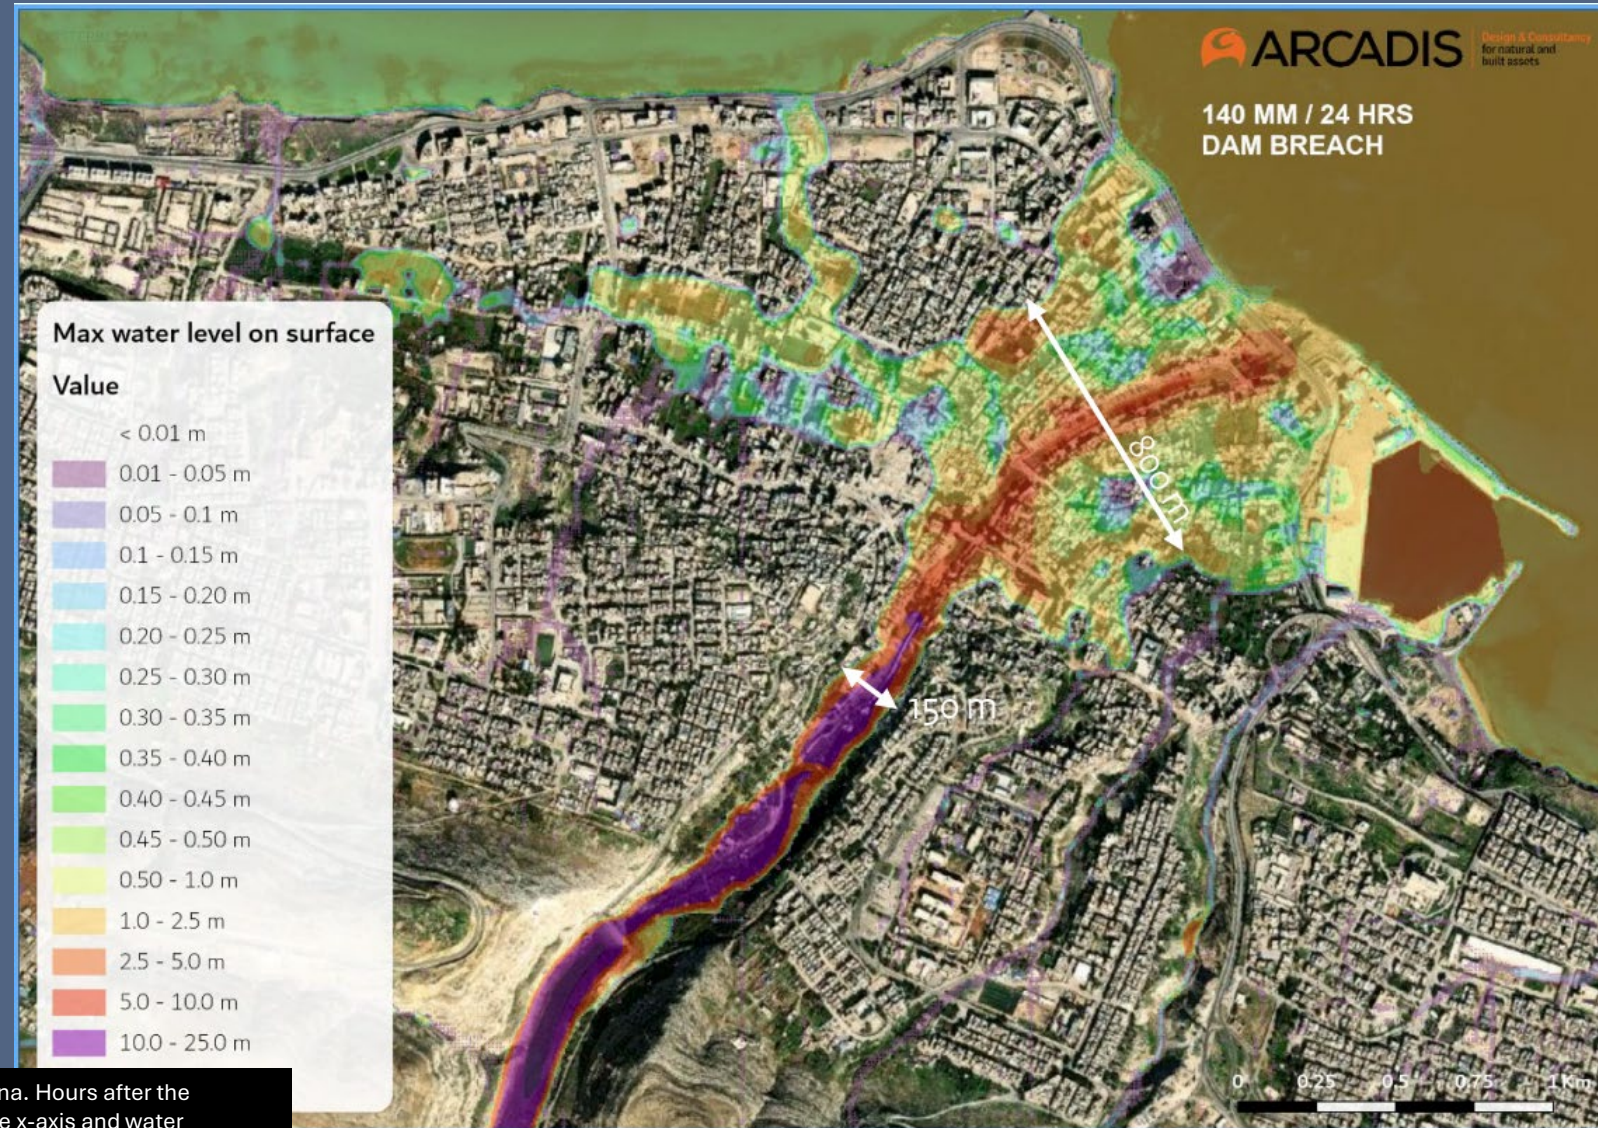
Results of the **max water level on surface** after the dam breach

- The width of the main flow channel would have extended over 800 meters (indicated by white arrow)
- **Water level rise in the city of Derna between approx. 5-8 masl within 30 minutes.**
- The water level drops and sinks out at about 1 meter in approximately 24 hours.

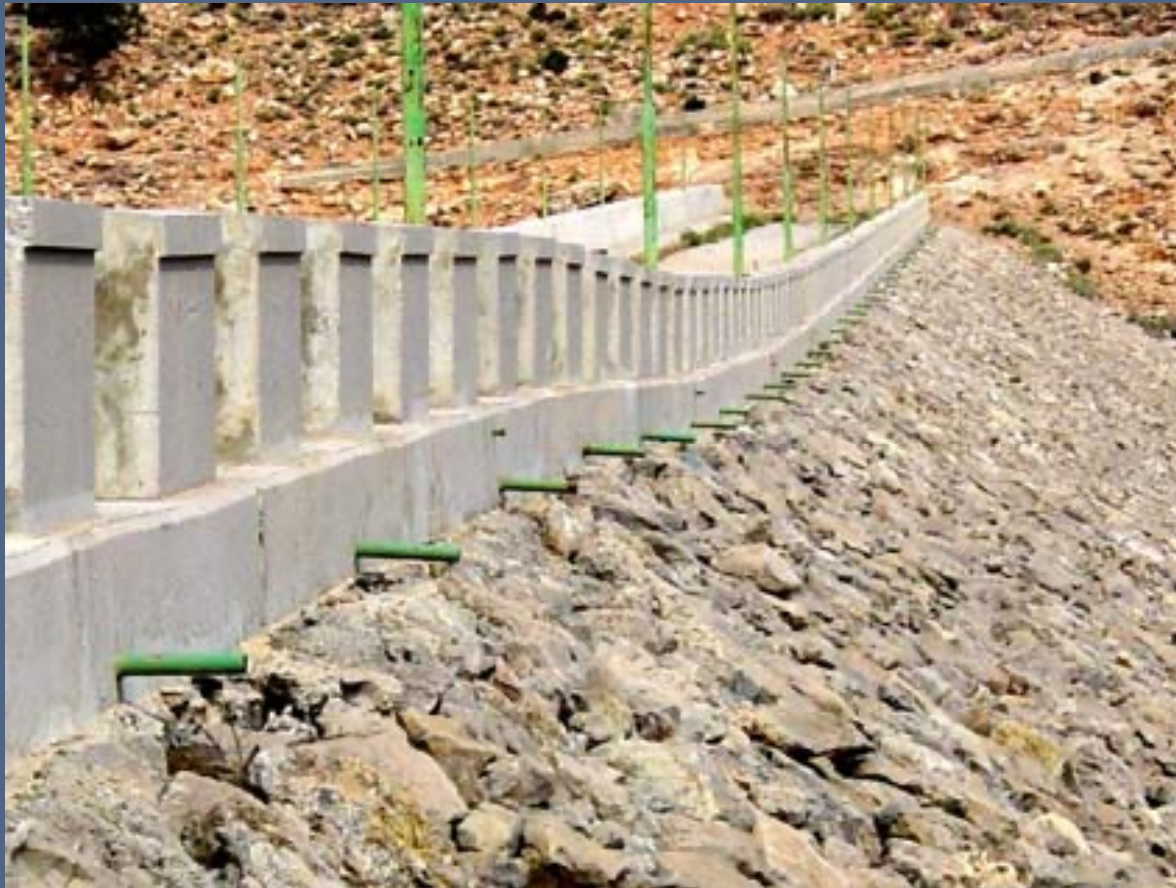
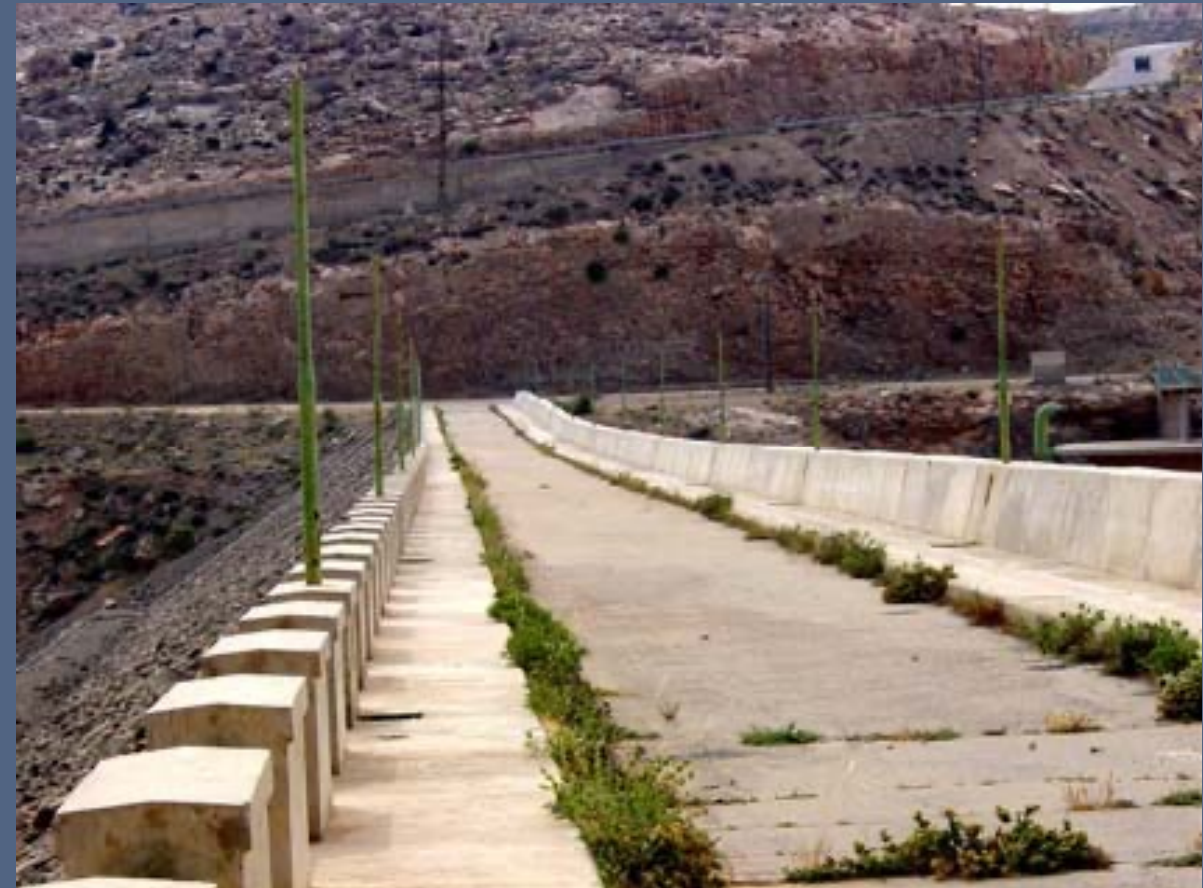
Crest Settlement – Abu Mansur Dam, 2004

- excessive settlement of both dams
- watertightness issue at the two dams
3 m³/s under less than 14m head at Abu Mansur,
3 sinkholes at immediate US Derna

- Concern with the settlement at Abu Mansur dam crest
- Recommendation: periodic inspections

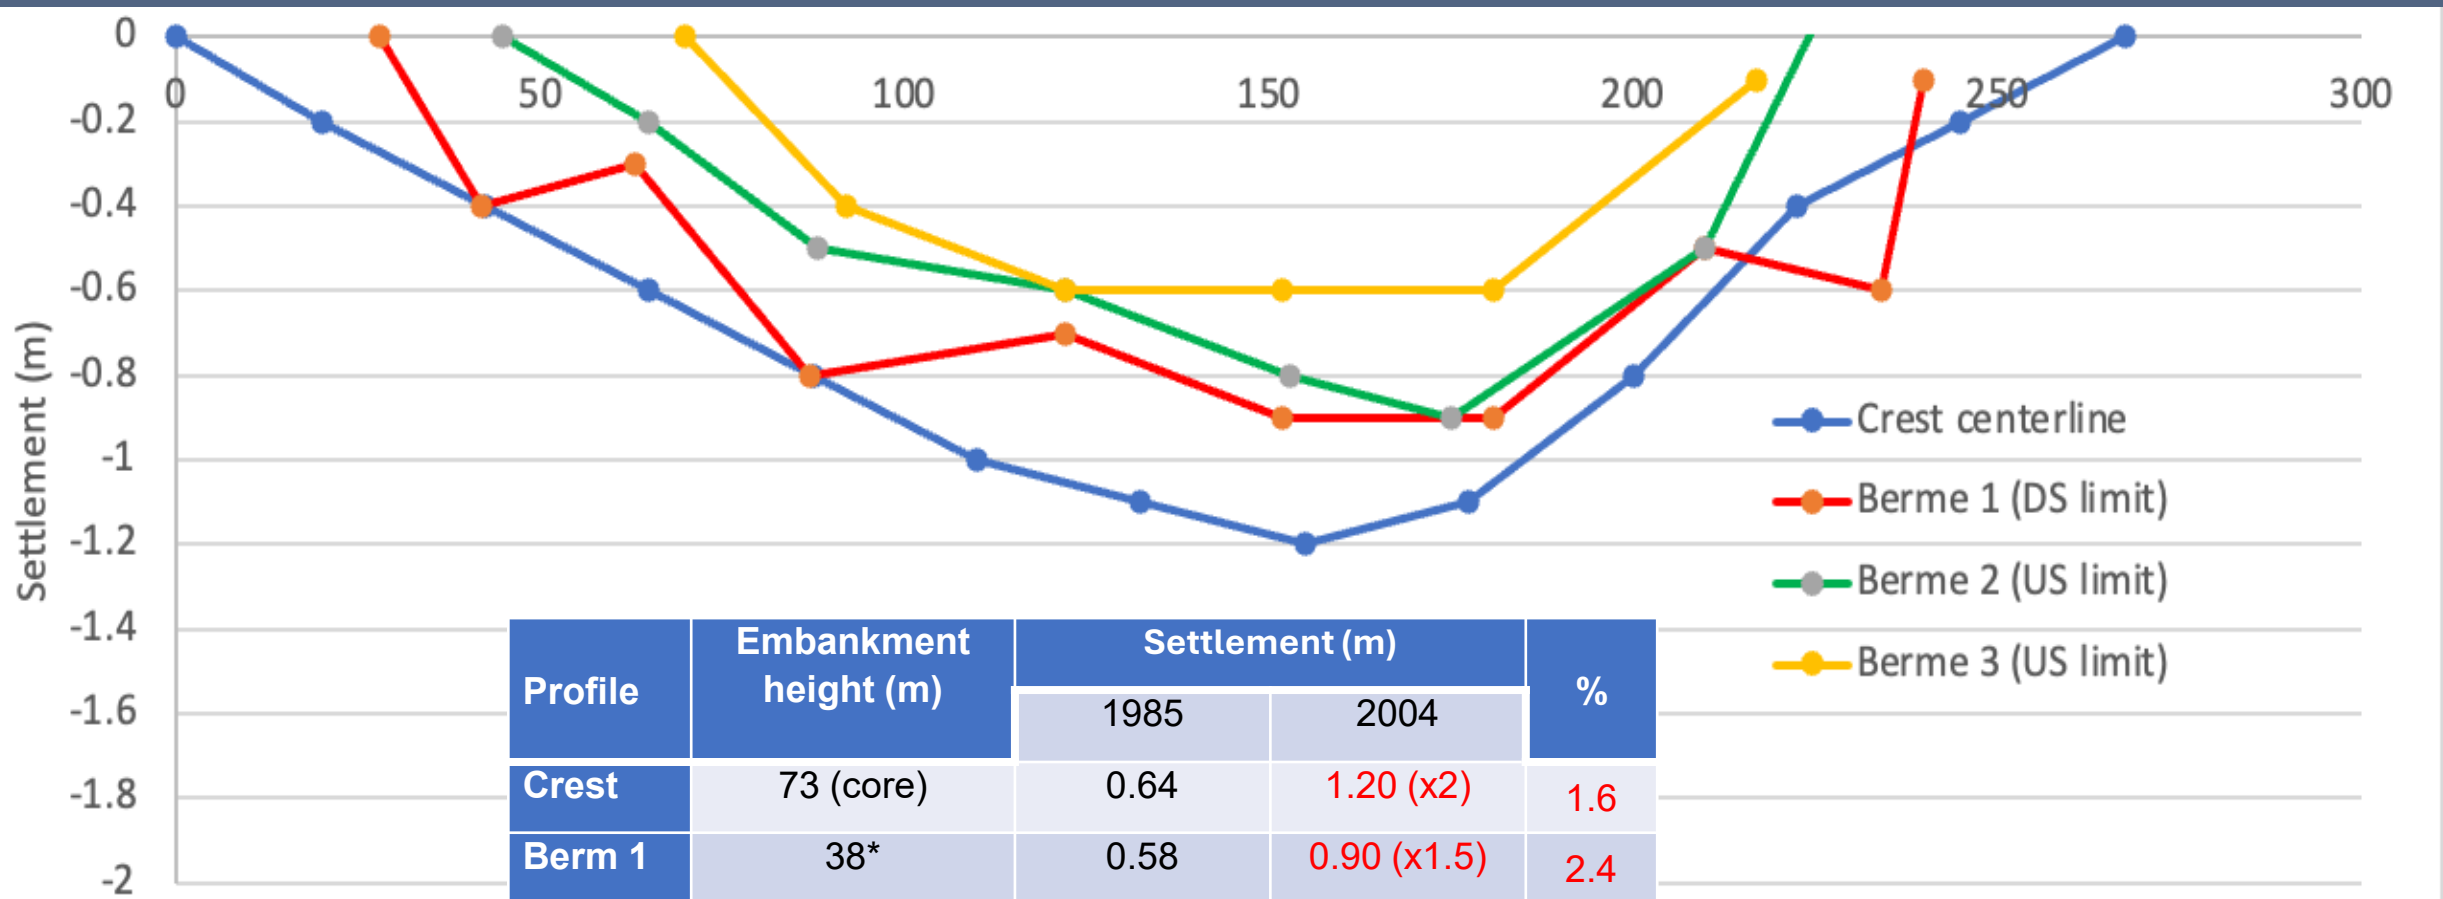
Crest Settlement – Abu Mansur Dam, 2004

Profile	Embankment height (m)	Settlement (m)		%
		1985	2004	
Crest	73 (core)	0.64	1.20 (x2)	1.6
Berm 1	38*	0.58	0.90 (x1.5)	2.4
Berm 2	26*	0.36	0.90 (x2.5)	3.4
Berm 3	14*	0.12	0.60 (x5)	4.3

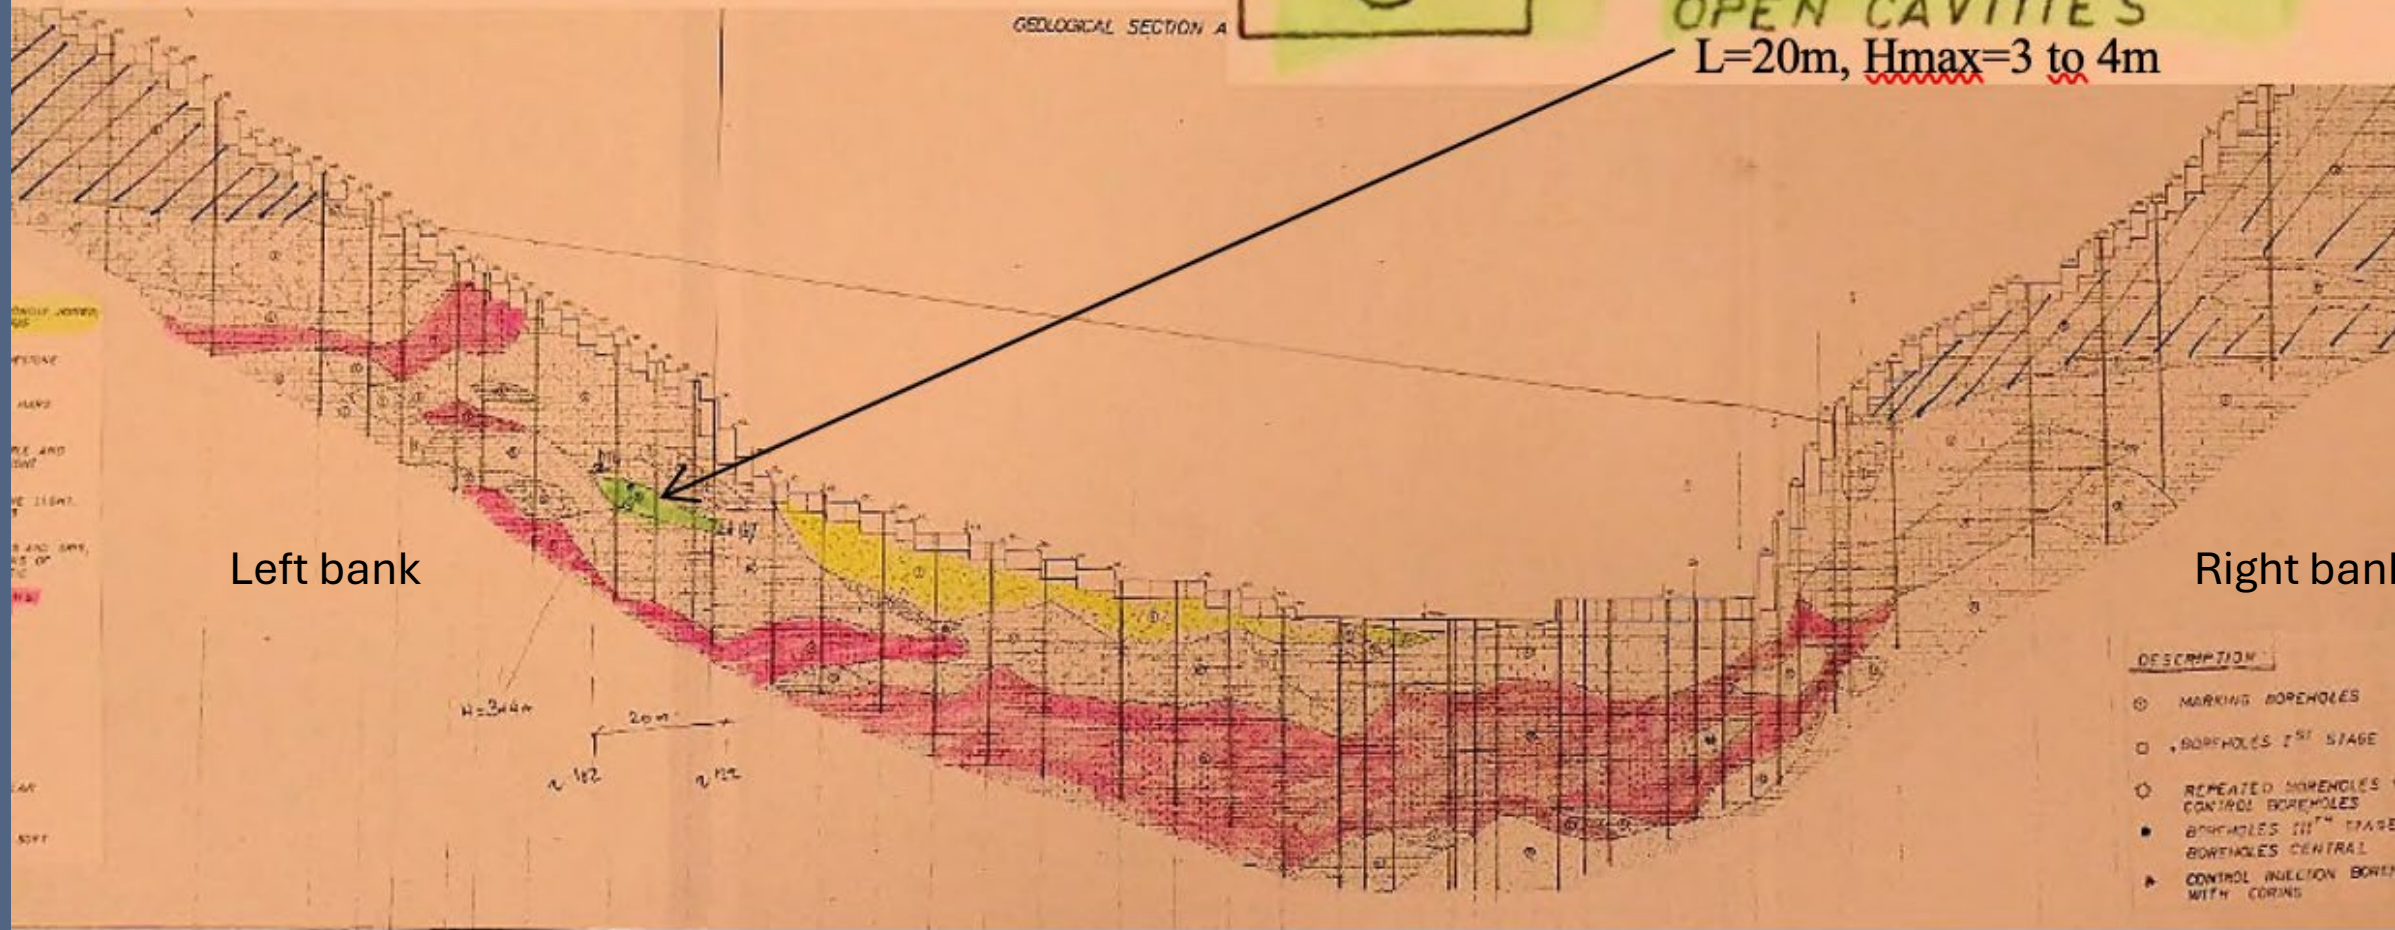
Figure 4-4: Bu Mansur dam: Geological cross section along the foundation of the core (Hidroprojekt, 1975/76)

OBSERVATED LARGE OPEN CAVITIES

L=20m, H_{max}=3 to 4m

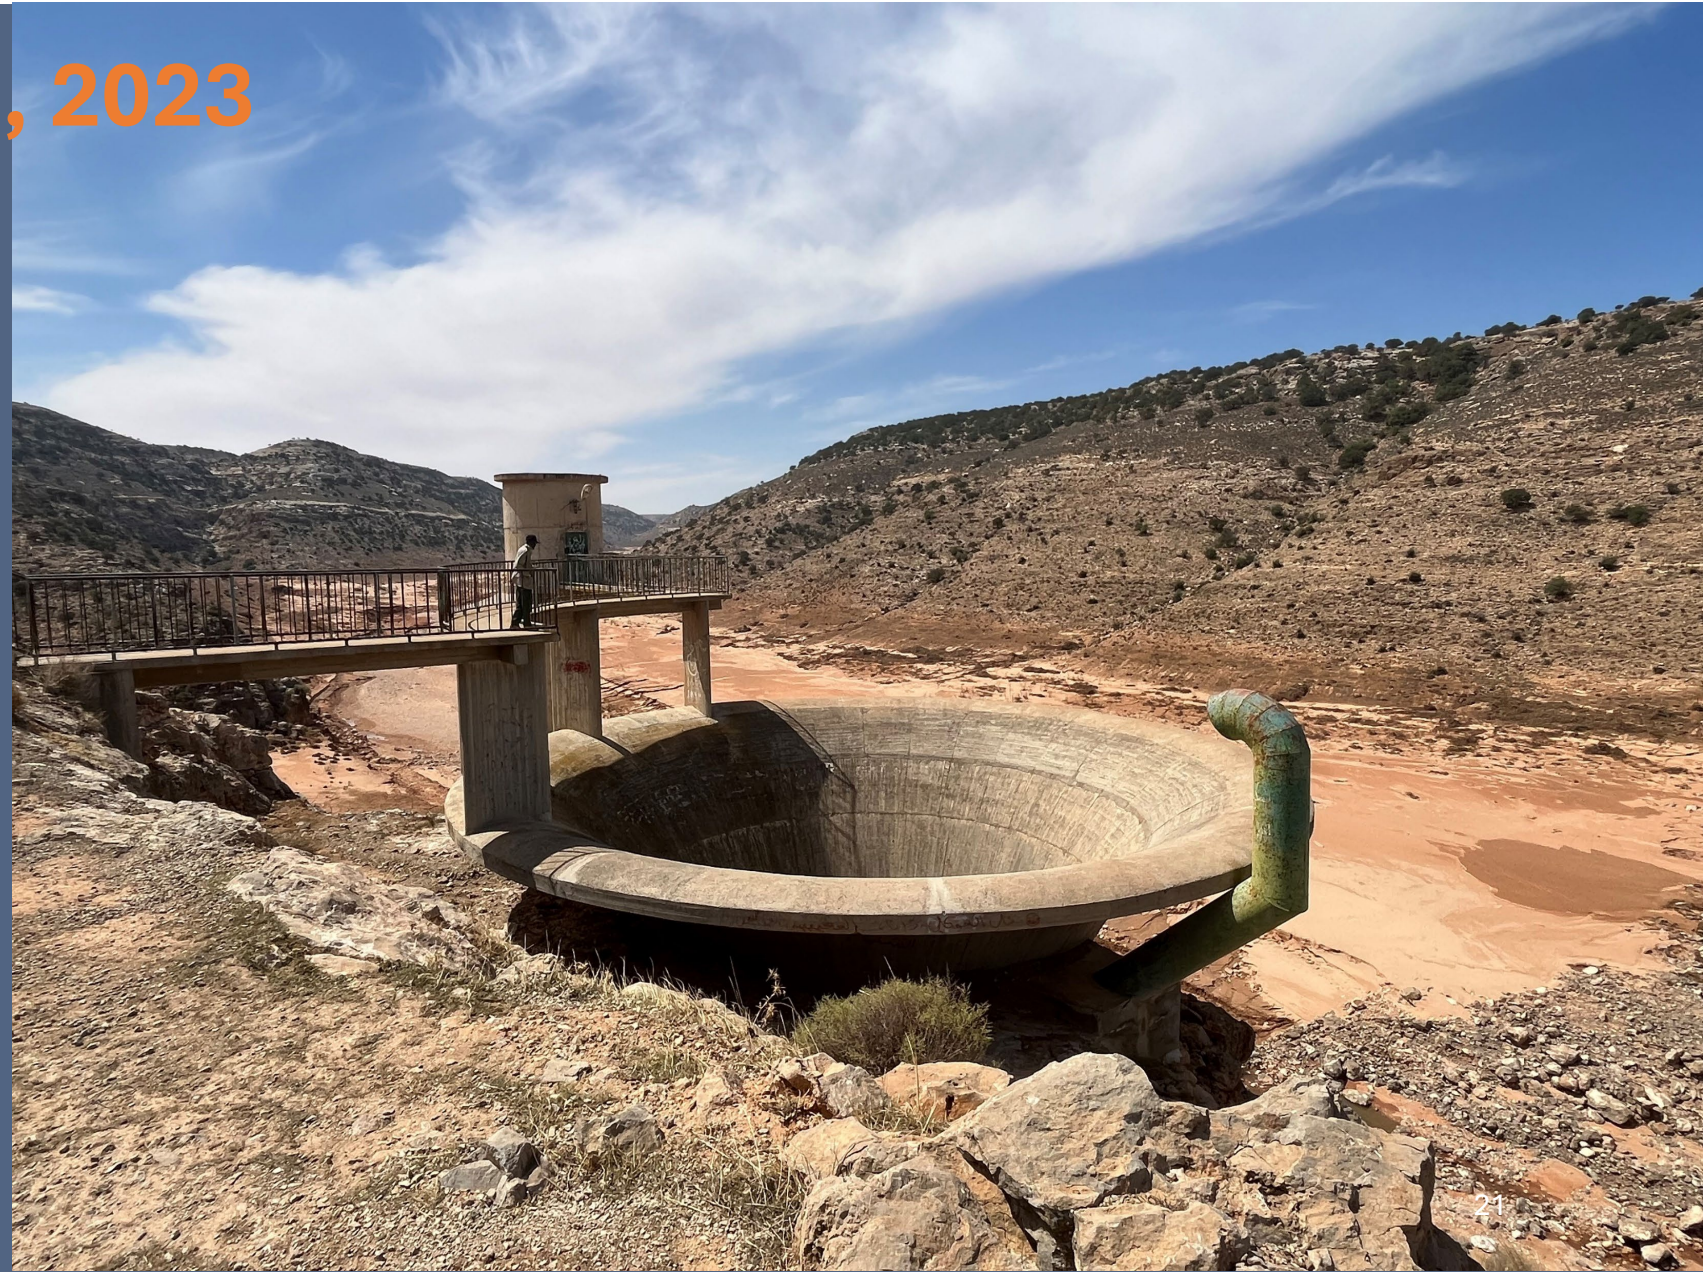
Abu Mansur Dam, 2023

Spillway intake is intact

Did it spill on the
11th September 2023 ?

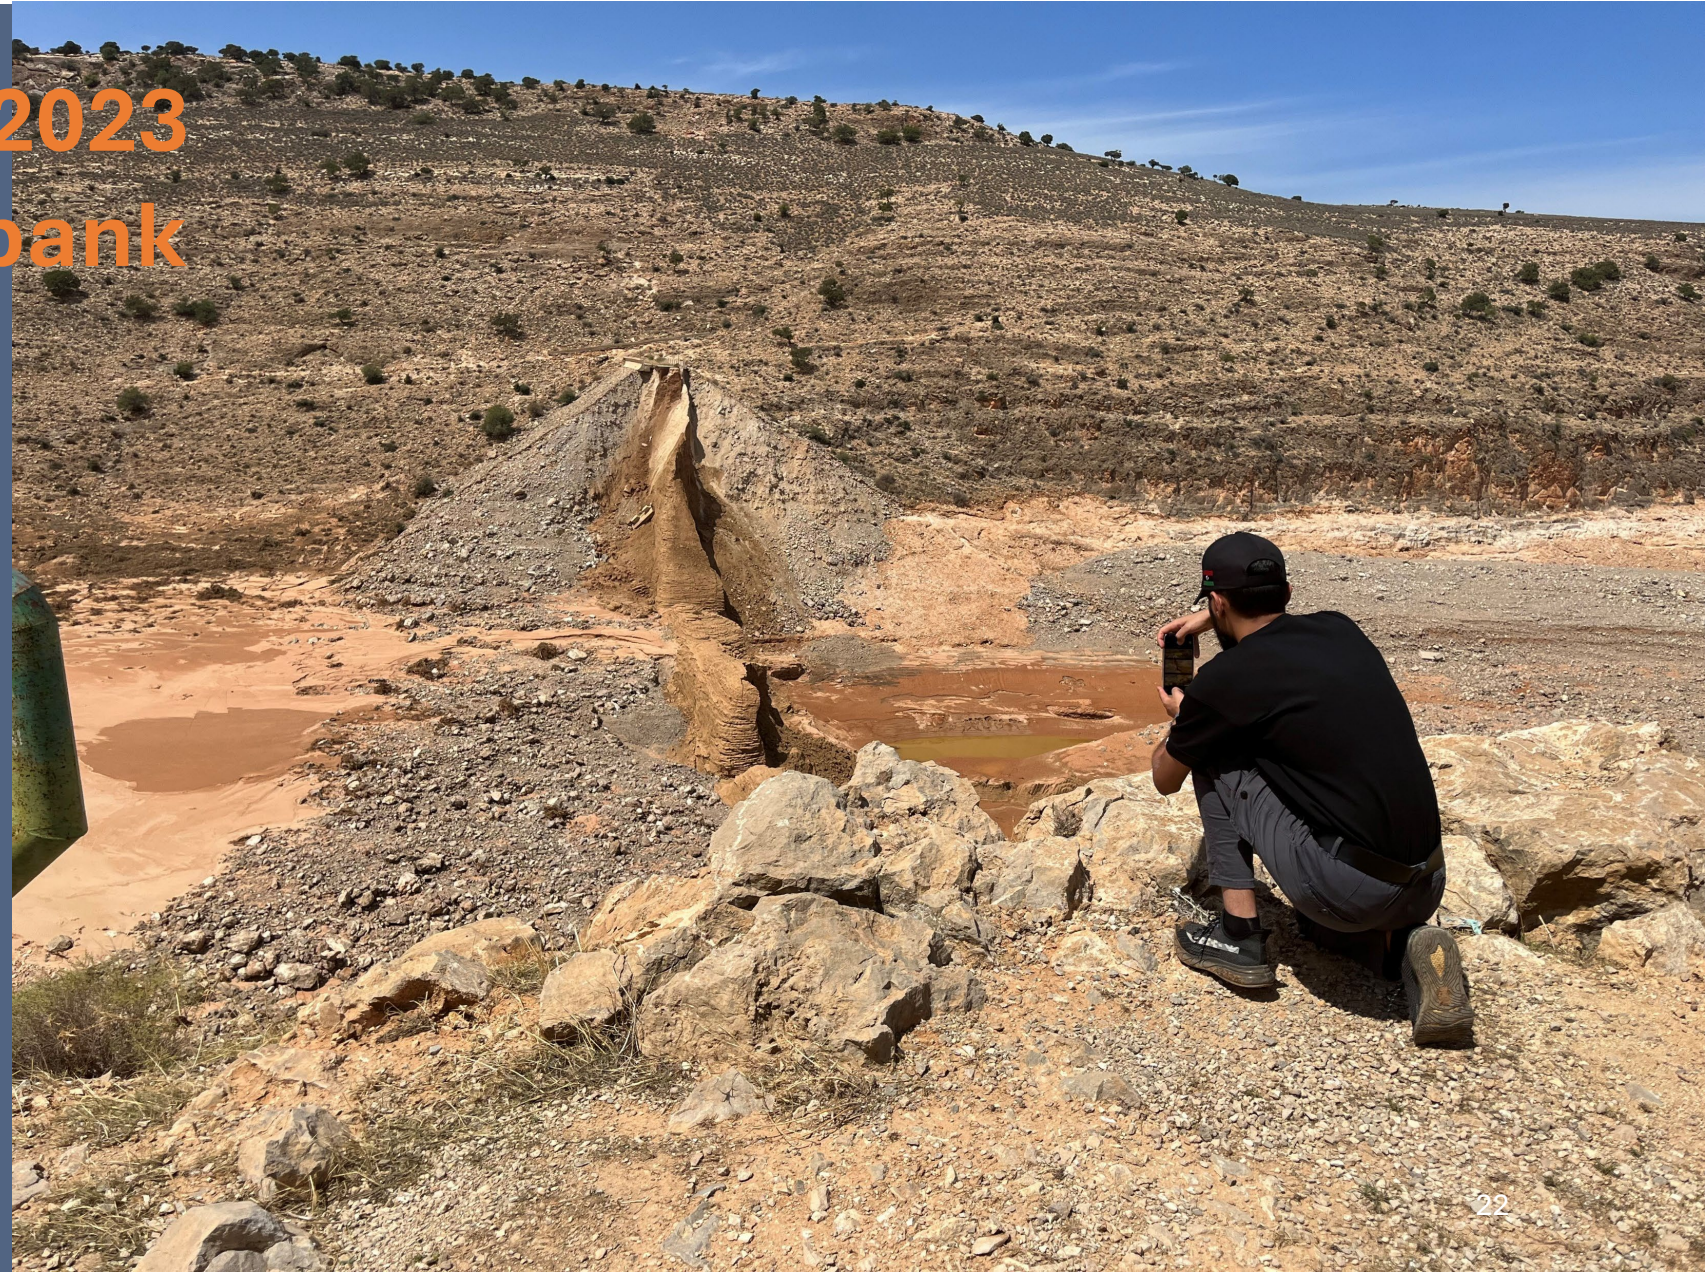
Abu Mansur Dam, 2023 Failure of the Left bank

What is the sliding plan
on the left bank?

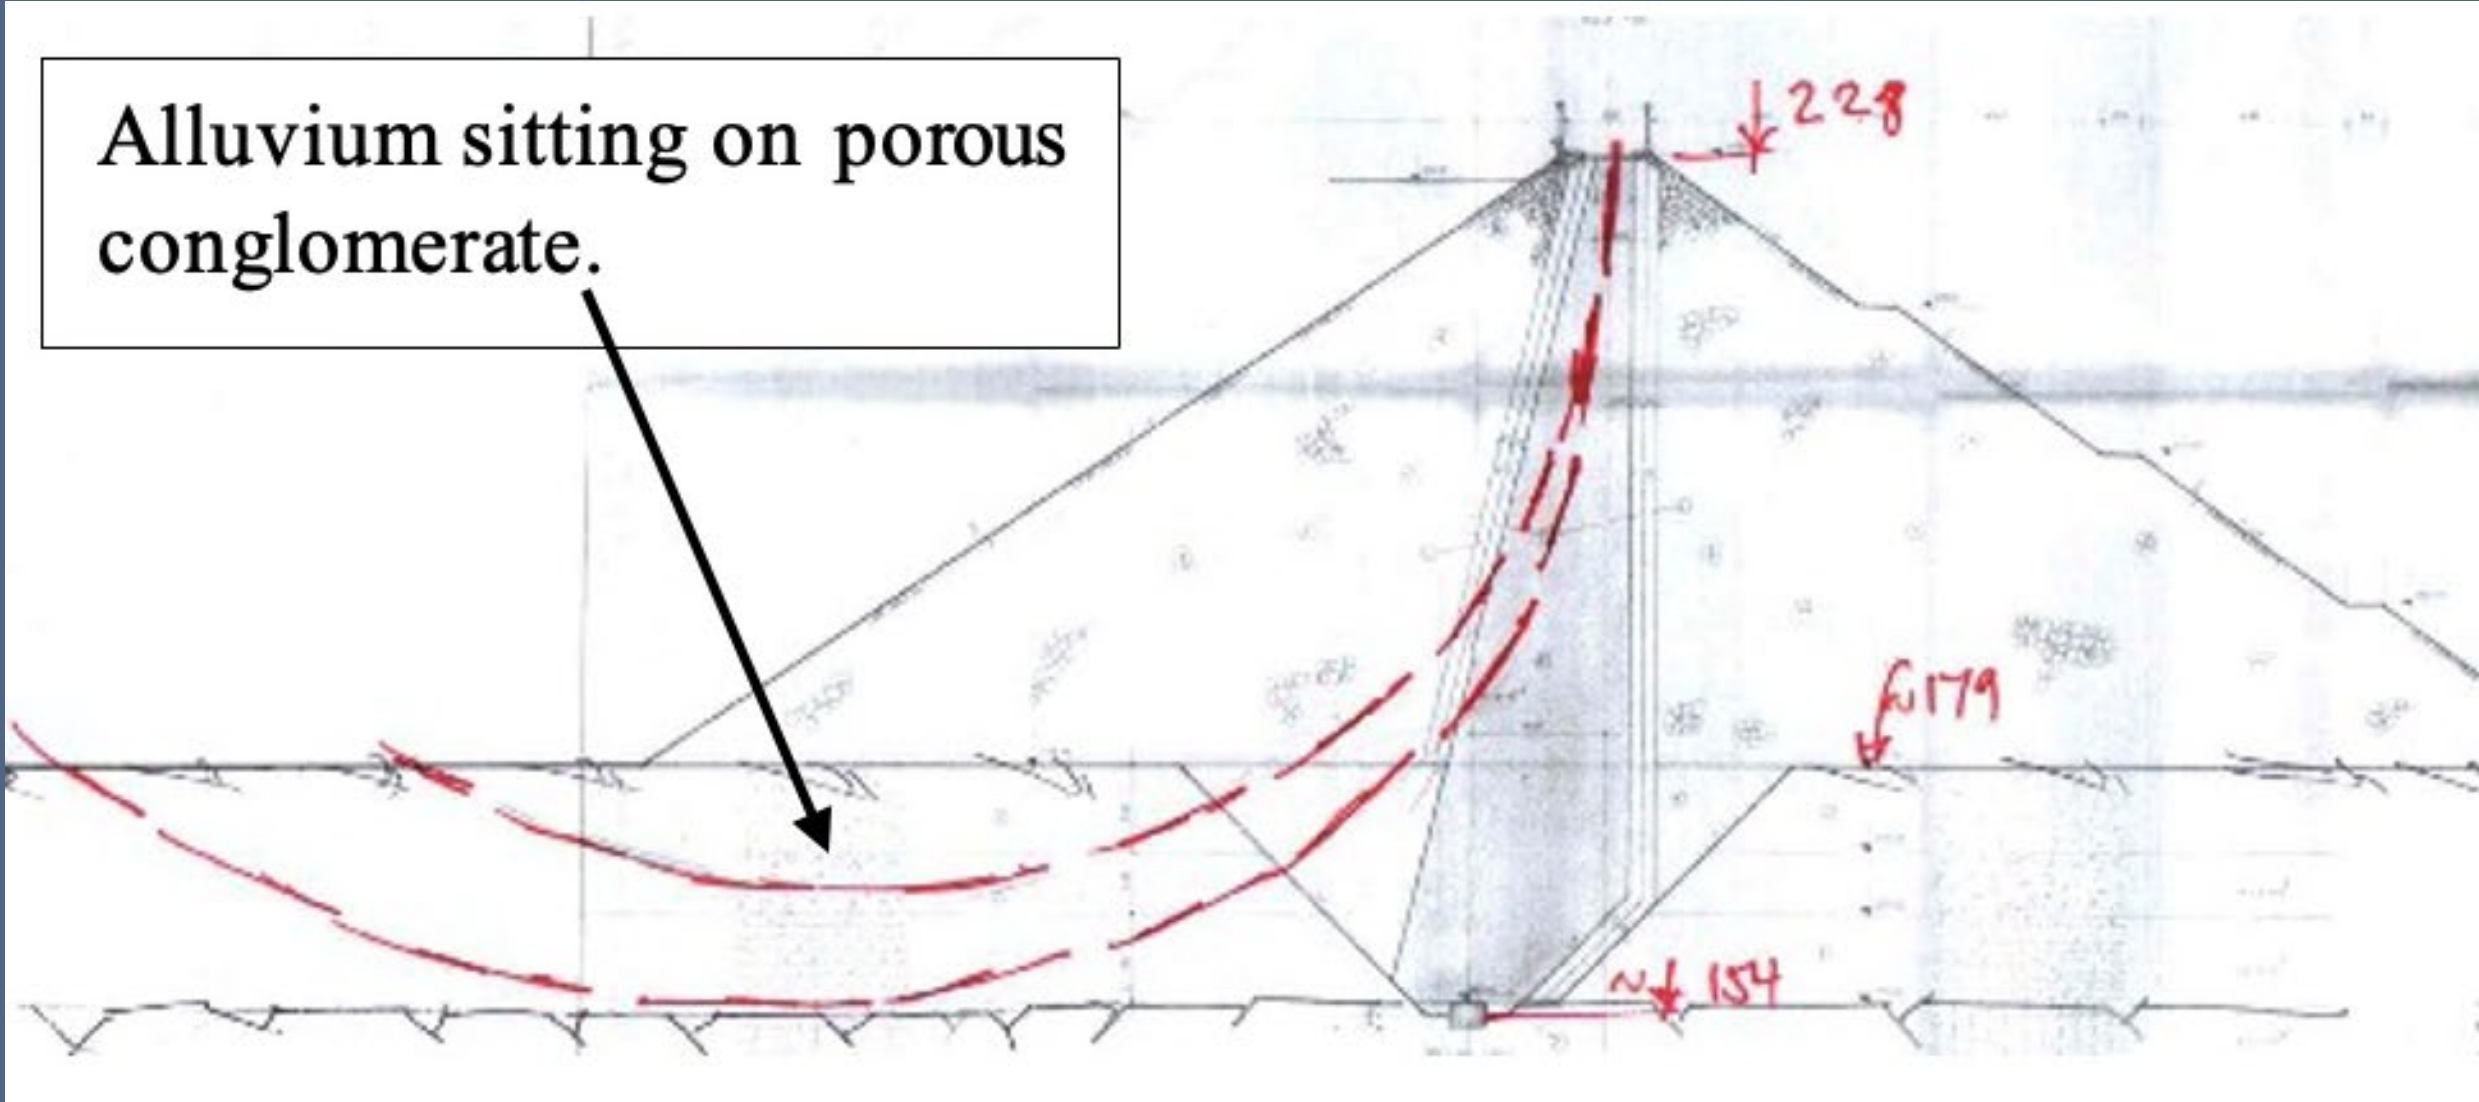
Alluvium sitting on porous conglomerate.
