# ***Geotechnical site investigations used in detection of internal erosion and leakage in dam foundations – a case study***

## Hydroelectric Power Plant (HPP) *Dubrava* in Croatia

## Issues at the reservoir's left embankment

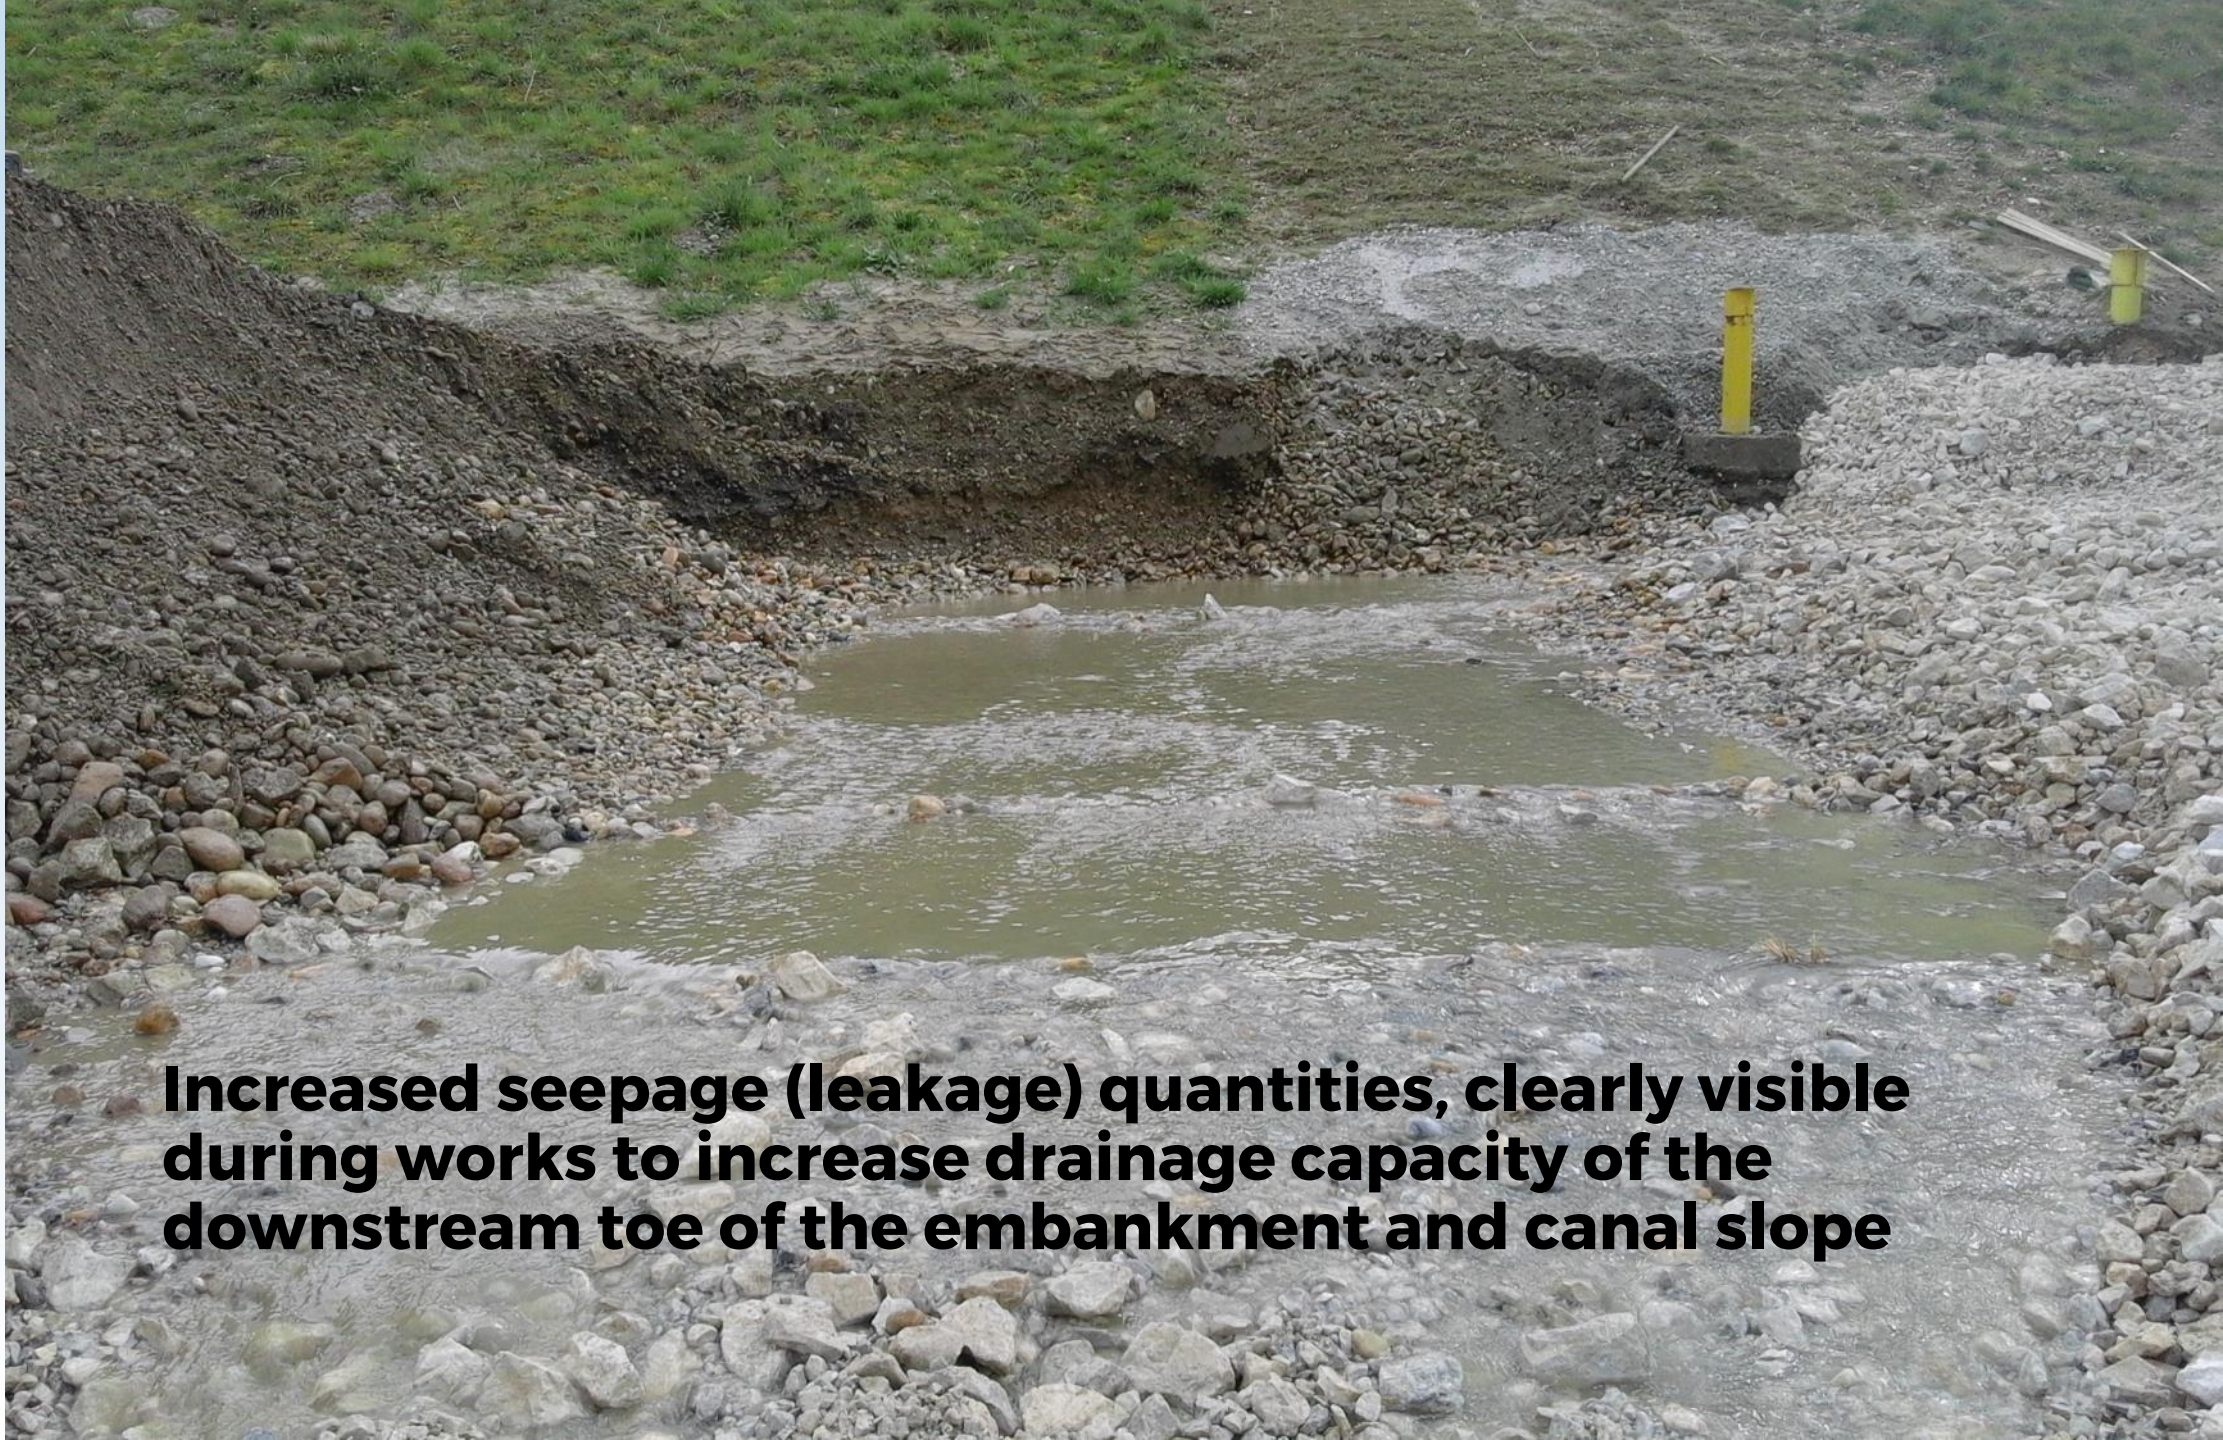
**Increased seepage (leakage) quantities, clearly visible during works to increase drainage capacity of the downstream toe of the embankment and canal slope**

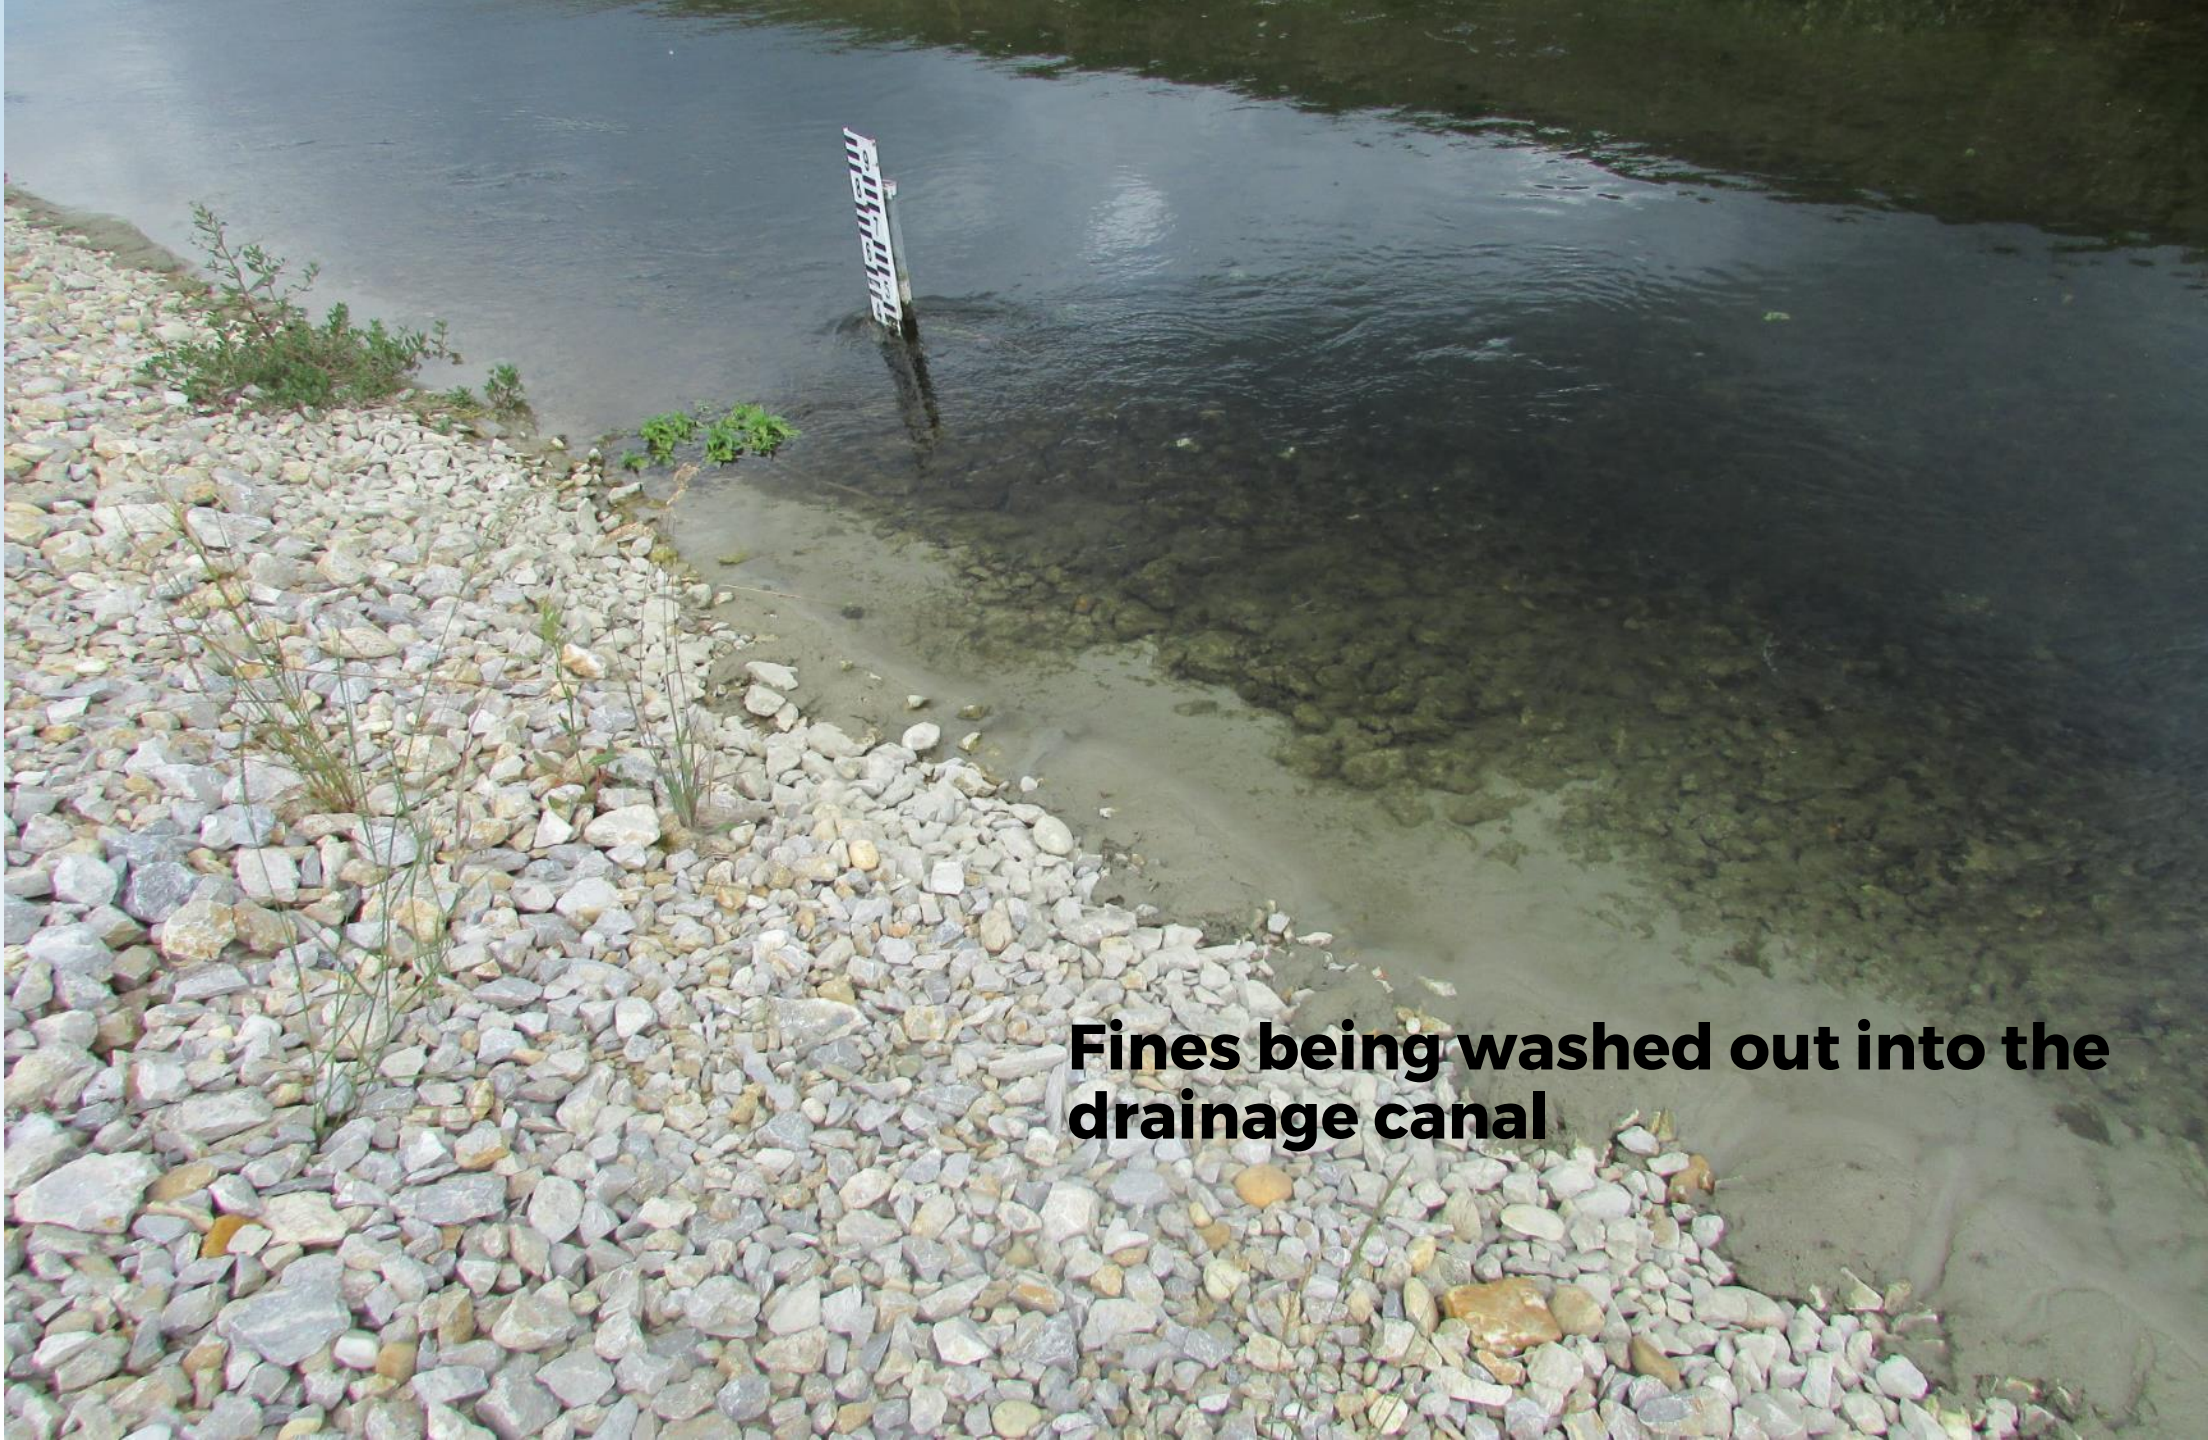
**Fines being washed out into the drainage canal**

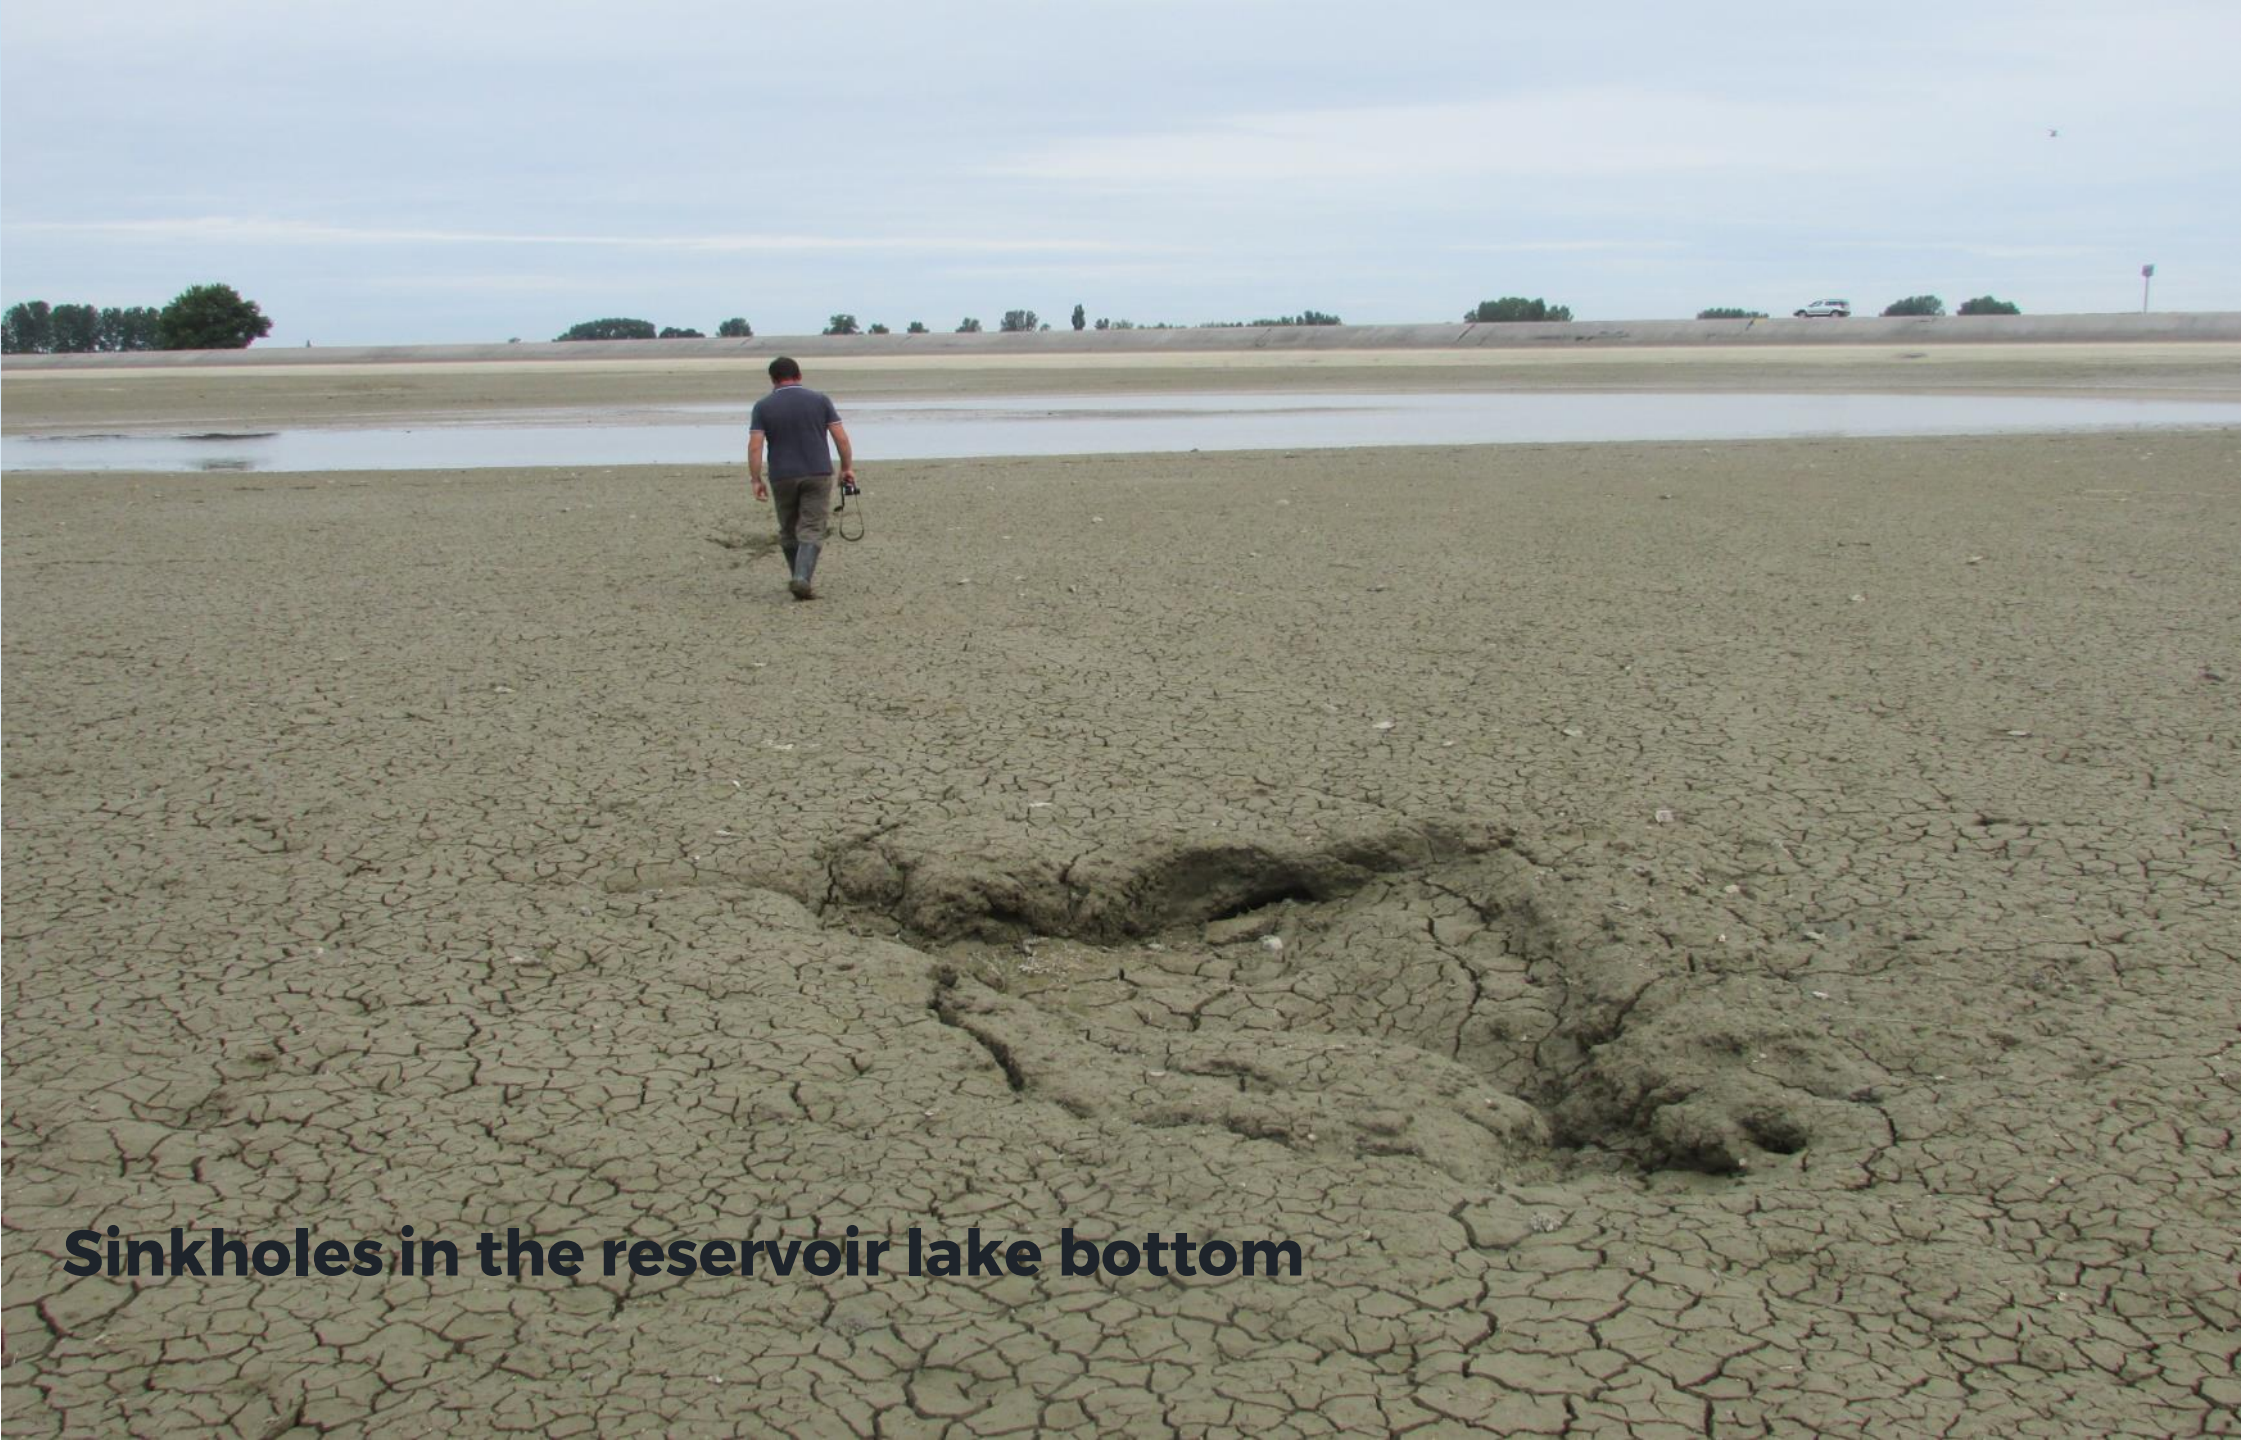
**Sinkholes in the reservoir lake bottom**

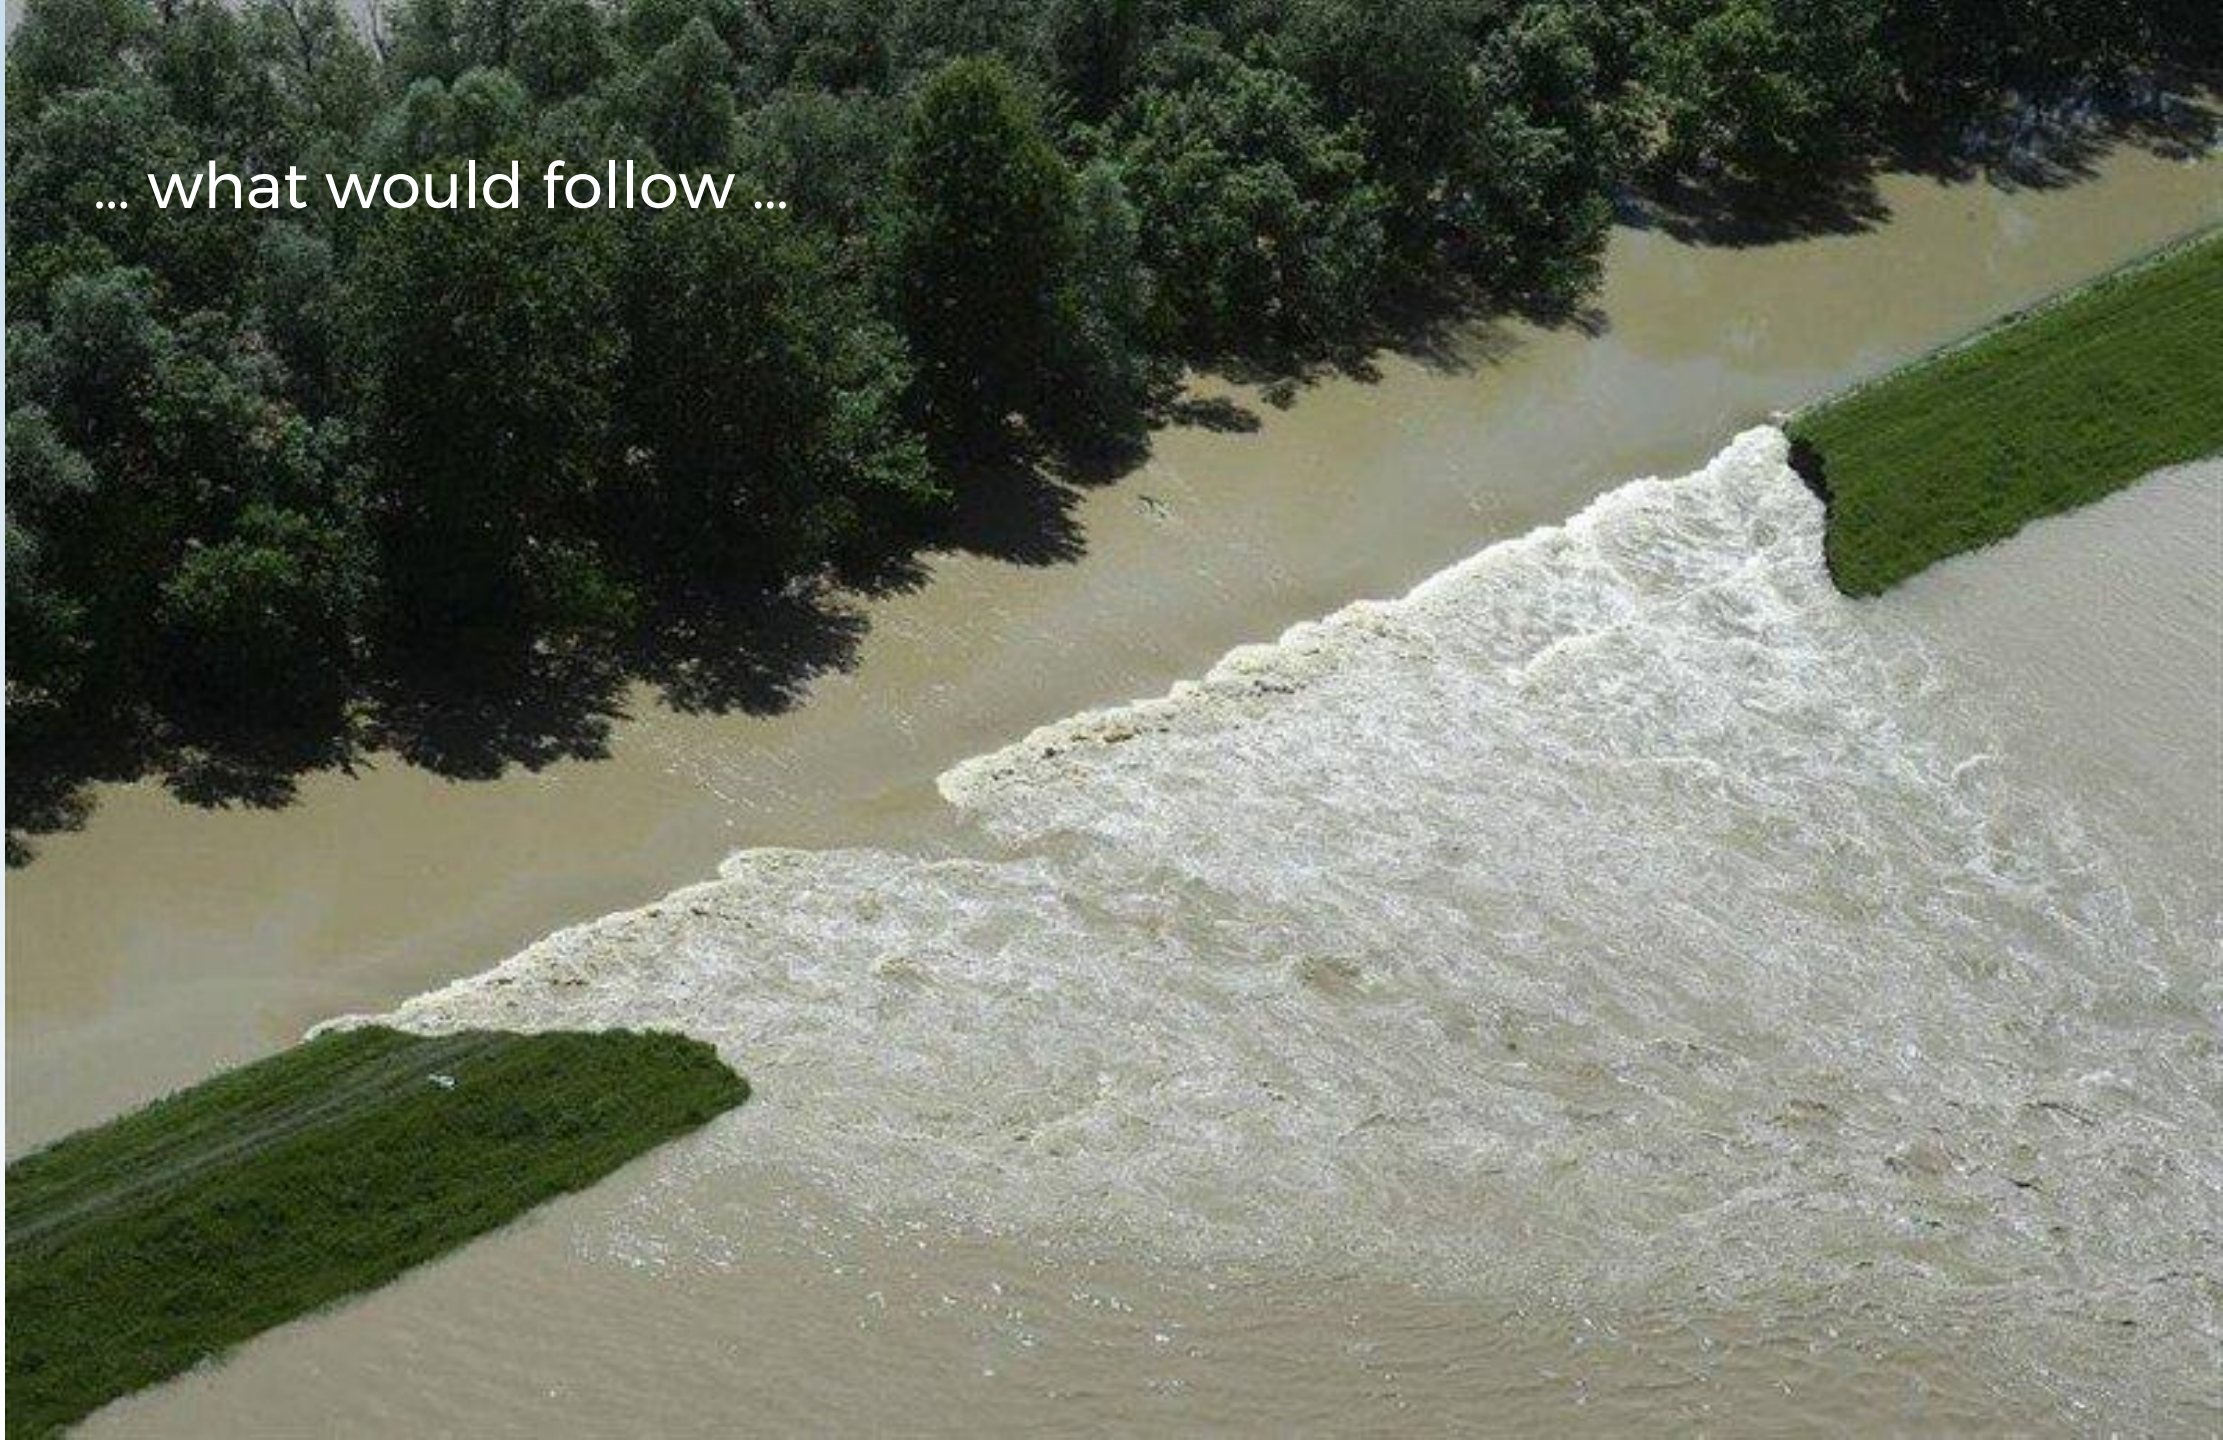
... what would follow ...

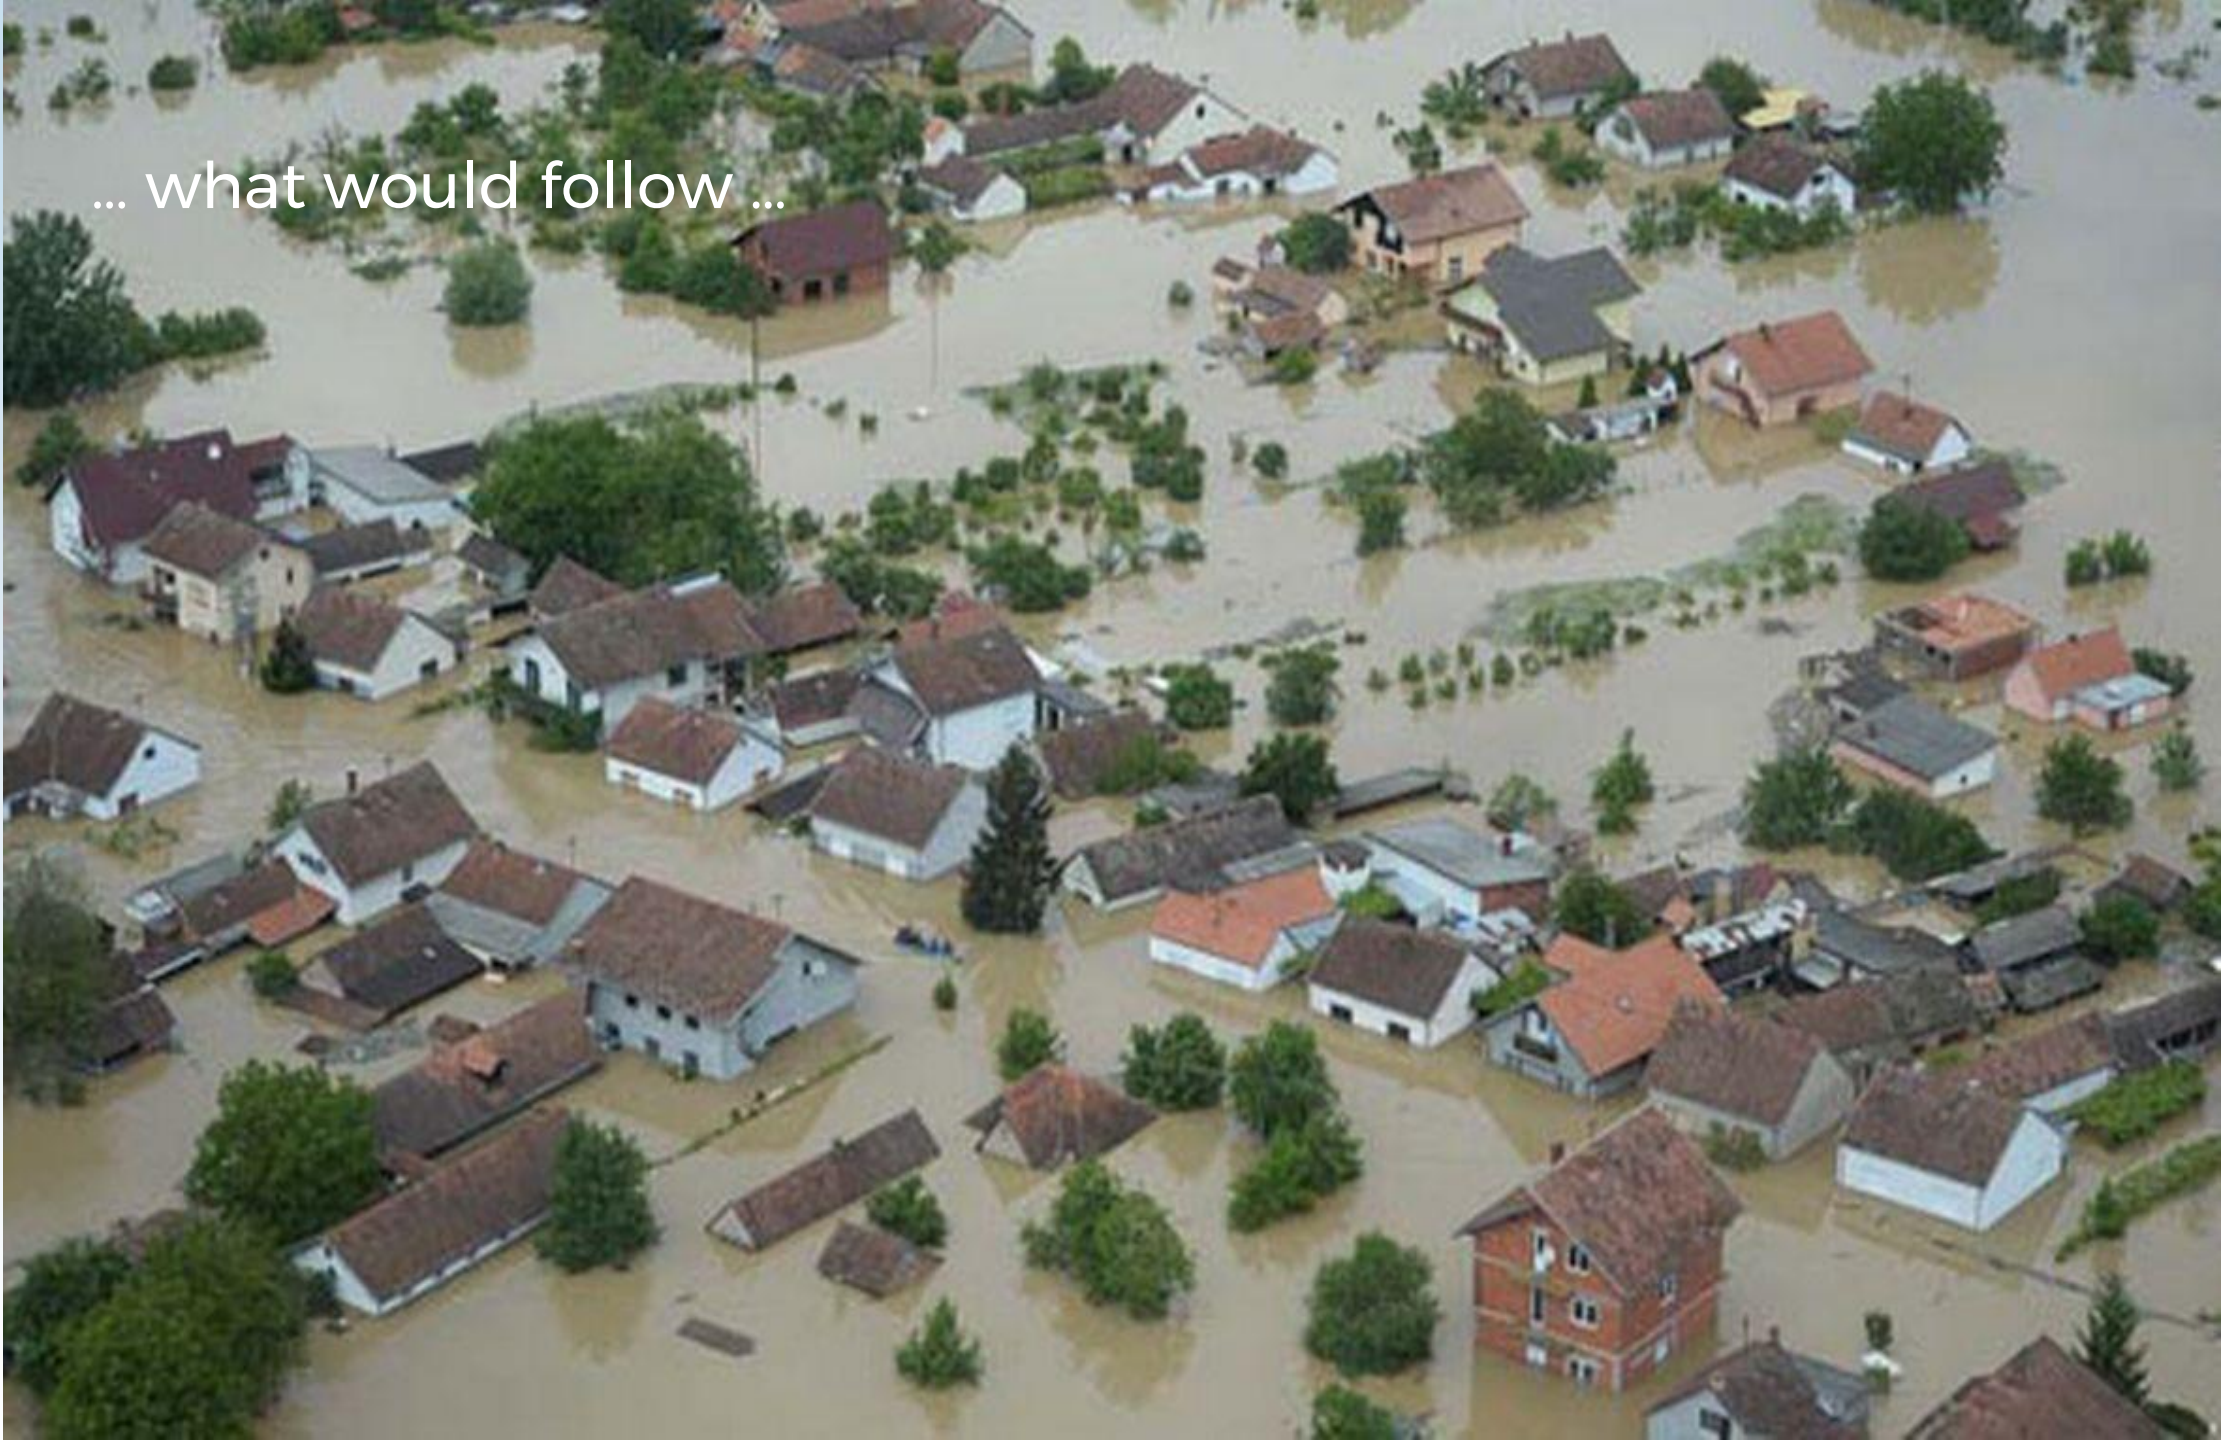
... what would follow ...

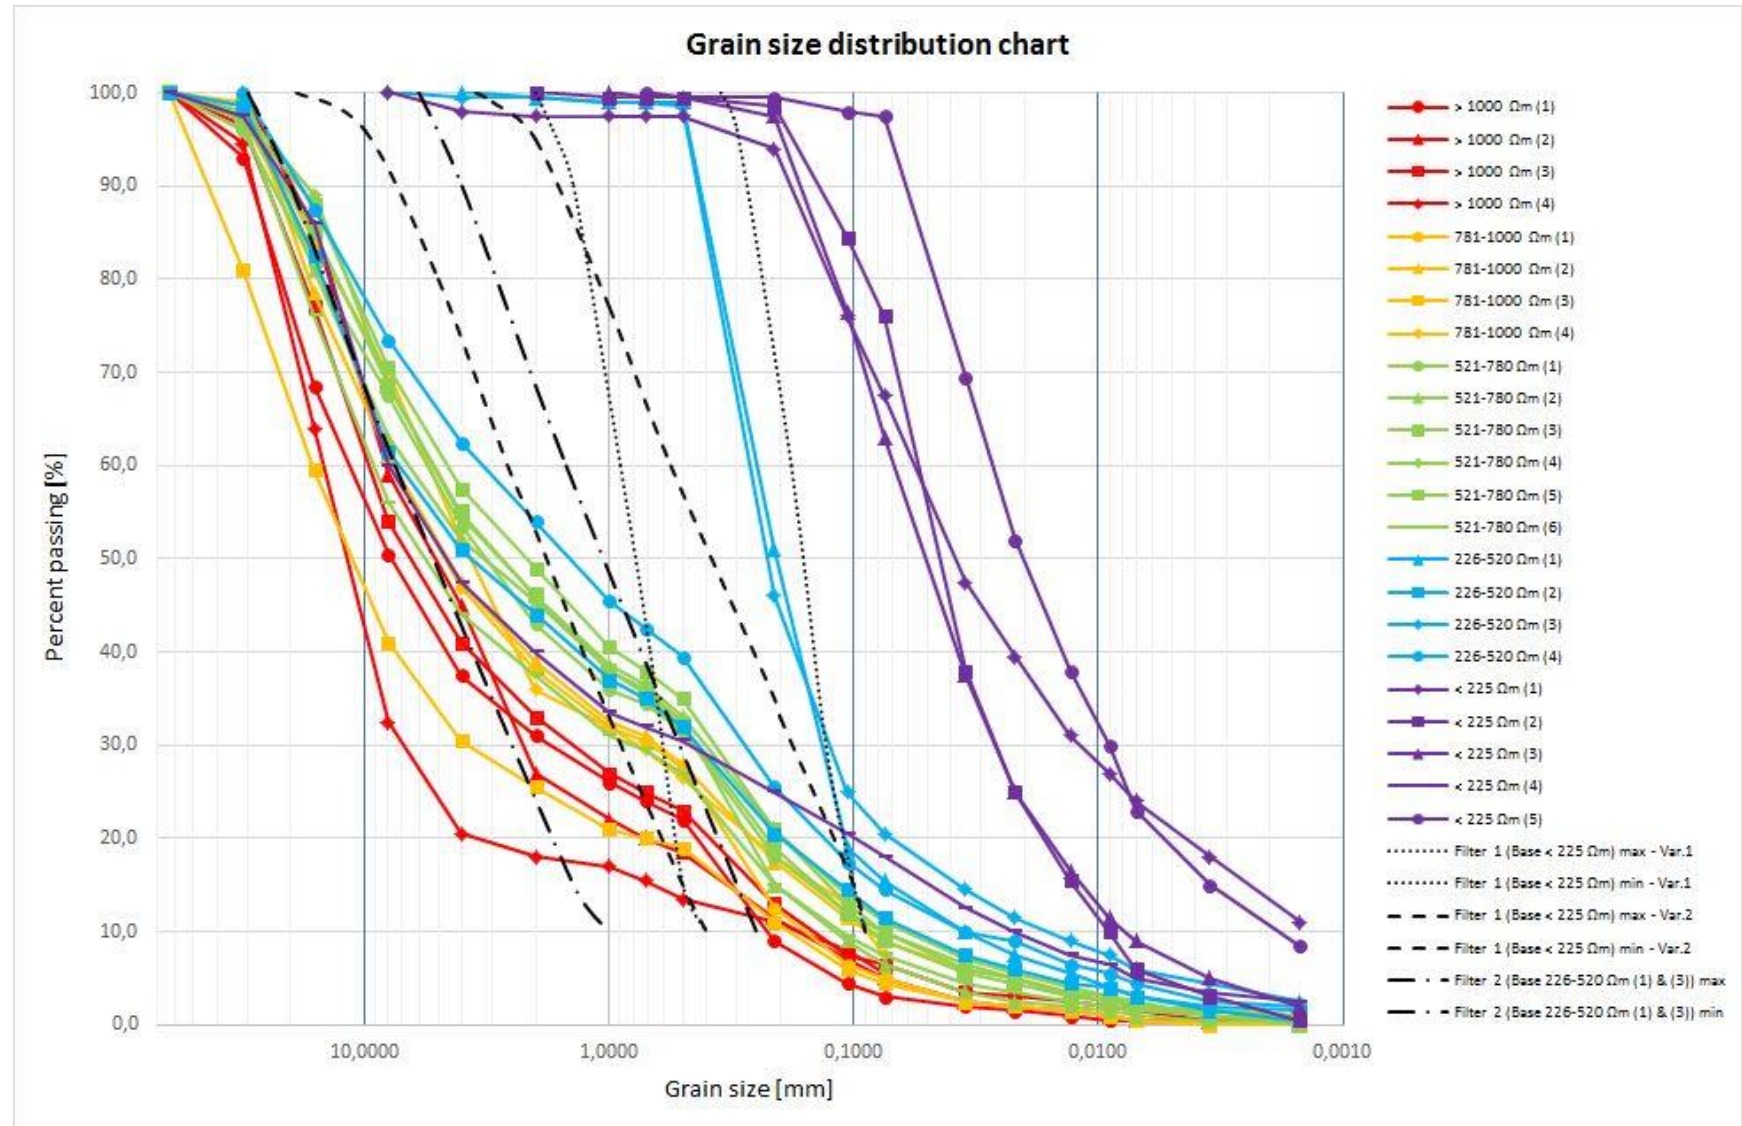
- This allowed for plotting of PSD curves on a joint graph, with the color of the curve depending on the resistivity of the surrounding soil from which a sample was taken
- Above-stated procedure showed the following:
  1. *Coarser materials, have higher resistivity than finer materials*
  2. *Well-executed and interpreted ERT method can distinguish between very small differences in material composition*
  3. *ERT results still need verification via drilling and sampling*
  4. *Dense spacing between contour lines in interpreted ERT sections (profiles) denotes a sudden change in material layers in terms of particle size*

# Chart with PSD curves linked to electrical resistivity values
