Åtgärder på läckande dammar i Australien

SwedCOLD

2016-10-25
Rohan Sutton
WSP Vattenbyggnad

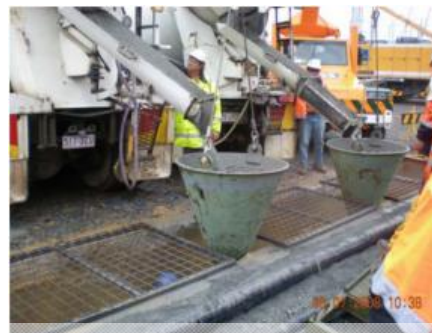
Tremie concrete placement

Diaphragm walls – Hinze Dam (cont.)

- 220m long and up to 53m deep Cut-Off Wall into Foundation and partly Stage 2 Embankment Core
- Cut-Off Wall Design – Plastic Concrete
 - 47 panels, 0.8m thick wall, constructed in alternating sequence of primary (7m wide) and secondary panels (2.8m wide, overcut)
- Technical requirements for plastic concrete
 - Strength between 2MPa and 4MPa
 - Ductile stress-strain properties to accommodate differential stresses and deformation without cracking
 - Low permeability ($<1 \cdot 10^{-9}$ m/s)
- Cement and bentonite concrete mix, typically 6-8hours to pour a primary panel
