# TOUS DAM REVISITED

## A Common Sense Disaster

Stockholm  
October, 19th., 2022

Dr. Juan B. Marco  
Professor "Ad Honorem"  
Universidad Politécnica de Valencia

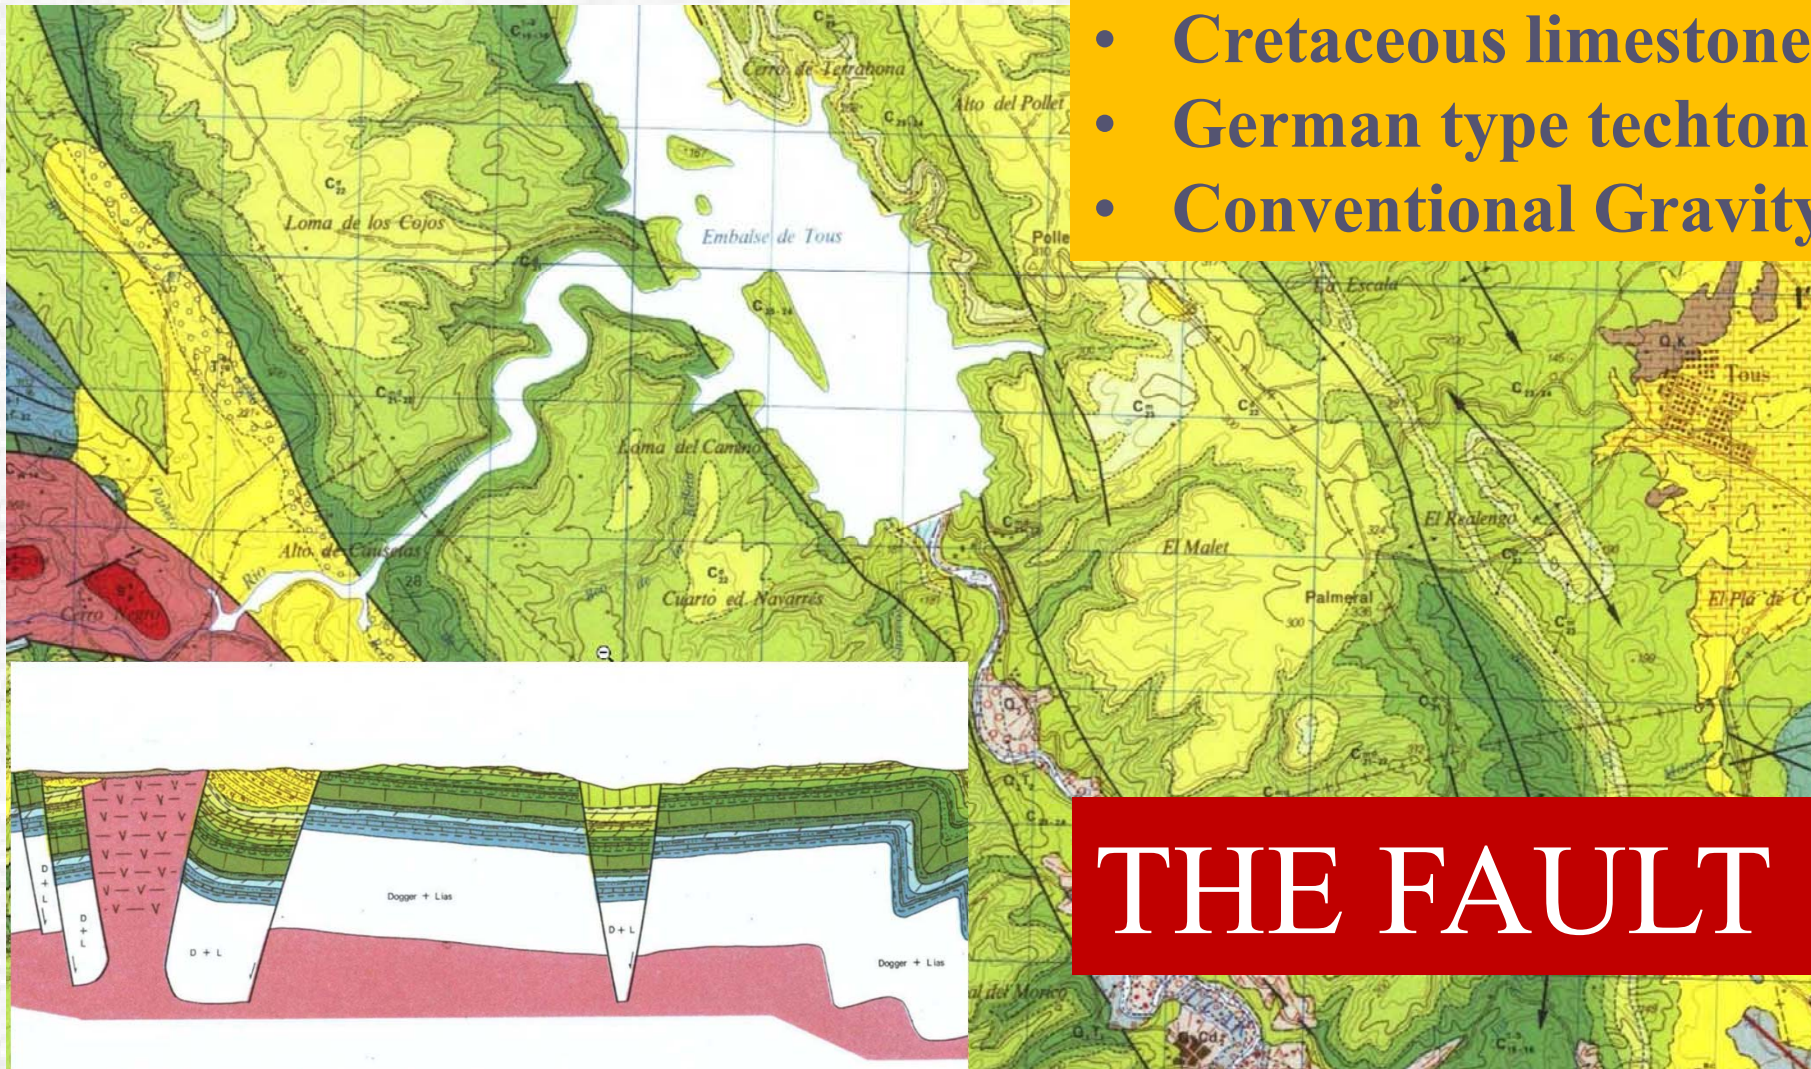
- Cretaceous limestones
- German type tectonics
- Conventional Gravity Dam

**THE FAULT !!!**

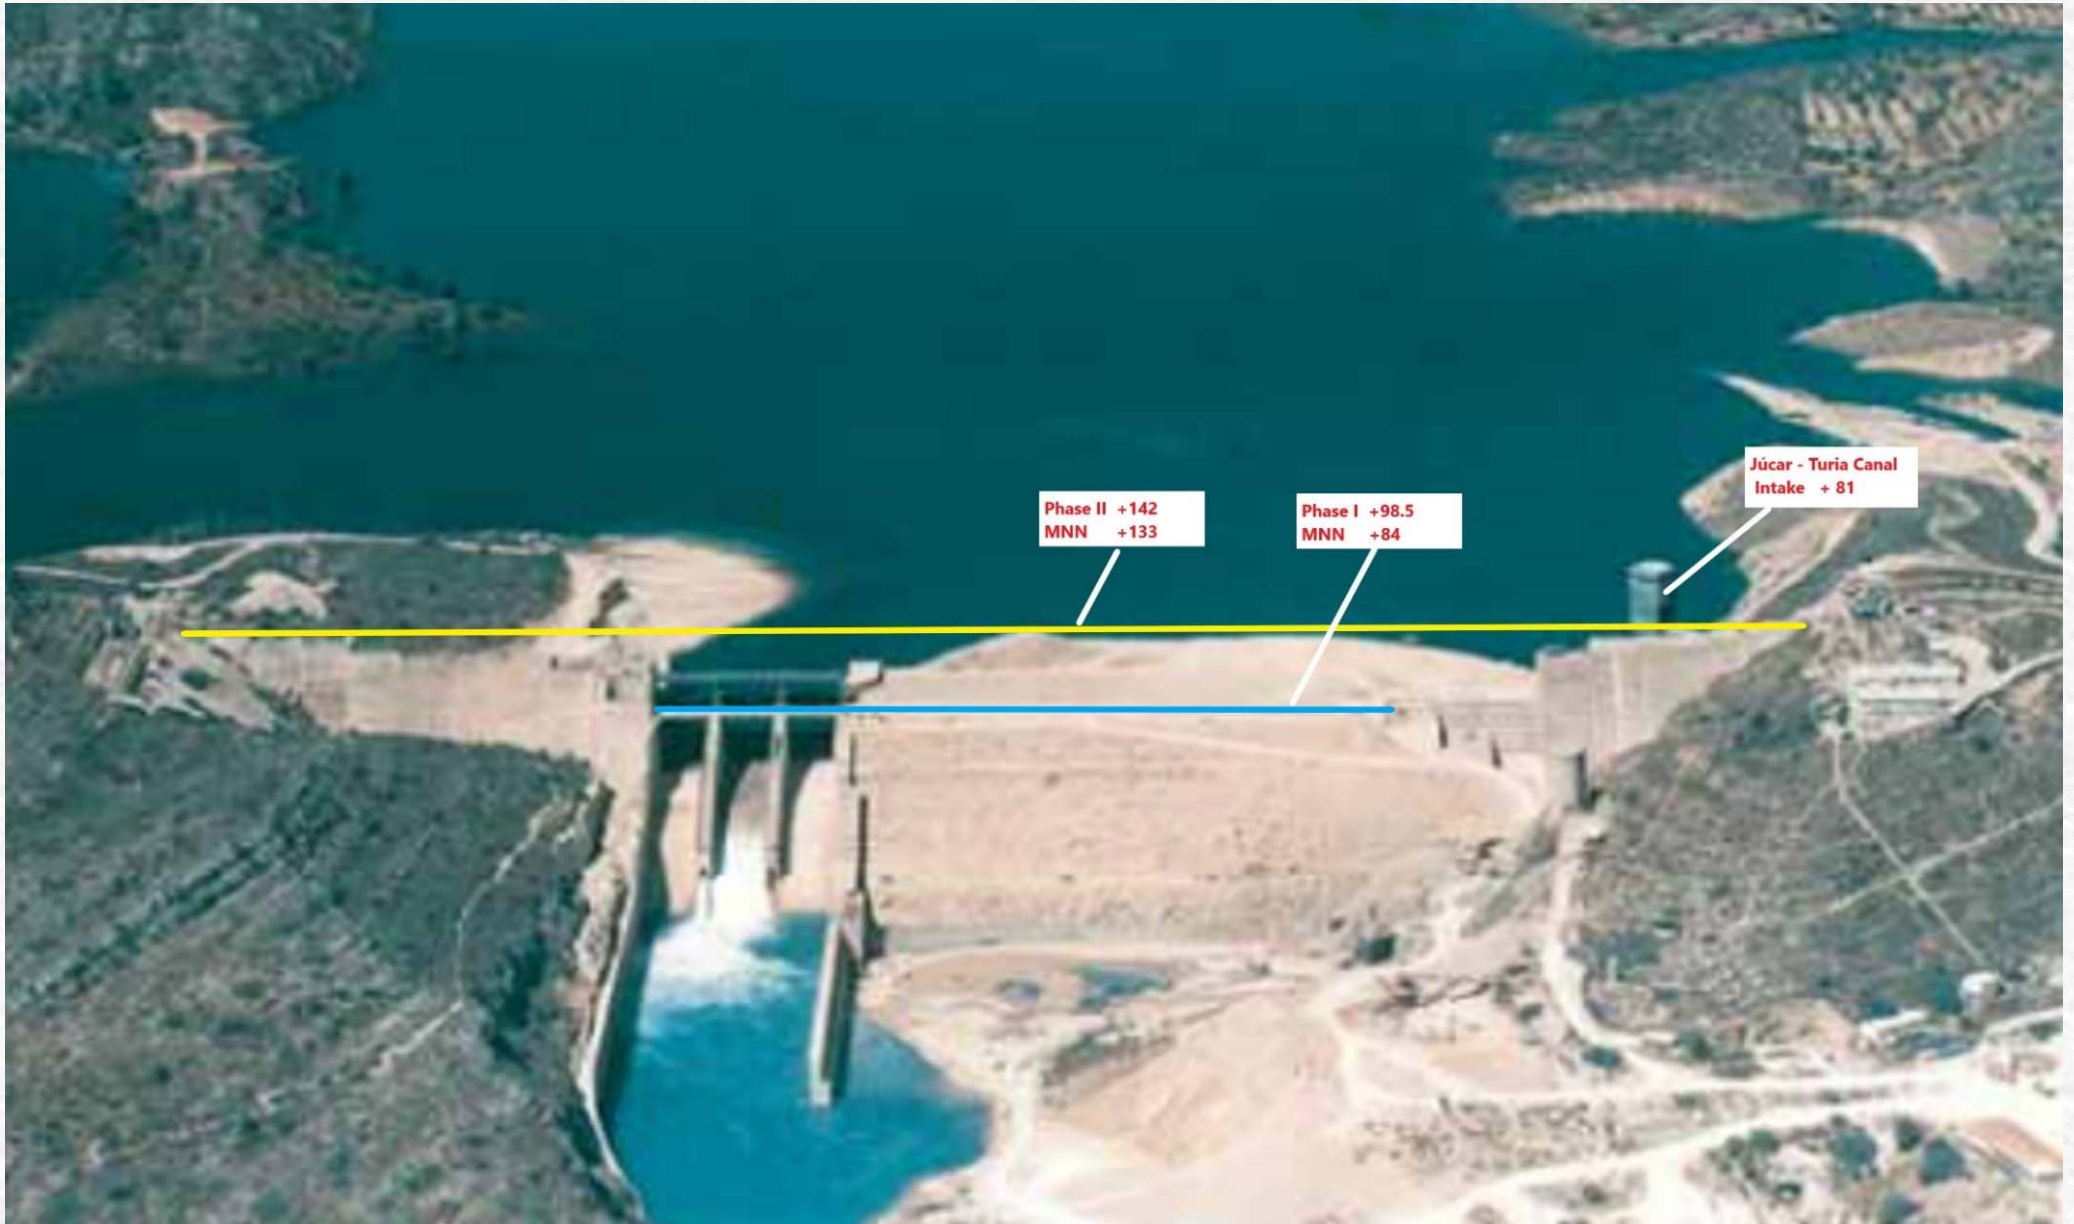
# TOUS DAM 1982

No Access by the right bank

Gates at provisional location

Flexible vertical wall

Acces to spillway through embankment.

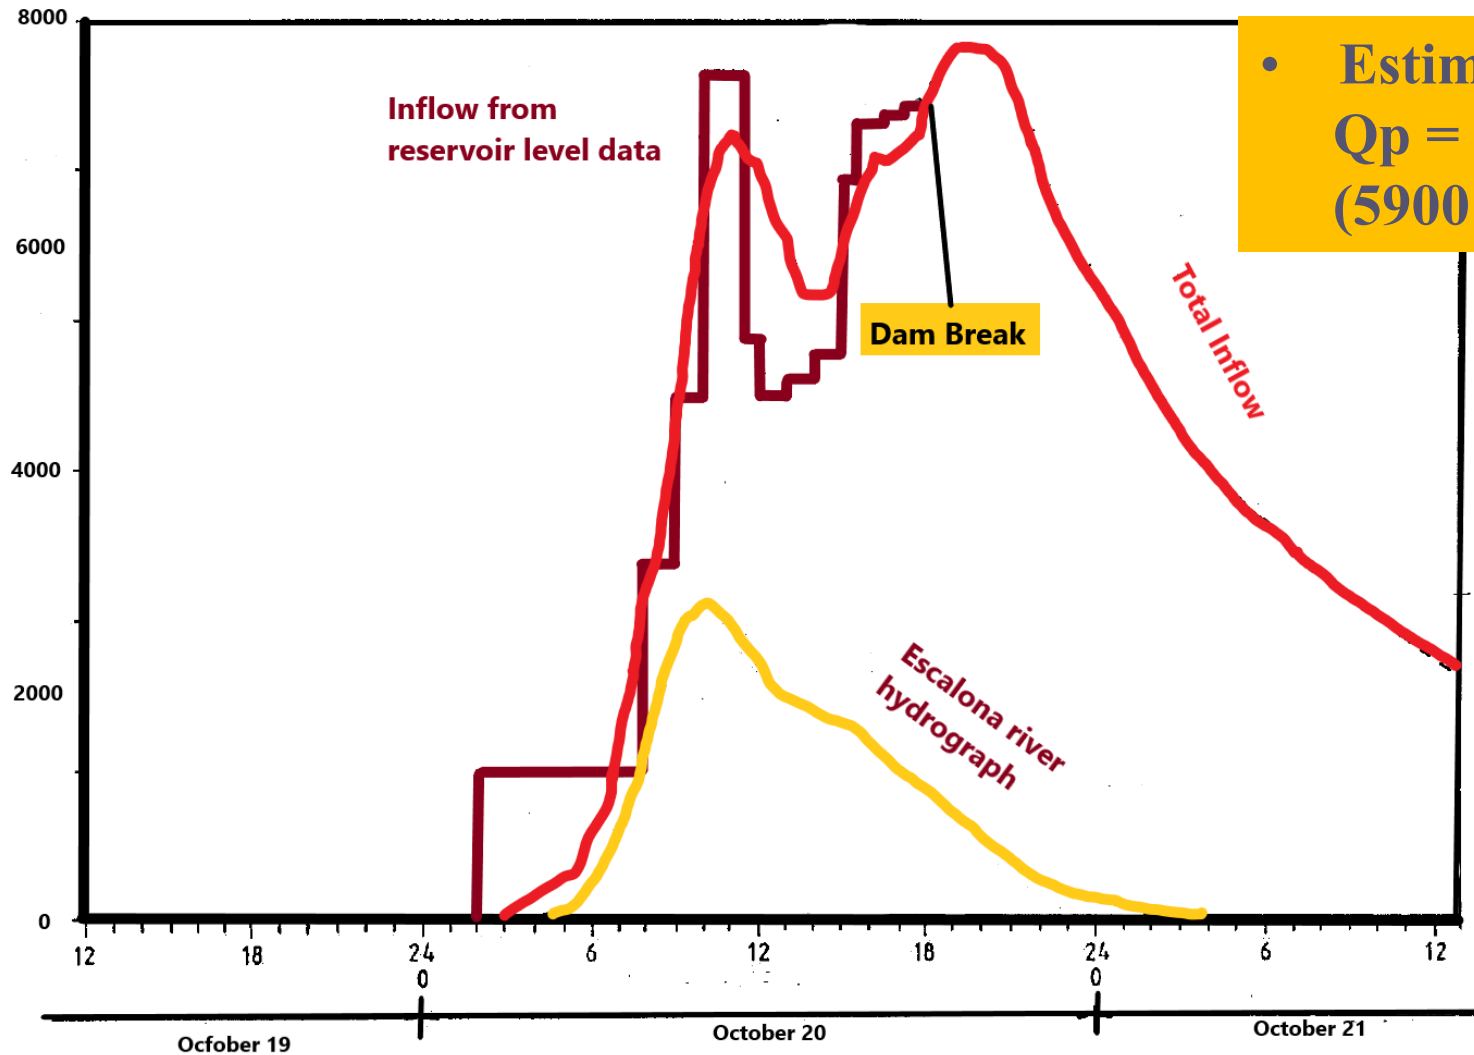
## Incoming Hydrograph at Tous Dam

- Estimated flood peak  
 $Q_p = 7850 \text{ m}^3/\text{s}$ .  
(5900 – 9000 m<sup>3</sup>/s.)

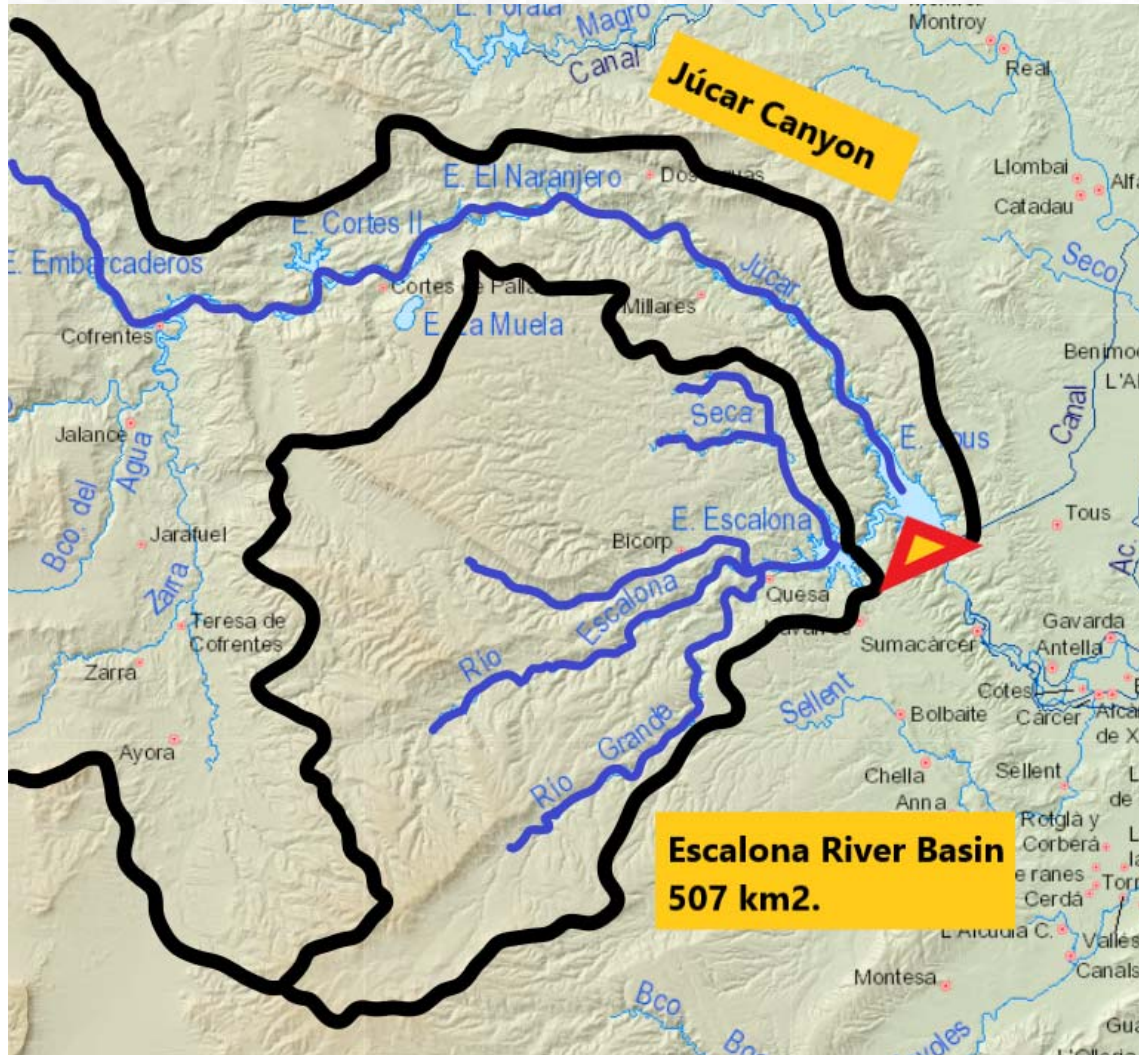
- It started raining strongly at 6 a. m.
- The dam is out of power
- At dawn the Escalona river flood filled up the reservoir spilling over the closed gates. Technicians arrive, and try to open the gates.
- Out of two emergency fuel electric generators, one was out of order, the other at a gallery for repairing a valve. The gallery entrance was flooded.

- It is decided to go to Tous village to get a new group. When returning, the road is cut by a landslide.
- They try to open manually the gates but the mechanism brokes.
- Strong rainfall resumes at 10 a. m. At 11 a.m. the dam starts to spill over the earth embankment.
- Access to the gates is cancelled. There is no road through the right bank.
- Helicopters tried unsuccessfully to fly.

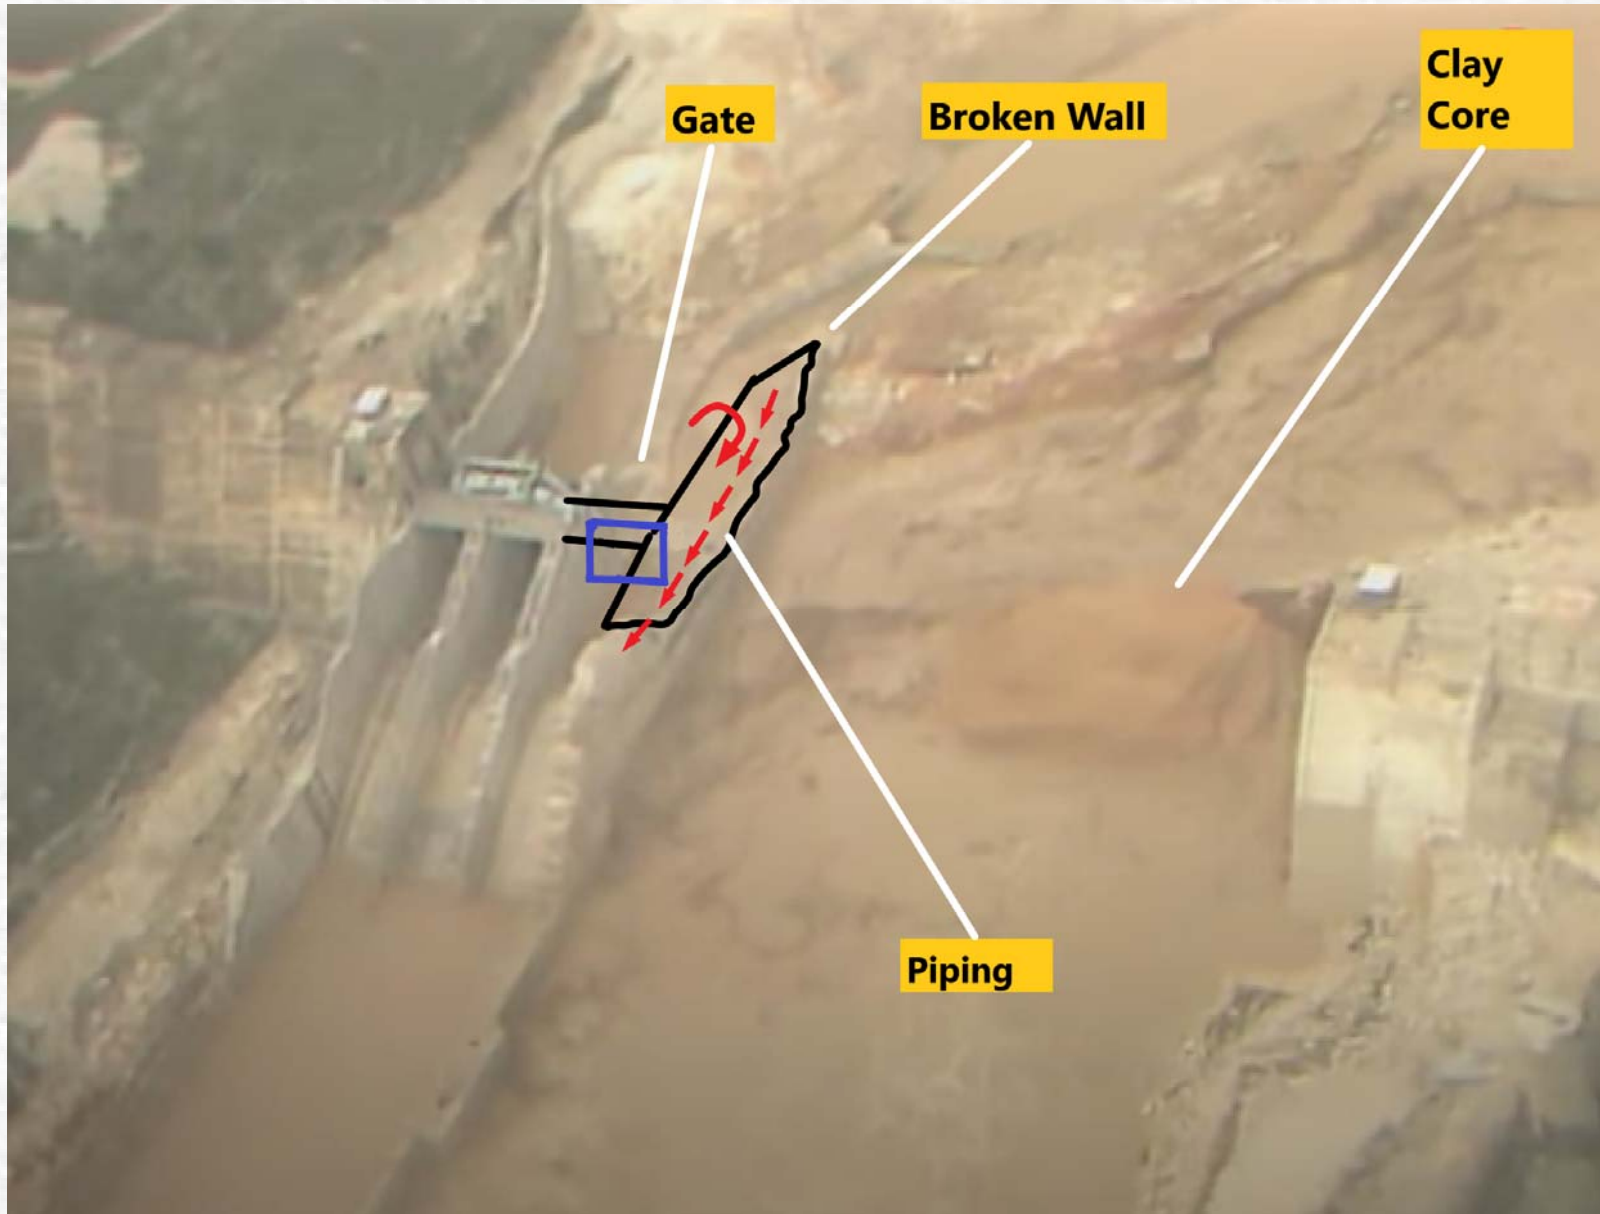
# THE EVENT OCTOBER 20th. 1982

- An important part of the central clay core, remained.
- No construction defects were detected.
- Failures were design (flexible wall, hydrology) and logistics

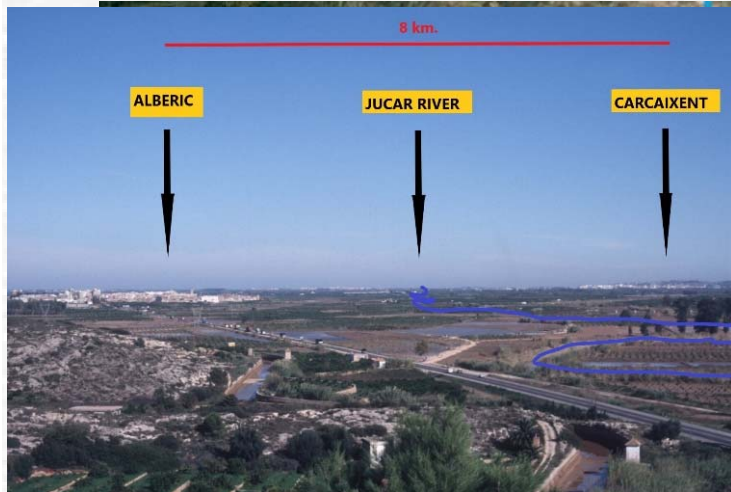
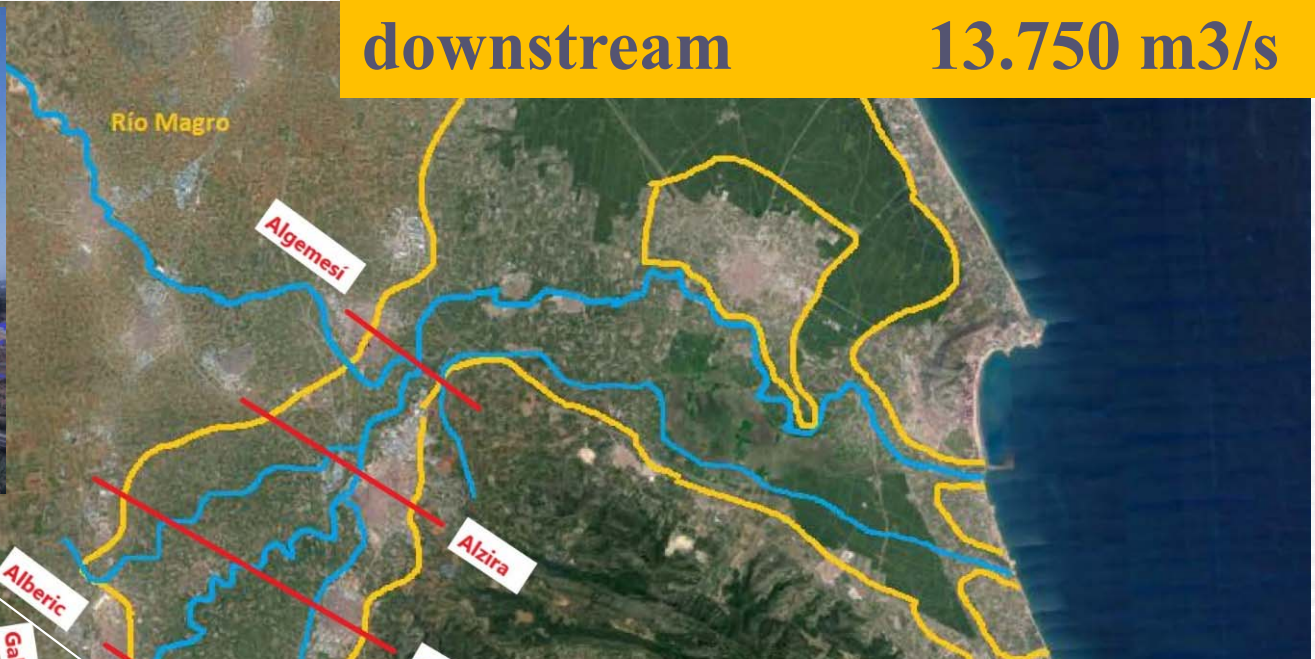
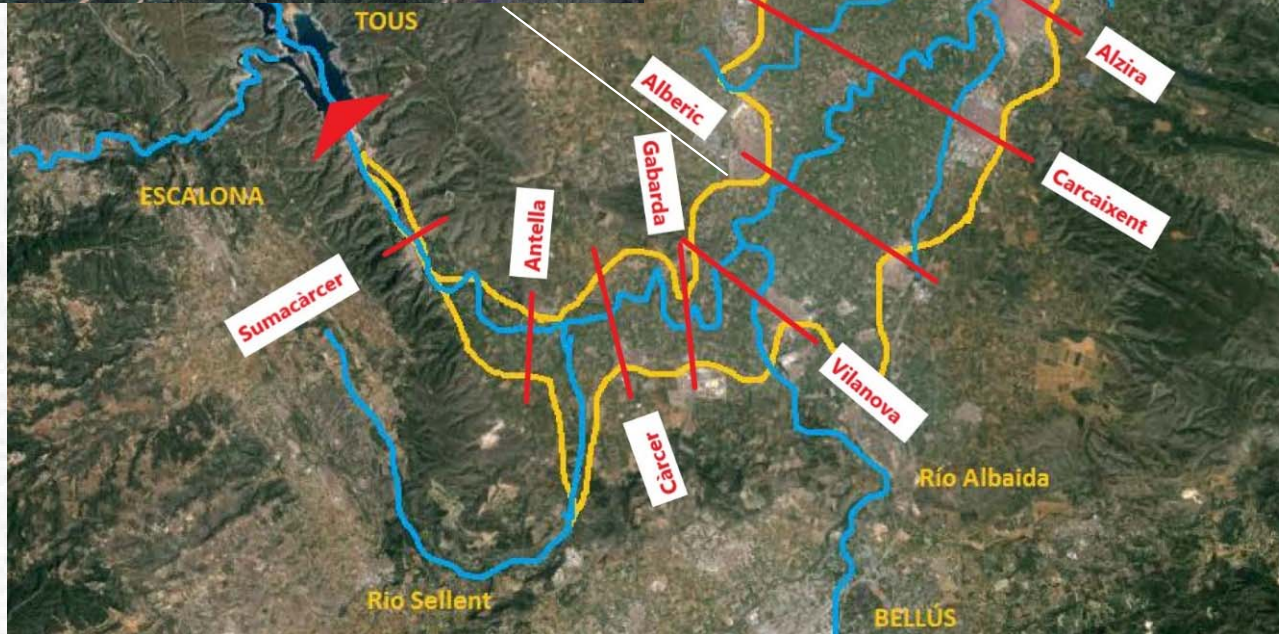
A dam break wave propagated  
downstream **13.750 m<sup>3</sup>/s**

Village	Time	Height
Sumacàrcer	19:25	6 m.
Gabarda	20:15	2.6 m.
Vilanova	20:30	1.4 m.
Alberic	20:45	1 m.
Carcaixent	21:10	0.6 m.

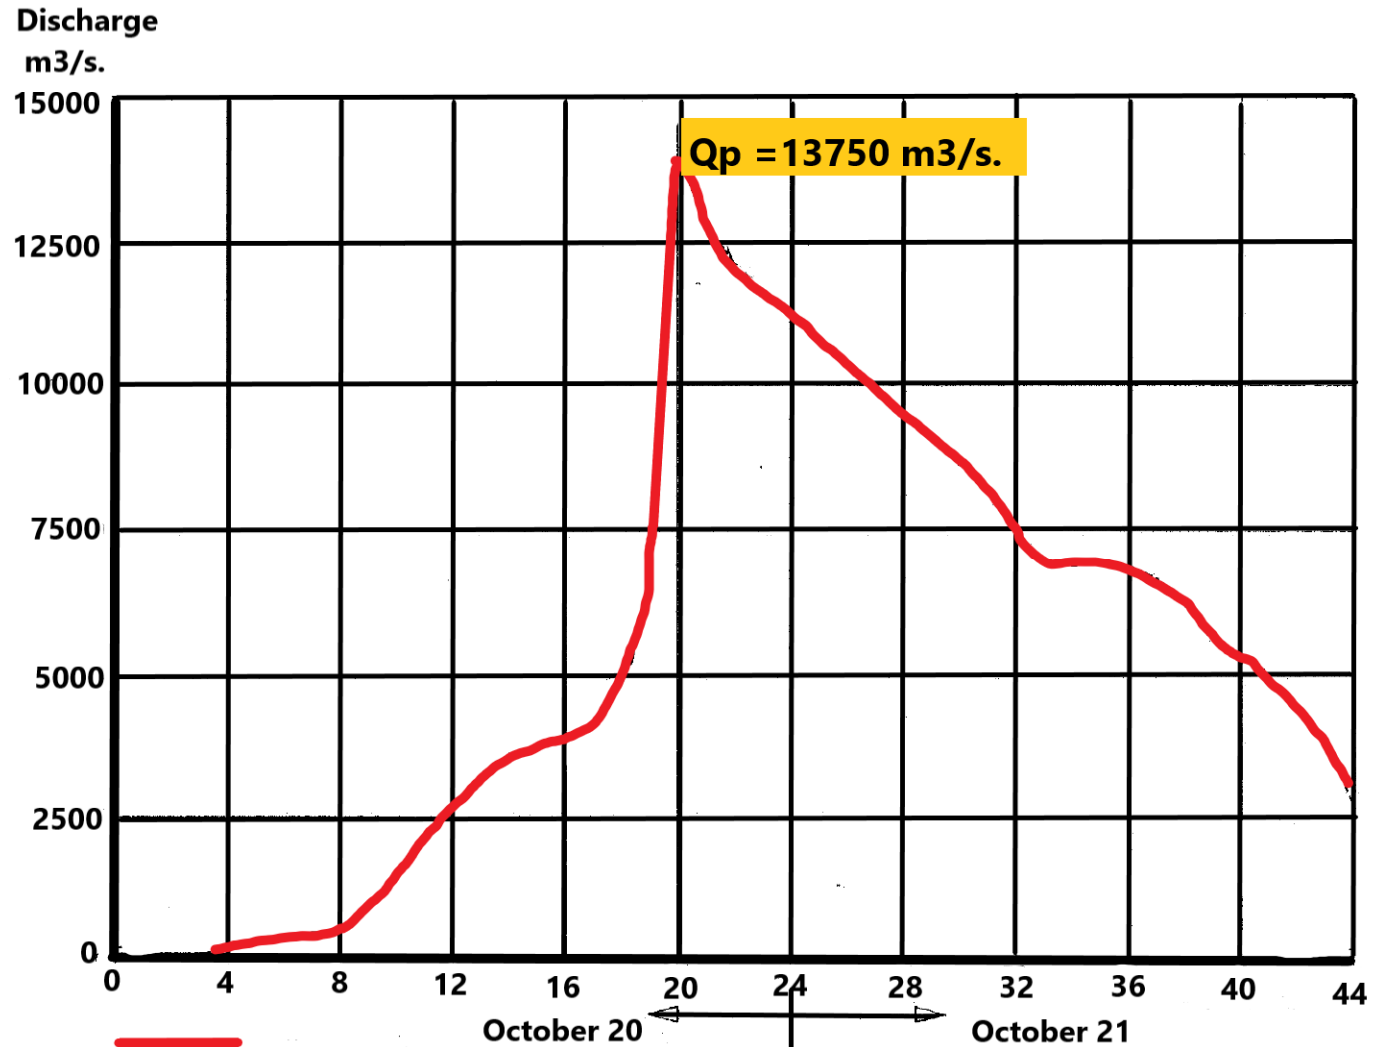
## OUTFLOW HYDROGRAPH

- Estimated flood peak  
 $Q_p = 13750 \text{ m}^3/\text{s}$ .  
(12900 – 15000  $\text{m}^3/\text{s}$ .)
- 1600 – 2000  $\text{hm}^3$ .  
2 days flood

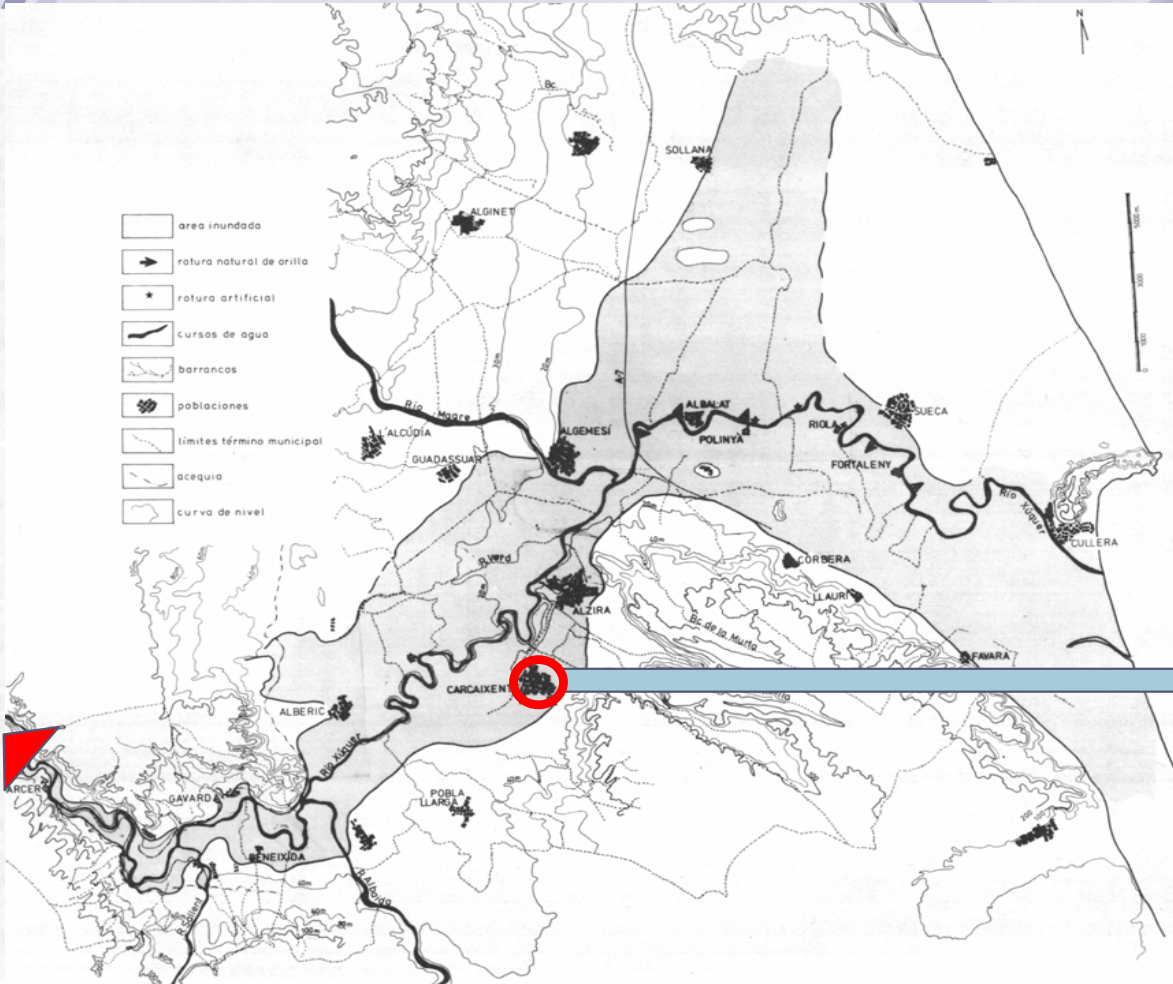
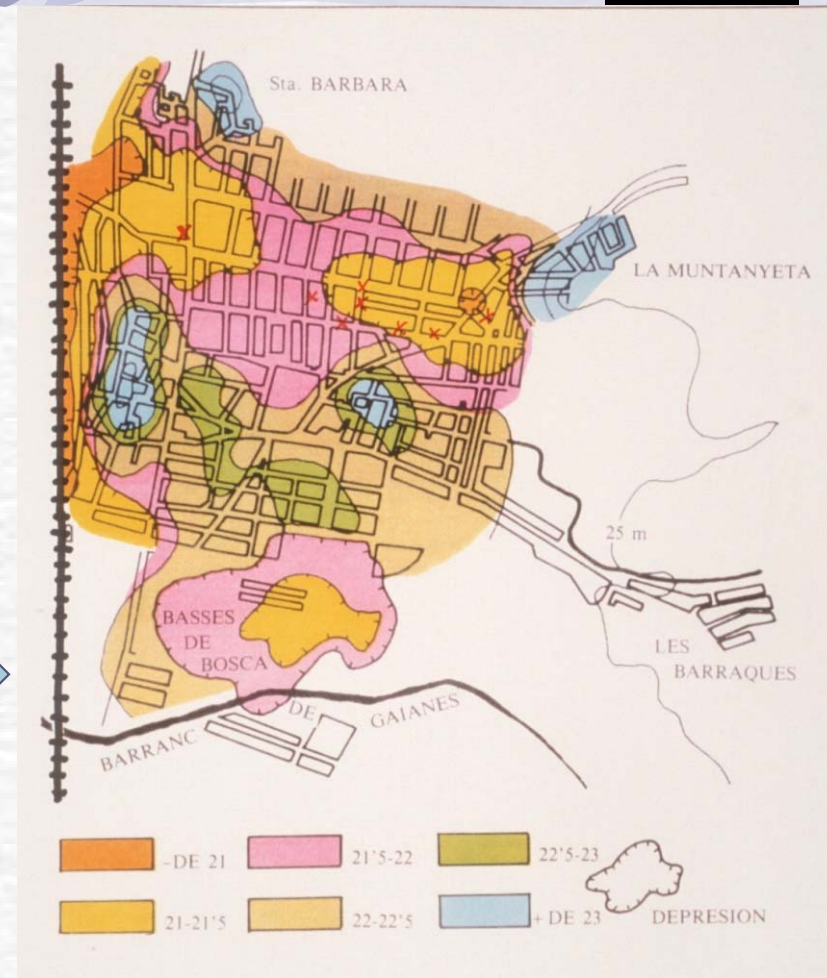
- 16 people died at the very same neighbourhood at Carcaixent
- It is not clear if they died from the dam break wave at 10 p.m. or the flood entrance at 4 p.m.
- This place is quite downstream from the flood

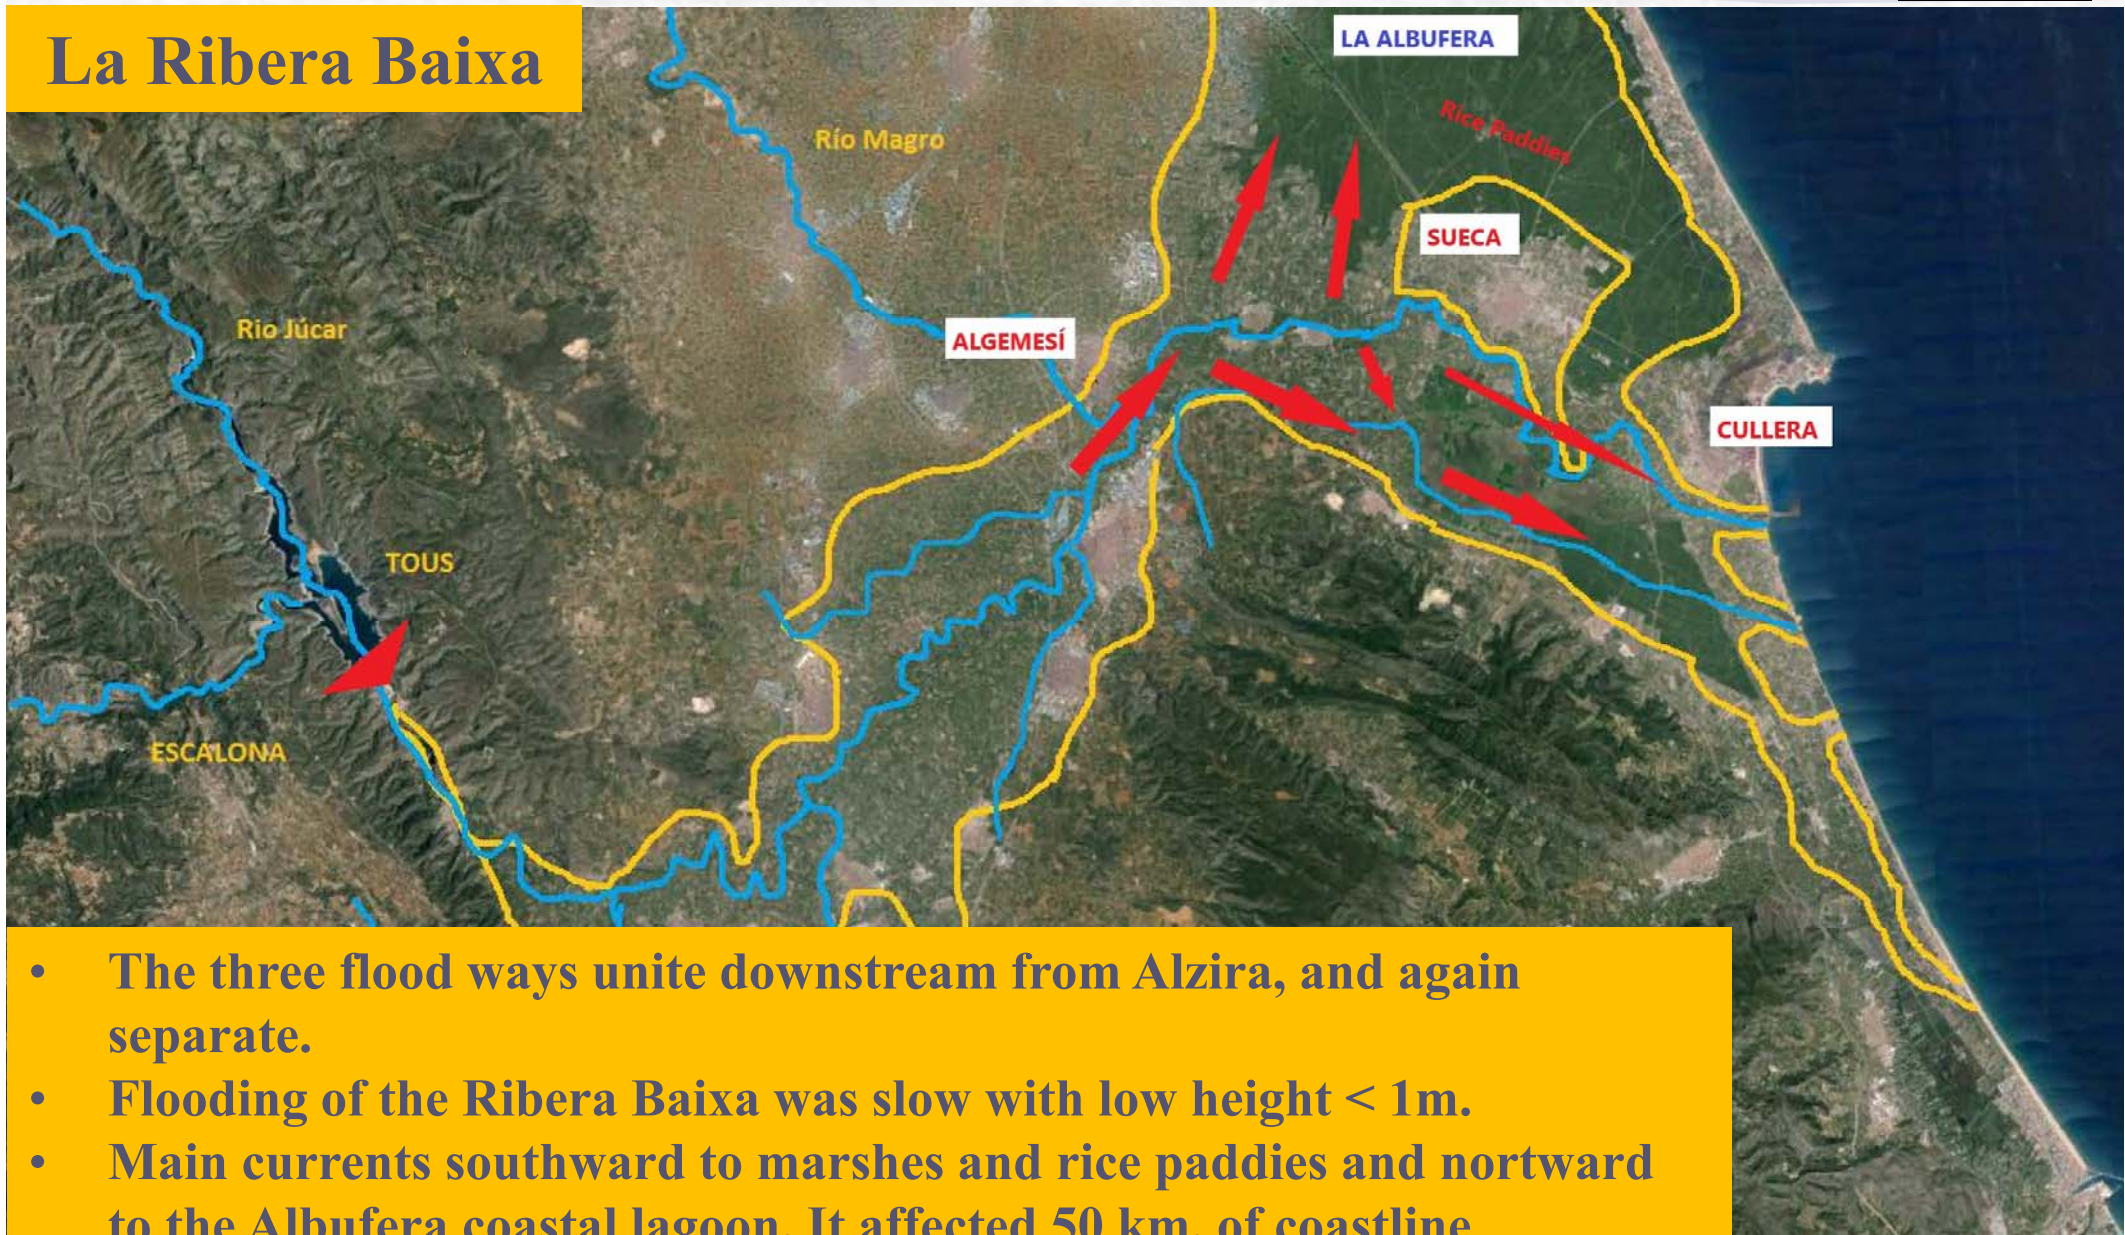
## La Ribera Baixa

- The three flood ways unite downstream from Alzira, and again separate.
- Flooding of the Ribera Baixa was slow with low height  $< 1\text{m}$ .
- Main currents southward to marshes and rice paddies and northward to the Albufera coastal lagoon. It affected 50 km. of coastline

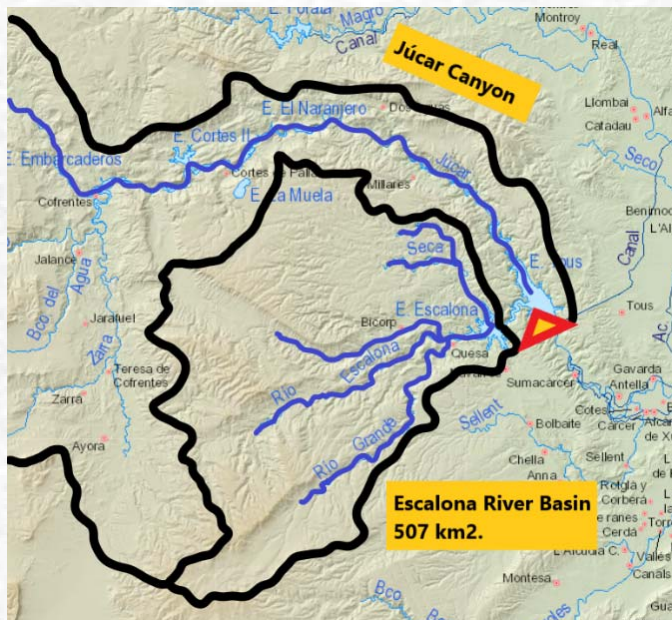
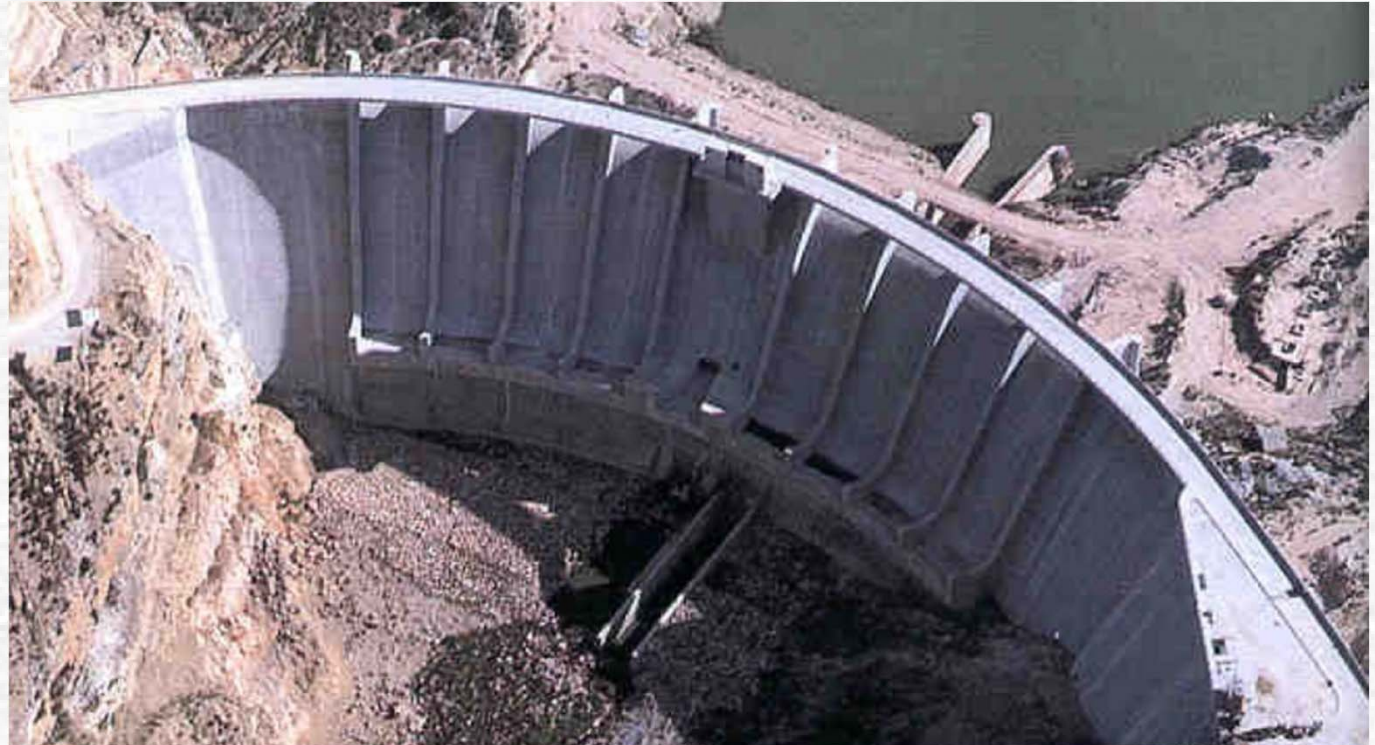
## ESCALONA DAM

- 70 hm<sup>3</sup>
- Arch concrete gravity dam 100 m. high.
- Protection of Tous Dam under its construction
- Avoid quick response of the Escalona river

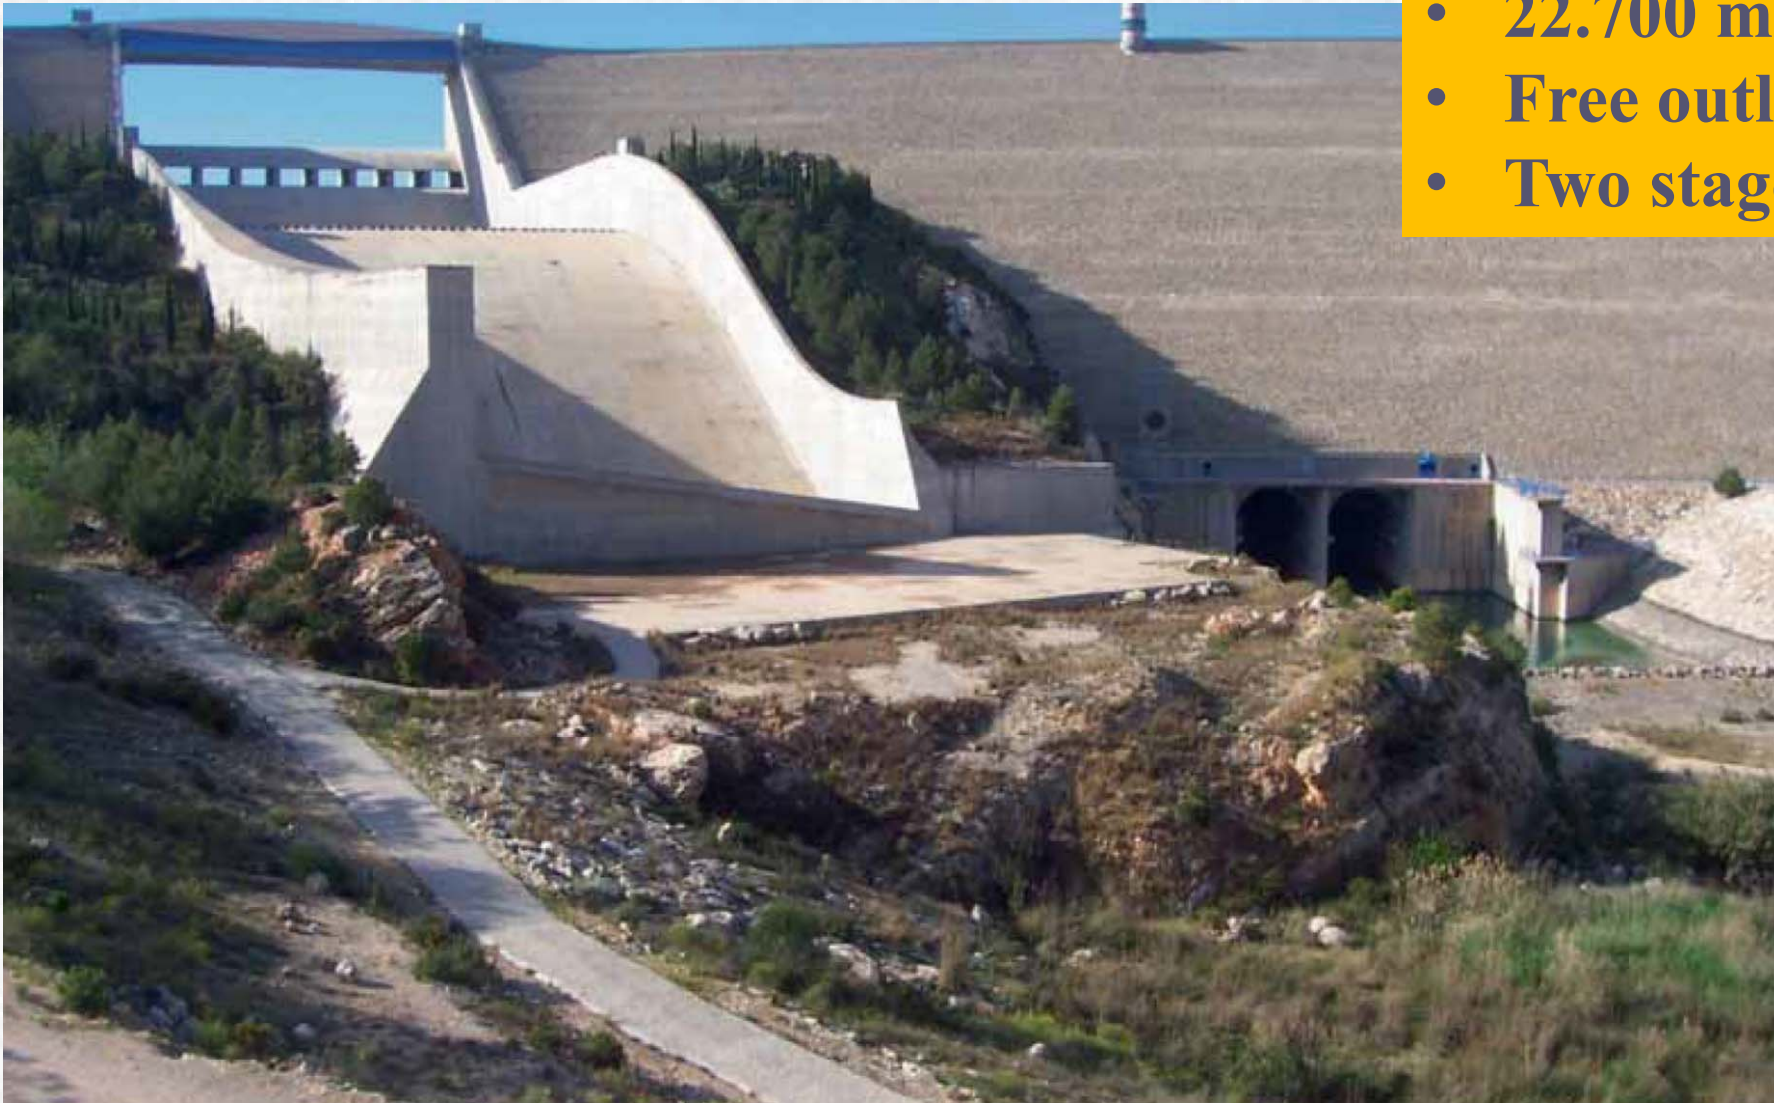
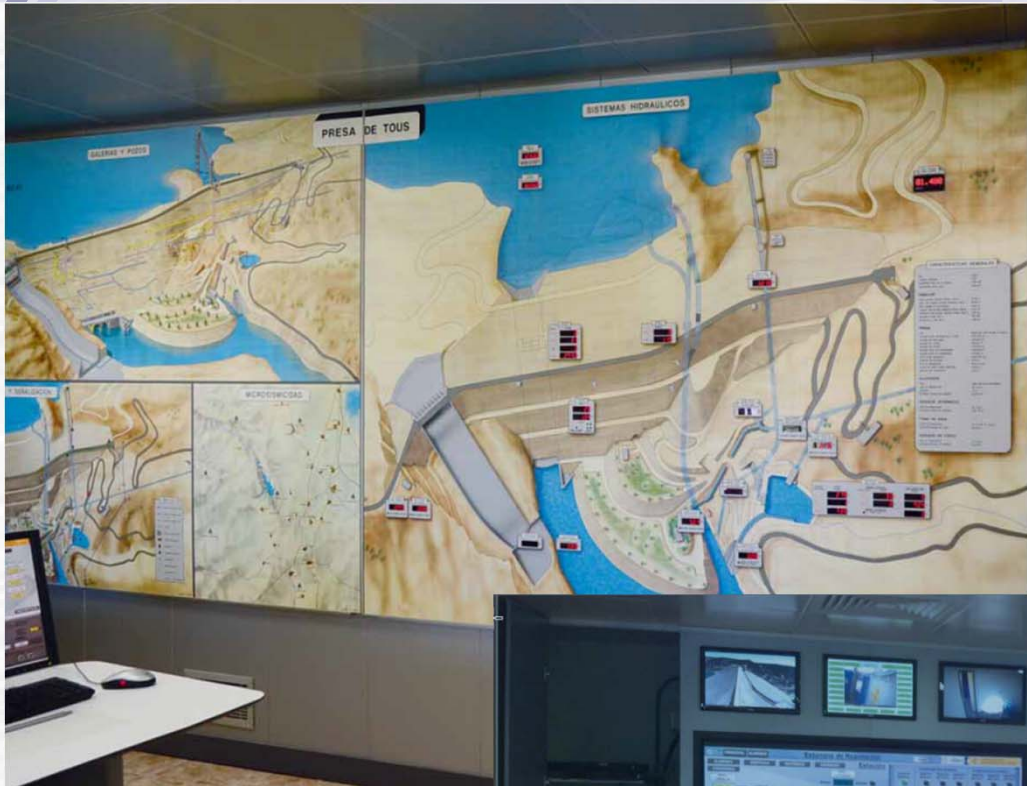
## NEW SPILLWAY

**OLD SPILLWAY  
WAS ADAPTED AS  
INTERMEDIATE  
OUTLET**

- Gated outlet
- 1500 m<sup>3</sup>/s.

- 22.700 m<sup>3</sup>/s.
- Free outlet
- Two stage

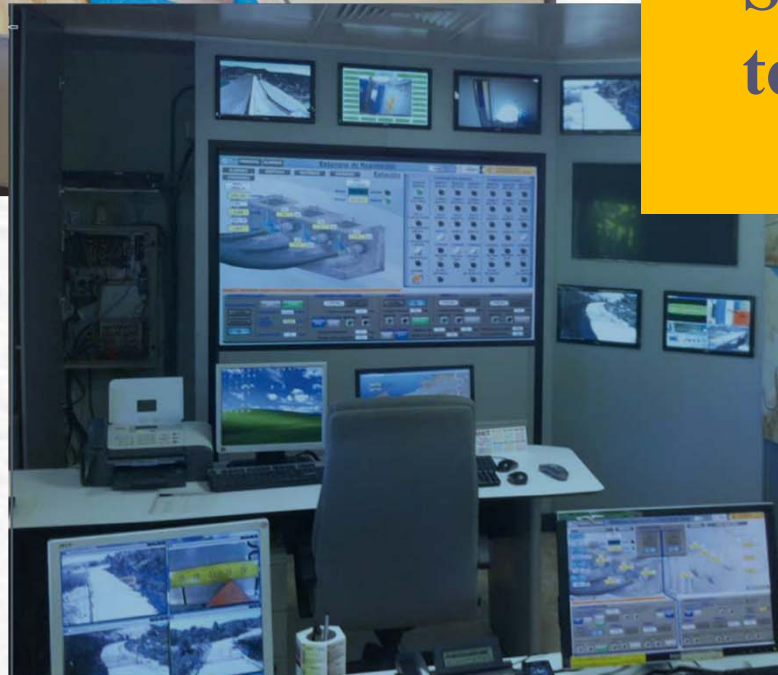
## FULLY INFORMATIZED INSTRUMENTATION AND CONTROL

- Linked to SAIH (Real Time Hydrologic Information System)
- SCADA 24 h. 365 d. Staff to control the dam
