**“Toddbrook: an English reservoir incident and its impact on the industry”**

**Maddie Prendergast**  
National Reservoir Safety Team  
Environment Agency (England)

# Toddbrook Reservoir

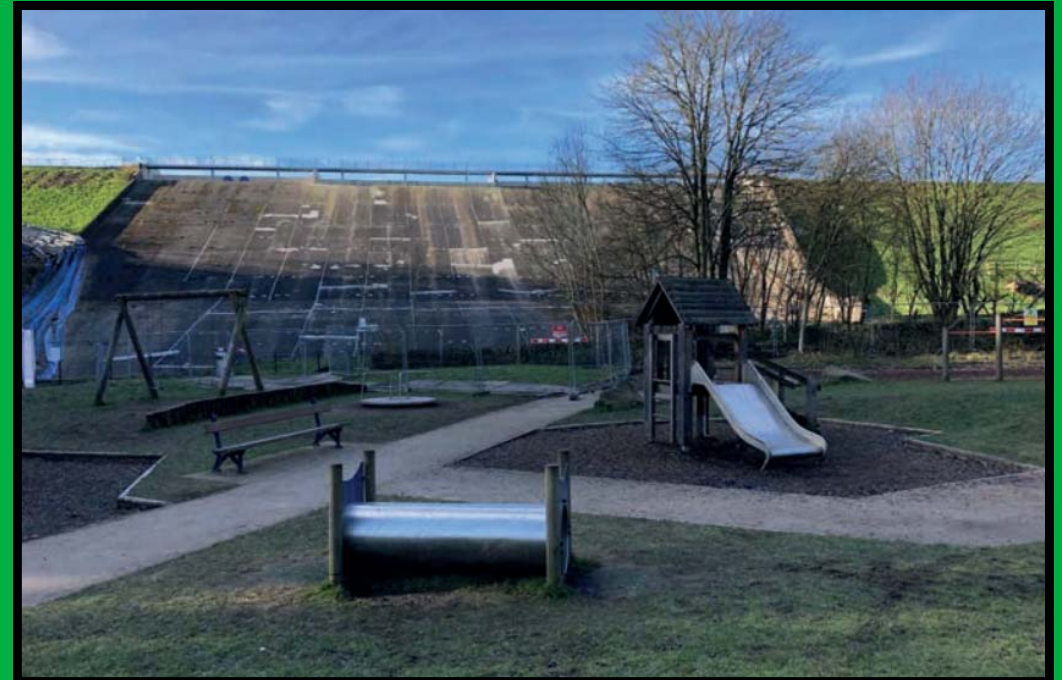
Arup, 2022

Toddbrook reservoir incident (2019): independent review, 2019

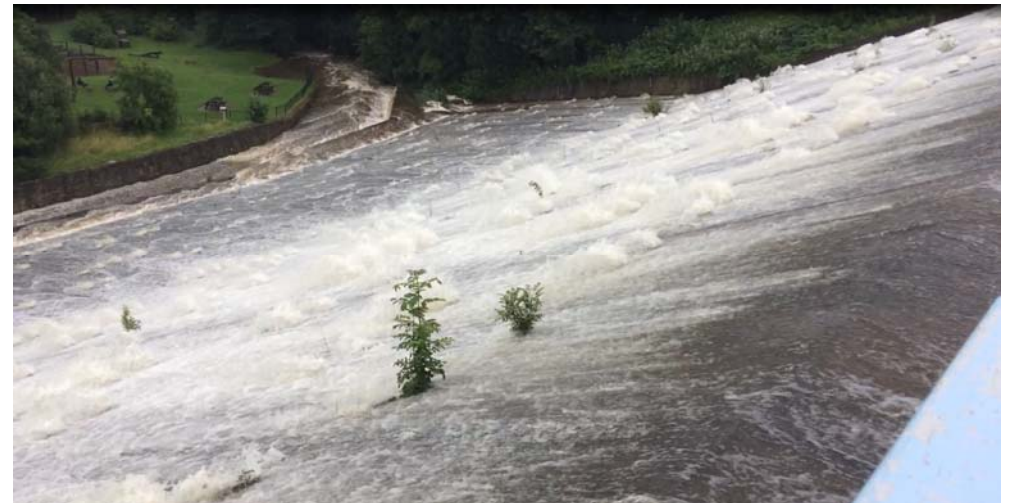
Government (Balmforth)	Owner's (Hughes)
Poor design	Poor design
Water ingress through slab joints, leading to crack injection and rapid erosion of fill.	Water ingress beneath top slab from lack of cut-off over many years, leading to long term internal erosion, exacerbated by the rainfall event of July 2019.
Poor maintenance	Maintenance issues not significant enough to contribute

## 22 Recommendations
