AN ASSESSMENT OF THE FAILURE OF THE WADI DERNA DAMS AND LESSONS FOR ENHANCING DAM SAFETY

Laurent Mouvet
Civil Eng. EPFL-SIA
Vice President ICOLD
Past President SwissCOLD

Wadi Derna Dams Failure

Libya - September 10-11, 2023

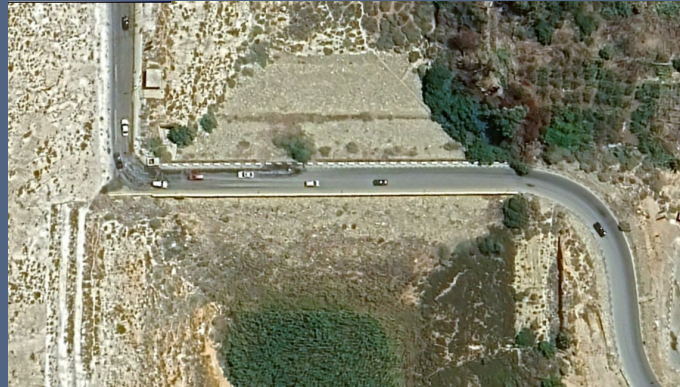
Derna dam

H_{\max} 40m (26m)
 $V=1.2 \text{ Mm}^3$

- excessive settlement of both dams
- watertightness issue at the two dams
3 m³/s under less than 14m head at Abu Mansur,
3 sinkholes at immediate US Derna

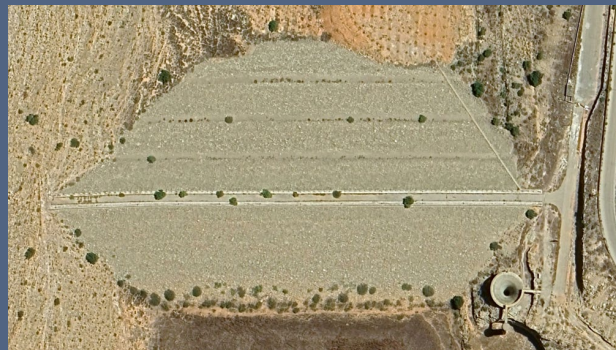
H_{\max} 73m (48m)
 $V=23.7 \text{ Mm}^3$

- Concern with the settlement at Abu Mansur dam crest
- Recommendation: periodic inspections

- Reassessment of the hydrology
- Design of new spillway facilities
- Improvement of water tightness
- Upgrade the monitoring system

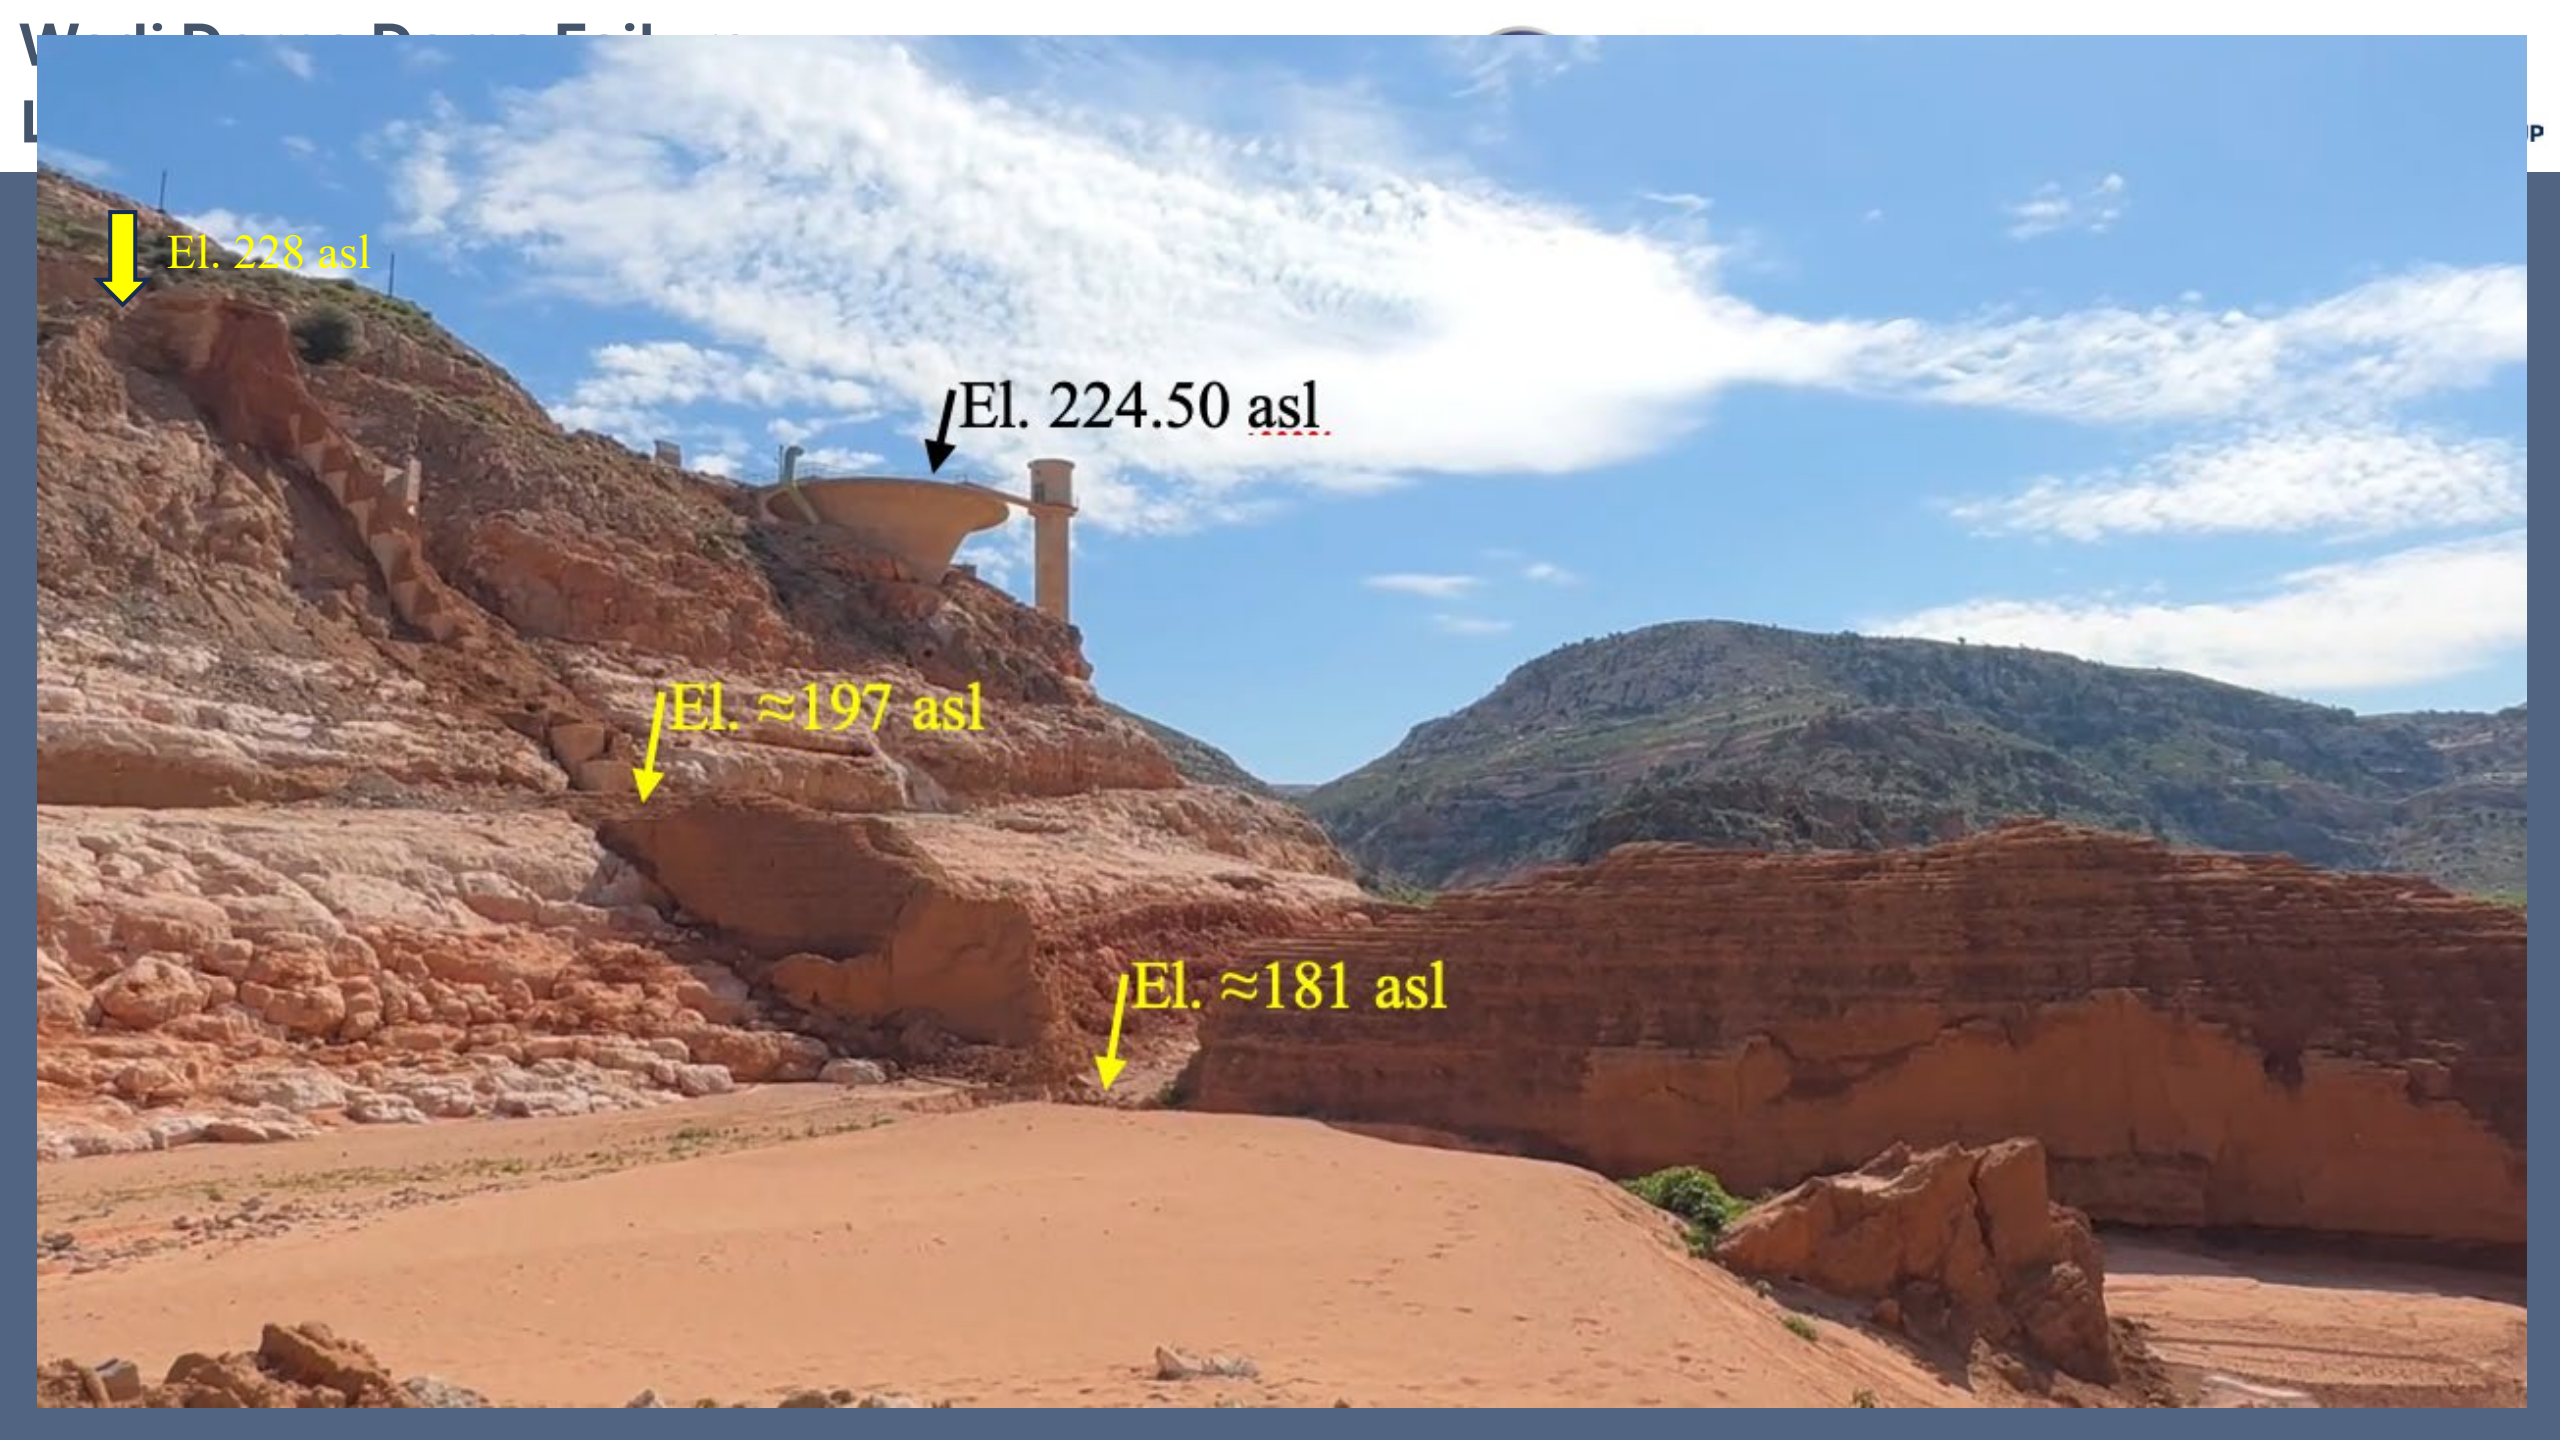
TYPICAL CROSS SECTION

Profile	Embankment height (m)	Settlement (m)		%
		1985	2004	
Crest	73 (core)	0.64	1.20 (x2)	1.6
Berm 1	38*	0.58	0.90 (x1.5)	2.4
Berm 2	26*	0.36	0.90 (x2.5)	3.4
Berm 3	14*	0.12	0.60 (x5)	4.3
