ICOLD TCDS - Technical Committee on Dam Surveillance

Technical Committee on Dam Surveillance

”Lessons learnt from case histories”

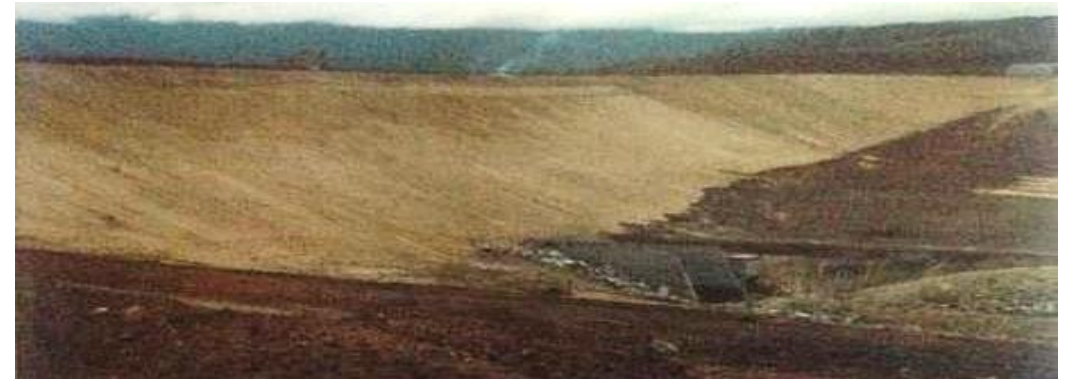
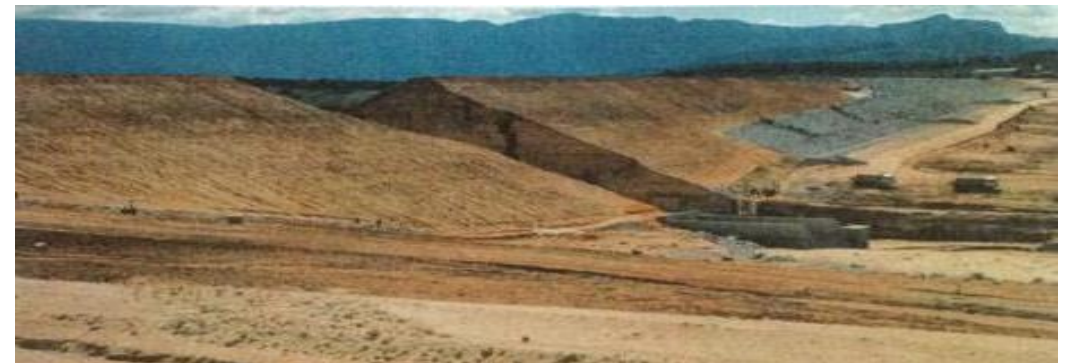
- **Piezometers** installed at two chainages (460 and 540) with three levels of instruments in each line to measure the phreatic line from upstream of the clay core to downstream of the chimney drain. Both lines were on the right bank, the first 30 metres from the outlet conduit and the second line of instruments 80 metres further
- Three **settlement cells** were added to the second line to measure the settlement at foundation level.
- The installation was done by an experienced private contractor
