SwedCOLD Workshop 3: Best Practices for Tailings Dam Breach Analysis

GruvRIDAS TV3 - The new guidelines for Tailings dam breach analysis and classification

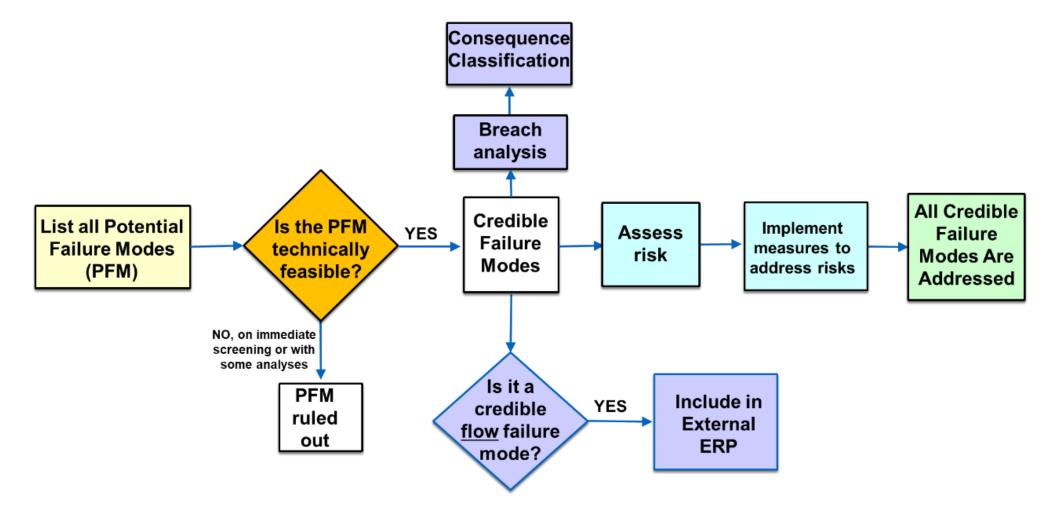
Credible Failure Mode – GISTM Flowchart

Prepared by: Angela Kupper for CFM workshop, Tailings and Mine Waste, 2021, Banff, Canada.

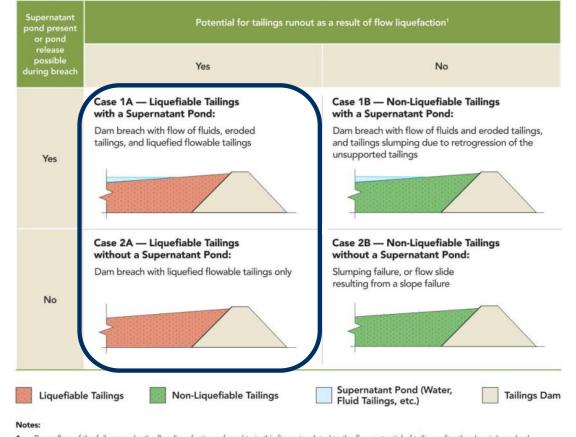
- Cases 1A & 2A: liquefiable tailings with/without a pond
- TDBA study case: Garpenberg TSF
 - Permit application
 - Consequence classification according to Swedish Environmental Law and GISTM
 - Disclaimer: no generalization from this specific example

1. Regardless of the failure mode, the flow liquefaction referred to in this figure is related to the flow potential of tailings after the dam is breached.

From Technical Bulletin on Tailings Dam Breach Analysis, CDA (2021)

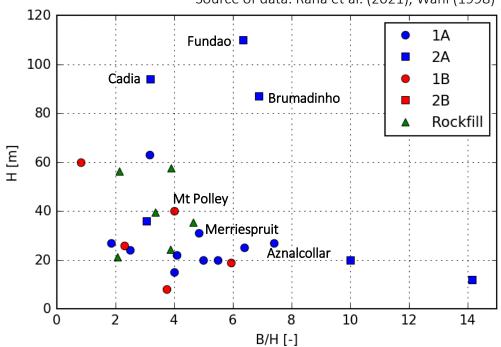
- Breach dimensions:
 - Analysis of historical events and existing guidelines
 - Data from rockfill dam failures included
 - Considered breach ratio B/H: 3 to 5
 - Advanced numerical models can also potentially be used

Source of data: Rana et al. (2021), Wahl (1998)

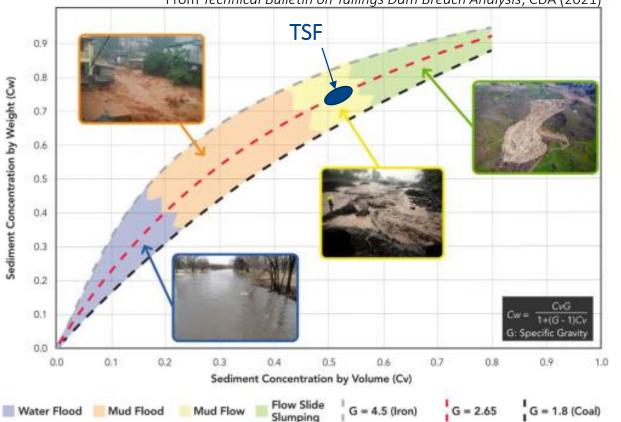
- Tailings rheology:
 - Outflow behaviour highly dependant ٠ on material concentration & degree of saturation
 - Tailings' volumetric concentration in • TSF estimated in range **Cv = 50-54%**
 - Rheological model used (runout):
 - Bingham ٠
 - Bulk density, viscosity, yield stress
 - Uncertaintes in rheological ٠ properties: two scenarios (span)
 - Mixing with d/s water bodies affects the rheological behaviour

From Technical Bulletin on Tailings Dam Breach Analysis, CDA (2021)

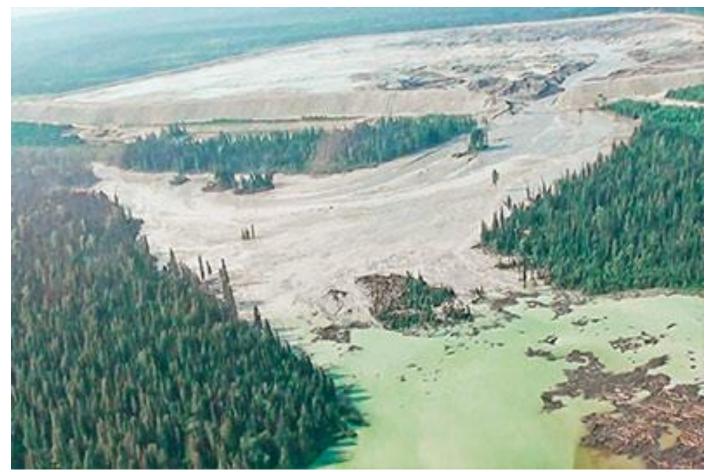
- Failure Mode:
 - Climate condition: Fair Weather
 - Triggers of the failure:
 - Weak foundation layer
 - Overly steep dam slope
 - Excavation near the dam toe
 - Mismanagement (pond close to the crest, insufficient freeboard)
 - Failure sequence
 - Phase 1 Dam crest deformation
 - Phase 2 Overtopping failure

Geotechnical Investigation of the Mount Polley Dam - KCB (klohn.com)

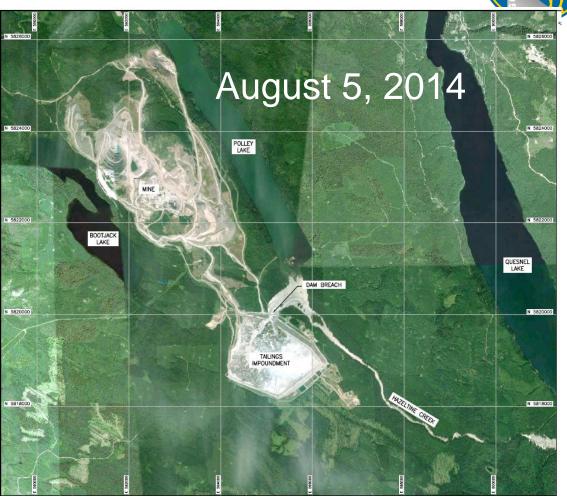
TABLE C4.5.2: BULK TAILINGS AND WATER VOLUMES

- Release Volume estimate:
 - Pond water:
 - ~10.6 Mm³
 - Mobilized Tailings:
 - ~13.8 Mm³
 - No noticeable flow liquefaction

MATERIAL/PROPERTY	PRE-BREACH CONTENTS (million cubic meters)	CONTENTS RELEASED (million cubic meters)	
FREE WATER	10.6*	10.6	
BULK TAILINGS	63.3	13.8	
TOTAL	73.9	24.4

Klohn Crippen Berger. 2015. Mount Polley tailings dam failure – Assessment of failure mechanism. Report No. M09954A01.730. BC Ministry of Energy and Mines, May 2015.

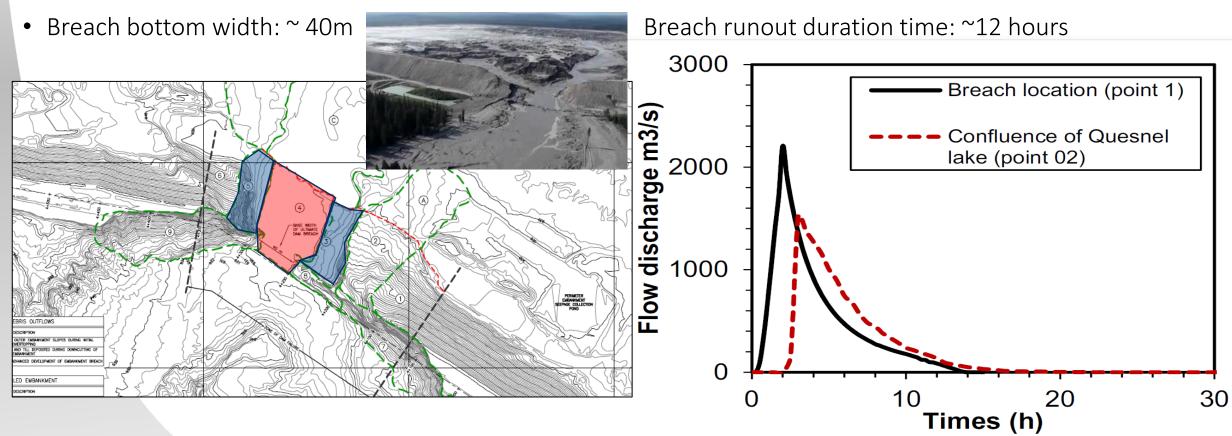
• Breach height: ~40m

• Breach side slope (H:V): ~1:1

Klohn Crippen Berger. 2015. Mount Polley tailings dam failure – Assessment of failure mechanism. Report No. M09954A01.730. BC Ministry of Energy and Mines, May 2015.

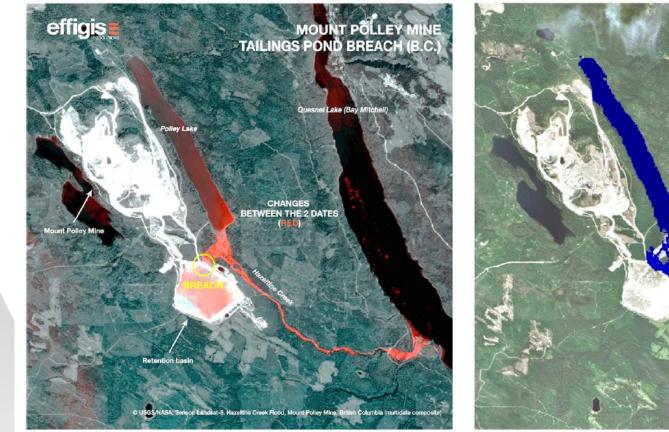
(a) Satellite Imagery

- Total volume of outflow was used assuming non-Newtonian flow
- Measured water level data from the lake at the downstream was used to calibrate rheology parameters
- Commercially available software Flo-2D was used (Mahdi and Dibike, 2020^{*})

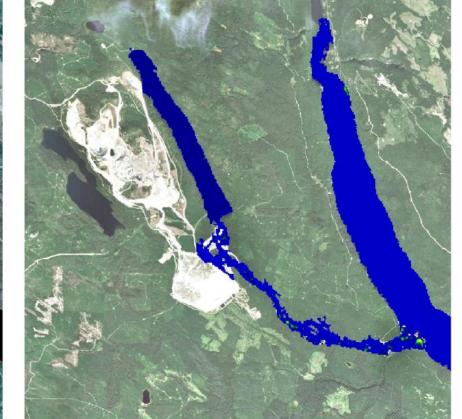
(b) Modelling result - inundation extent

Mahdi, A., Shakibaeinia, A., Dibike, Y.B., 2020. Numerical modelling of oil-sands tailings dam breach runout and overland flow. Sci. Total Environ. 703, 134568. https://doi.org/10.1016/J.SCITOTENV.2019.134568.

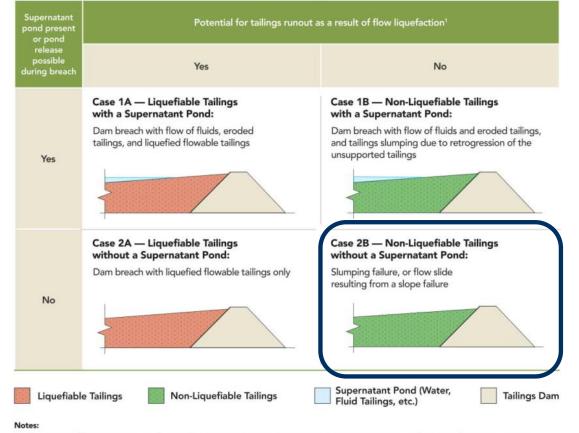
- Two hypothetical cases presented
- Both are closed sites
 - One site assumed postearthquake failure condtion
 - Other site assumed foundation shearing at normal conditon

From Technical Bulletin on Tailings Dam Breach Analysis, CDA (2021)

1. Regardless of the failure mode, the flow liquefaction referred to in this figure is related to the flow potential of tailings after the dam is breached.

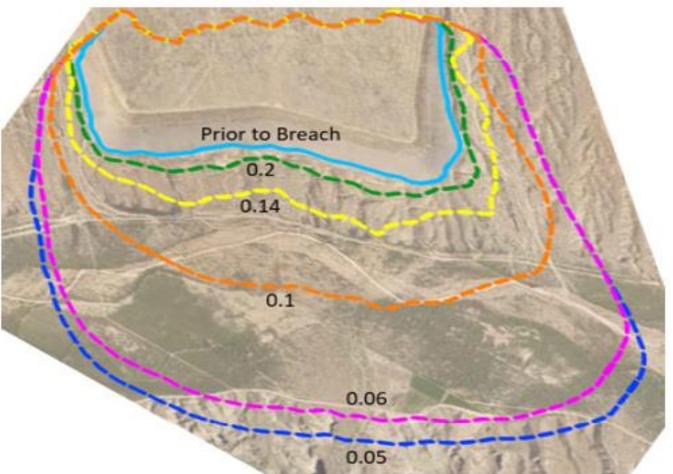
- Closed TSF with no liquefiable tailings stored
- It assumed entire dam can be breached
- Post-earthquake factor of safety was assumed less than 1.0 to initiate a hypothetical failure.
- Sensitivity analysis conducted on runout extent using a range of residual undrained shear strength ratios.

CDA 2021 Annual Conference (Chen et al. 2021)

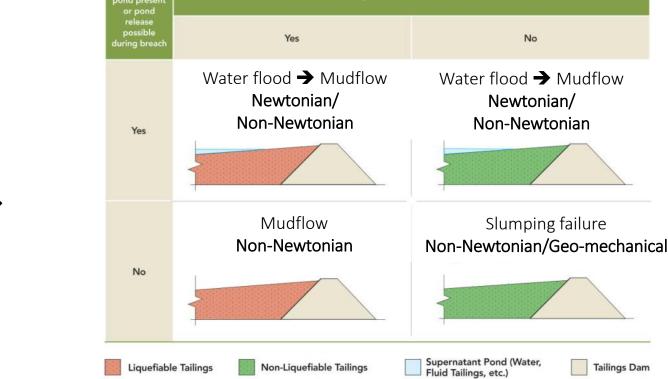
Potential for tailings runout as a result of flow liquefaction

- Type of analysis based on expected rheological behaviour (liquefaction potential, value of Cv)
- Importance of outflow processes and their order (water pond, tailings)
- For outflow of types water flood → mudflow, 2D hydrodyamic models with Newtonian & non-Newtonian rheological models are adapted
- Use of geomechanical models required for slumping failures

1. Regardless of the failure mode, the flow liquefaction referred to in this figure is related to the flow potential of tailings after the dam is breached.

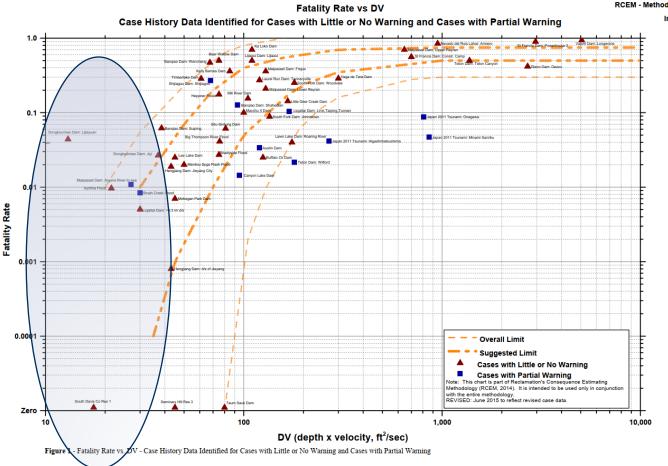
• RCEM Methodology (USBR, 2014)

- Database with world-wide case histories of fatalities caused by floods/breaches in water dams
- Two charts:
 - "Little or no warning"
 - Warning is considered to be "adequate".
- Observed fatality rates are specific to the warning scenario, time of day and year, etc of the incident
- Uncertainty range is increasing for the lowest flood severity values (DV values < approx. 5 m2/s)

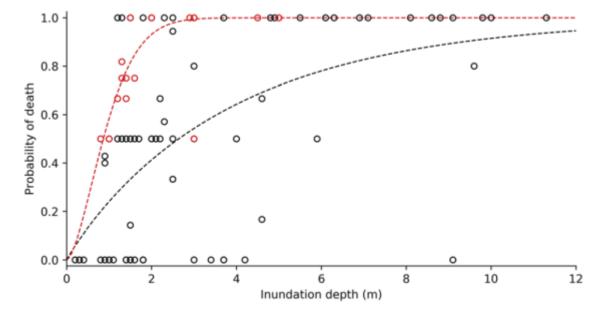
• Ex debris flows and fluidized landslides, Pollock and Wartman, 2020

Figure 11. Fatality rate depending on flow depth for debris flows and fluidized landslides in economically developing (red curve) and developed (black curve) countries (Pollock and Wartman, 2020).
